# Geoenvironmental Appraisal

## Land at Lundhill Road, Wombwell For Persimmon Homes West Yorkshire

Report no: 2409/2A

Date: December 2017

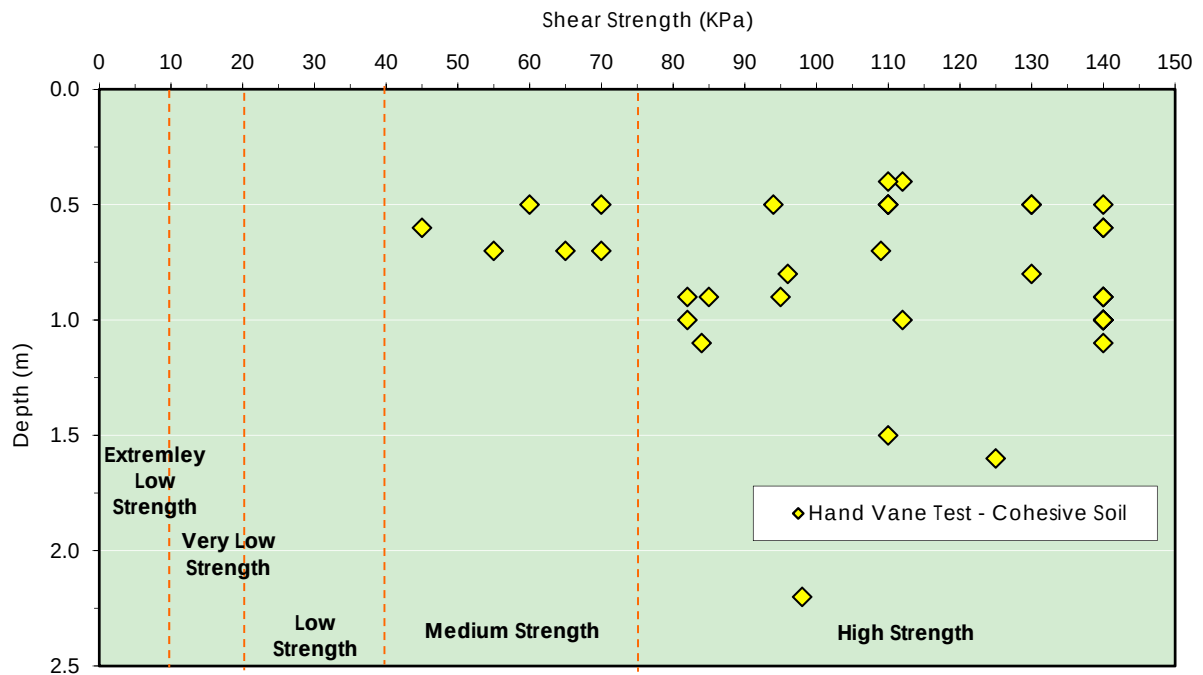
### Hand Vane Test - Cohesive Soil

- 11.3.7 Hand shear vane testing was undertaken within trial pits in-situ to around 1.2m depth and from larger blocks of excavated clay below that depth.
- 11.3.8 The results are summarised within the plot below and illustrate a linear increase in undrained shear strength ( $S_u$ ) with depth within the cohesive deposits. Below approximately 0.5m depth  $S_u$  is typically greater than 80kPa.
- 11.3.9 The plot on page 25 provides a summary of undrained shear strengths.

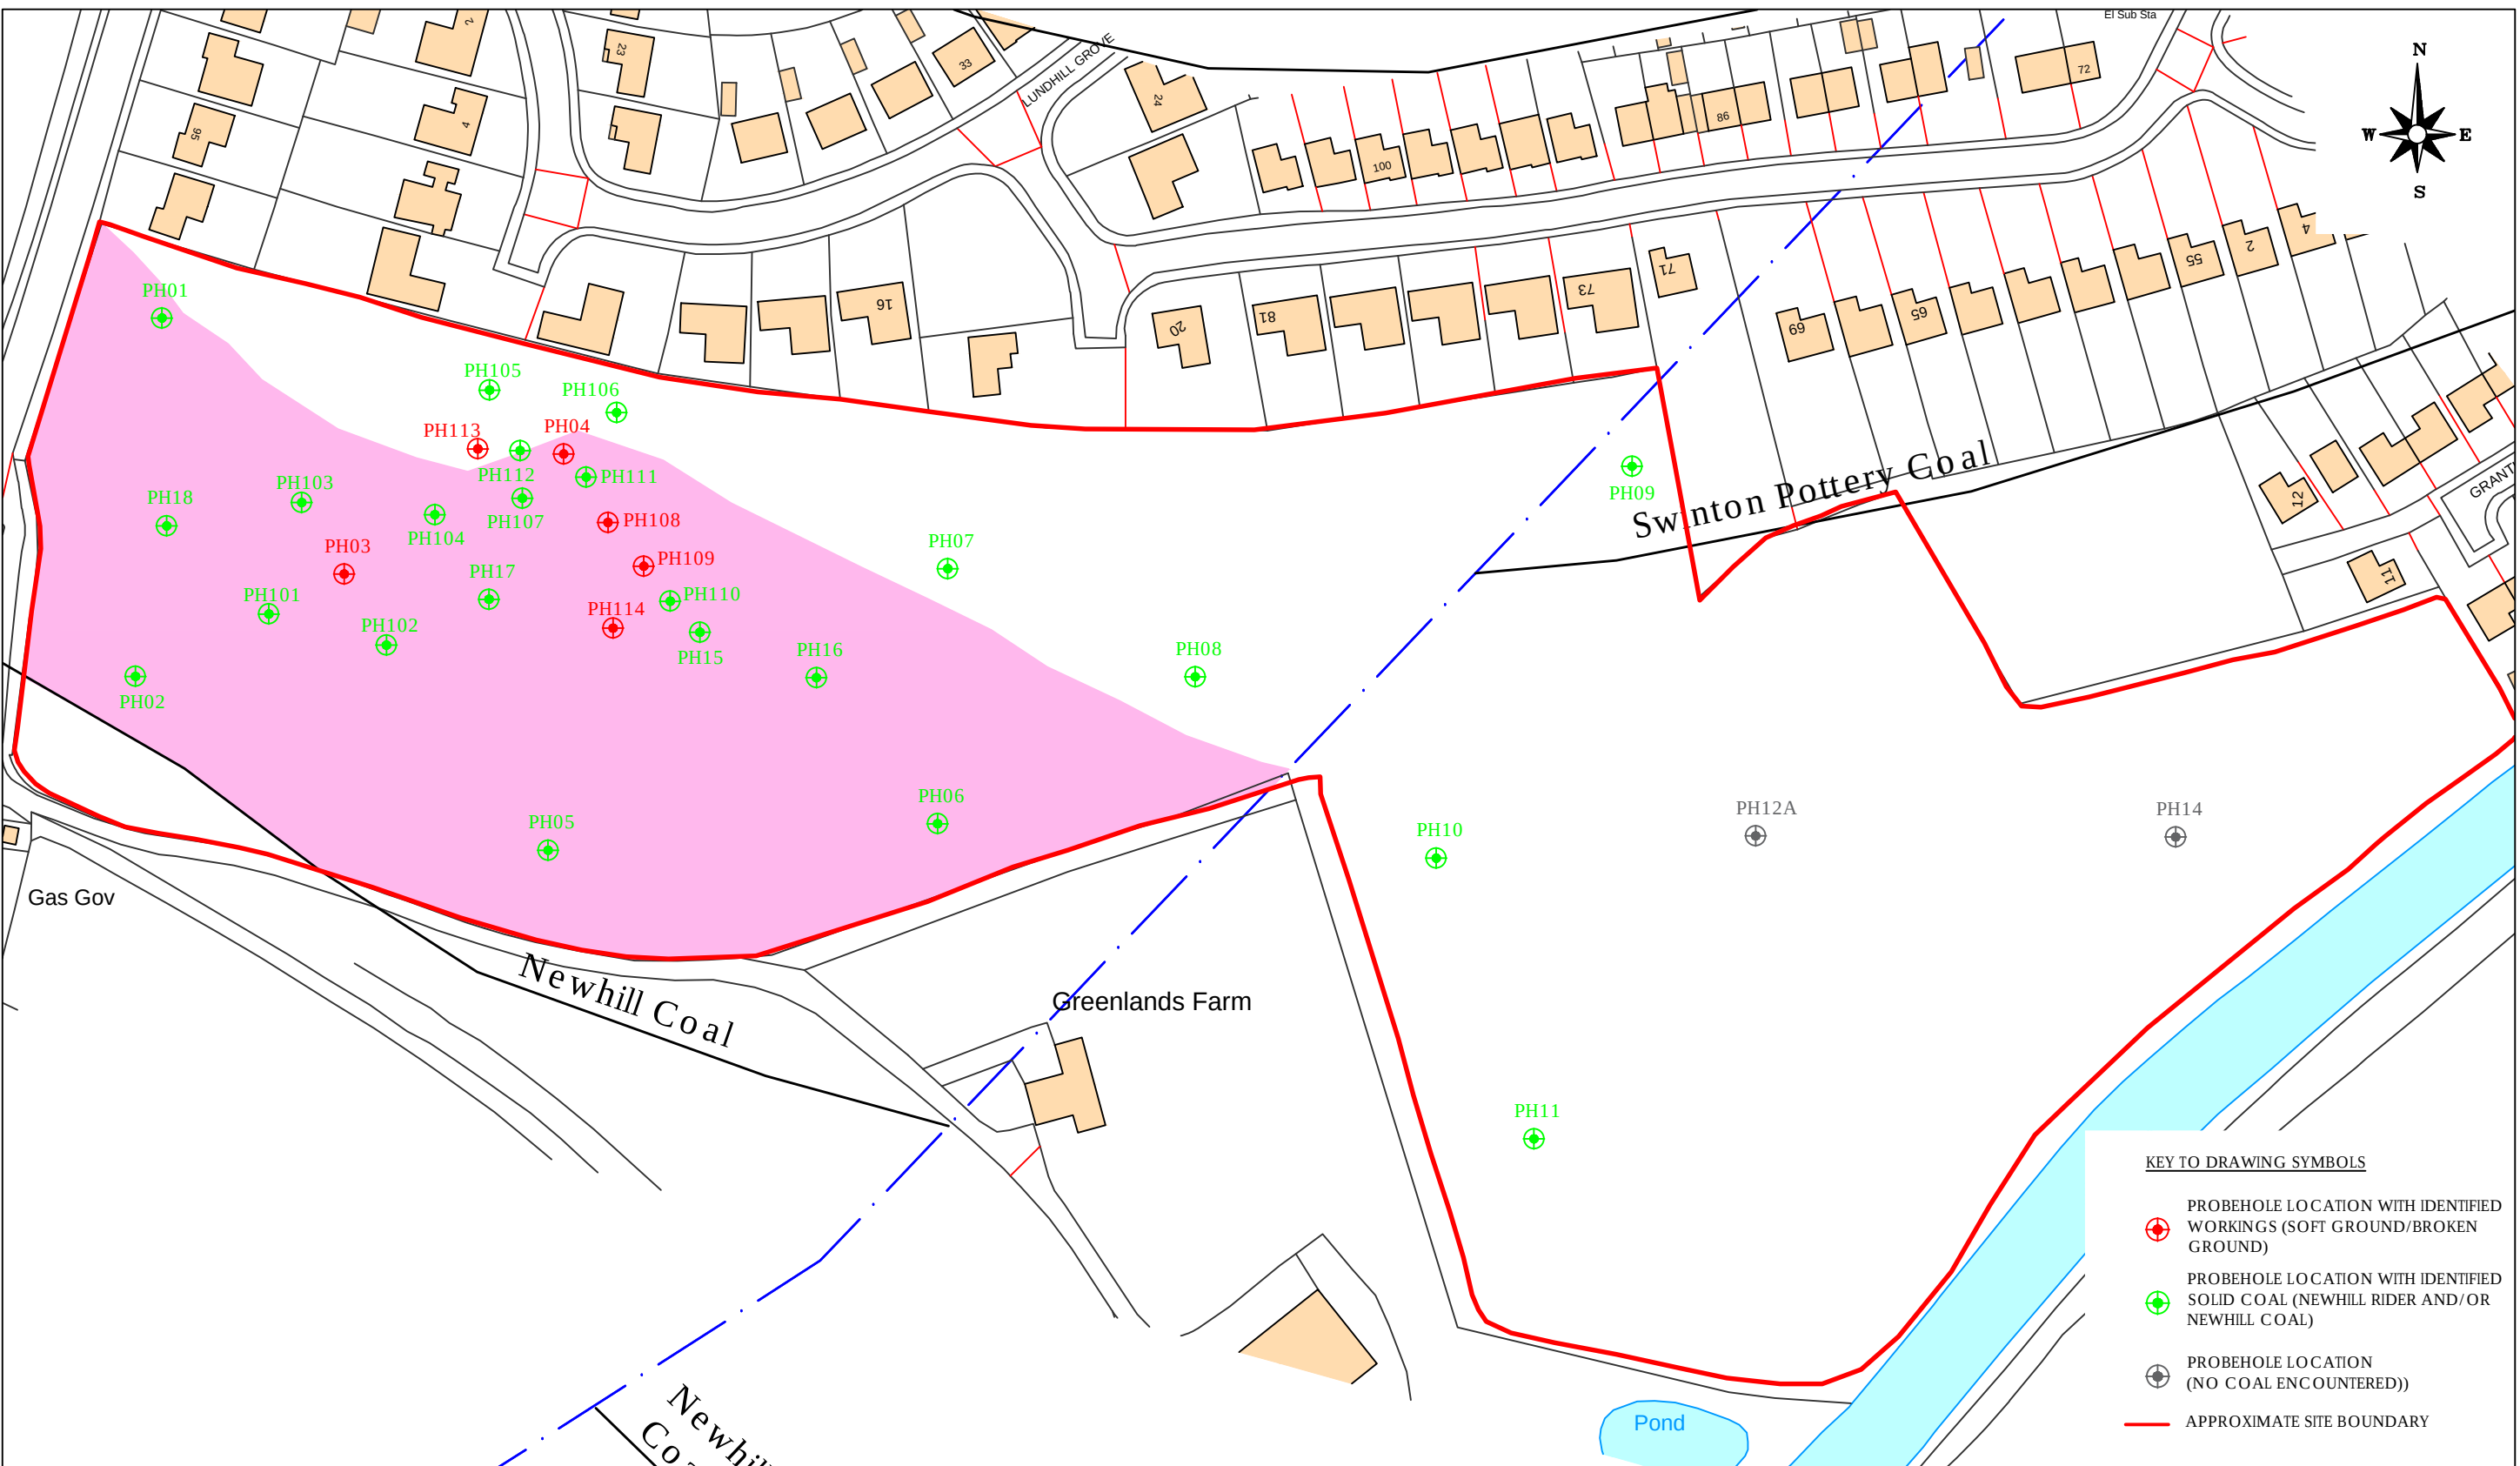
- 7.8.8 However, soft and broken ground with less than 10x competent cover was identified in 5 of the probeholes (PHs 3, 4, 108, 109 & 114). Further soft and broken ground with >10 times competent cover was also recorded in PHs 112 & 113. Probeholes with identified shallow workings (Soft Ground/Broken Ground) are shown on Drawing 2409/9 in Appendix B.

- KEY TO DRAWING SYMBOLS**
- PROBEHOLE LOCATION WITH IDENTIFIED WORKINGS (SOFT GROUND/BROKEN GROUND)
  - PROBEHOLE LOCATION WITH IDENTIFIED SOLID COAL (NEWHILL RIDER AND/OR NEWHILL COAL)
  - PROBEHOLE LOCATION (NO COAL ENCOUNTERED))
  - APPROXIMATE SITE BOUNDARY

- 12.2.5 Probeholes with identified shallow workings (Soft Ground/Broken Ground) are shown on Drawing 2409/9 in Appendix B.
- 12.2.6 Consequently, given the above, mitigation of risks to surface stability are considered necessary in the north-west of the site

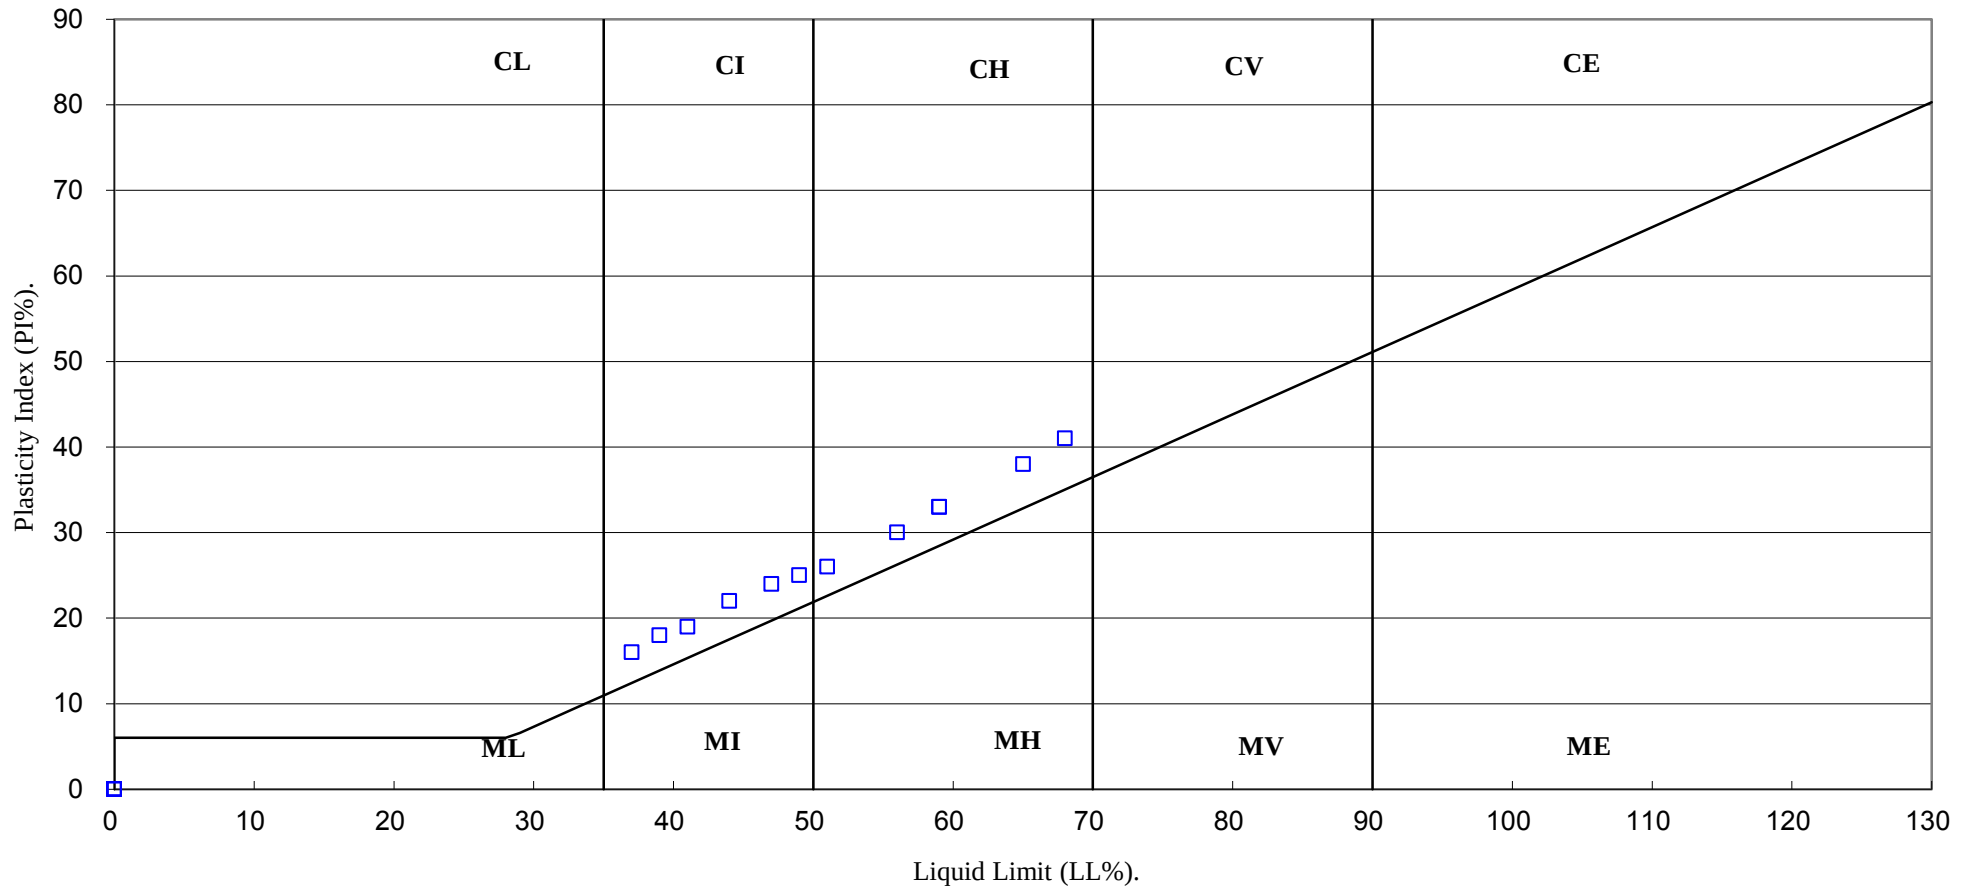
# PLASTICITY CHART FOR CASAGRANDE CLASSIFICATION.

(BS5930 :2015)

- 11.2.2 Only one sample had a PI of >40% (at 41%), therefore, for the purposes of foundation design, it is recommended that all cohesive soils be regarded as being of medium shrinkability.
