WINDOW SAMPLE LOG

| Contract:<br><b>A635 Barnsley Bus RapidTransit Route</b> | | Client:<br><b>Barnsley Metropolitan Borough council</b> | | Window Sample:<br><b>WS18</b> |
| Contract Ref:<br><b>765865</b> | Start: <b>21.08.24</b><br>End: <b>21.08.24</b> | Ground Level:<br><b>46.77</b> | National Grid Co-ordinate:<br><b>E:437304.5 N:405618.9</b> | Sheet:<br><b>2 of 3</b> |

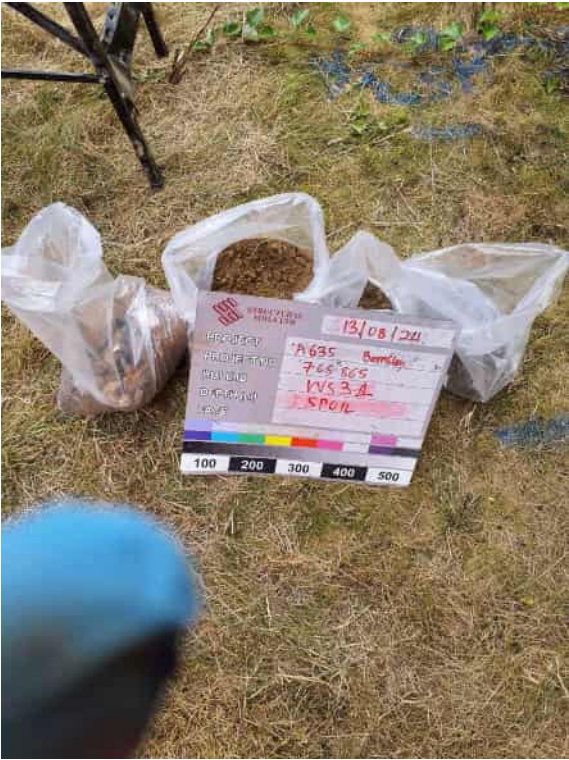
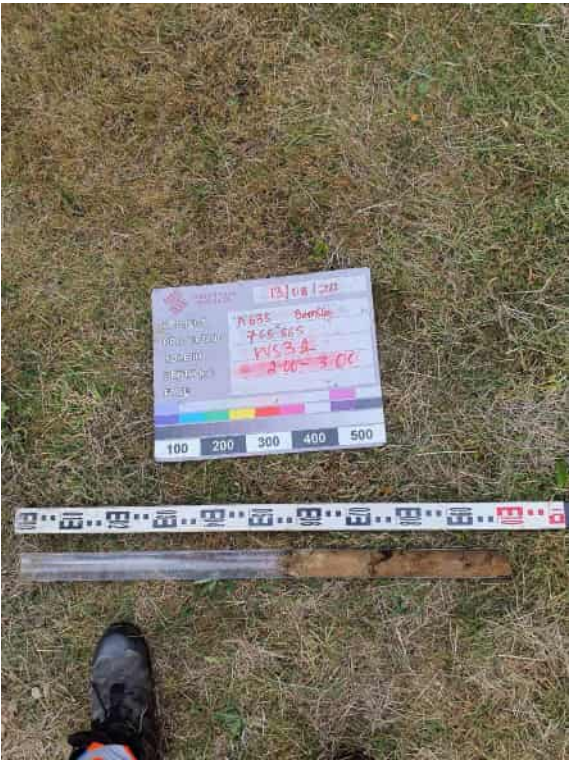
| Contract: <b>A635 Barnsley Bus RapidTransit Route</b> | | Client: <b>Barnsley Metropolitan Borough council</b> | | Window Sample: <b>WS34</b> |
| Contract Ref: <b>765865</b> | Start: <b>13.08.24</b><br>End: <b>13.08.24</b> | Ground Level: <b>42.60</b> | National Grid Co-ordinate: <b>E:437260.4 N:405788.7</b> | Sheet: <b>3</b> of <b>4</b> |

| Method Used: <b>Inspection pit + Tracked window sampling</b> | Plant Used: <b>Archway Competitor</b> | Drilled By: <b>Sam Keenan</b> | Logged By: <b>KAdedotun</b> | Checked By: <b>AG</b> | <b>AGS</b> |
