# FALL HEAD FARM

Fall Head Lane, Silkstone, Barnsley

## Historic Building Record

Document No: TJC2021.76  
Planning No: 2021/0190  
OASIS No: thejesso1-426744

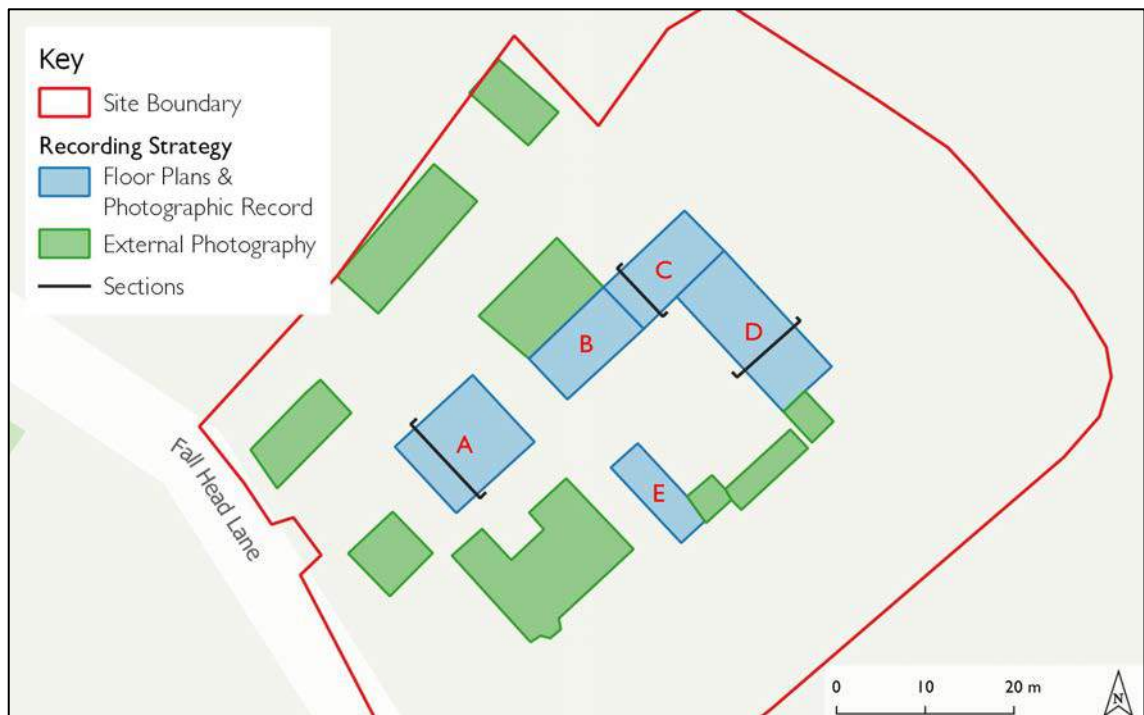
Figure 2: Site Layout showing recording strategy

3.3.1. The site (**Figure 2**) comprises a courtyard plan farmstead with detached two-storey farmhouse towards the south. The application for conversion encompasses the following buildings, where detailed recording is proposed:

- **Building A:** Two storey ancillary accommodation and implement shed
- **Building B:** Two storey stables and loft
- **Building C:** Single storey cattle shed
- **Building D:** Two storey combination barn with threshing barn and attached cowhouse
- **Building E:** Single storey range of loose boxes

The recording strategy is illustrated on **Figure 2**.

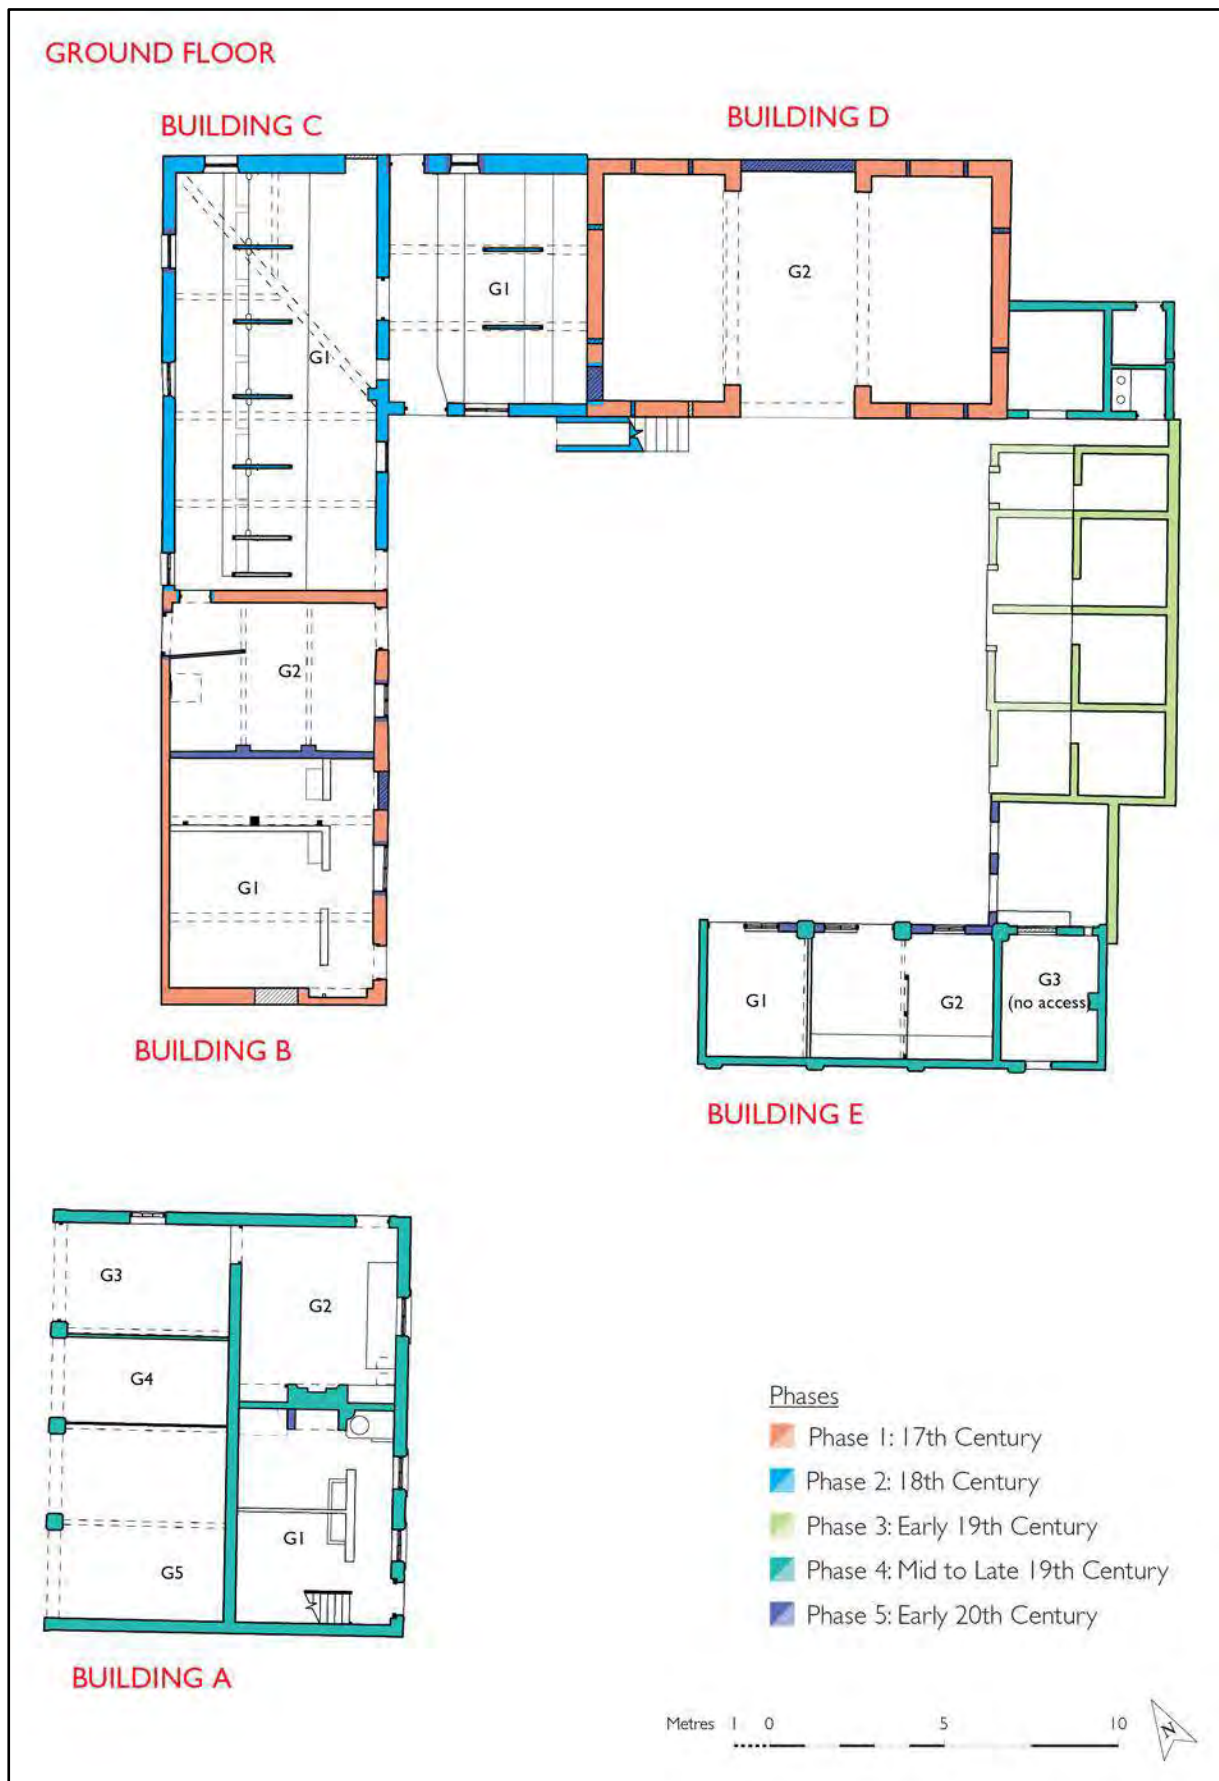
Figure 3: Phased ground floor plans

Four principal phases of development and alterations have been identified at Fall Head Farm:

| <b>Phase 1:</b> Mid-18 <sup>th</sup> Century | Construction of the farmhouse, <b>Building B</b> , <b>Building C</b> and <b>Building D</b> . |
| <b>Phase 2:</b> Early 19 <sup>th</sup> Century | Construction of <b>Building C</b> , potentially on the site of an earlier building.<br>Extension of <b>Building D</b> . |
| <b>Phase 3:</b> Mid-19 <sup>th</sup> Century | Construction of the pigsties. |
| <b>Phase 4:</b> Late 19 <sup>th</sup> Century | Extension of the farmhouse.<br>Construction of <b>Buildings A</b> , on the site of an earlier building.<br>Re-roofing a of <b>Building C</b> .<br>Construction of <b>Building E</b> and the outhouse east of <b>Building D</b> . |
| <b>Phase 5:</b> Mid to Late 20 <sup>th</sup> Century | Refurbishment of <b>Buildings A, B, C, D &amp; E</b> |

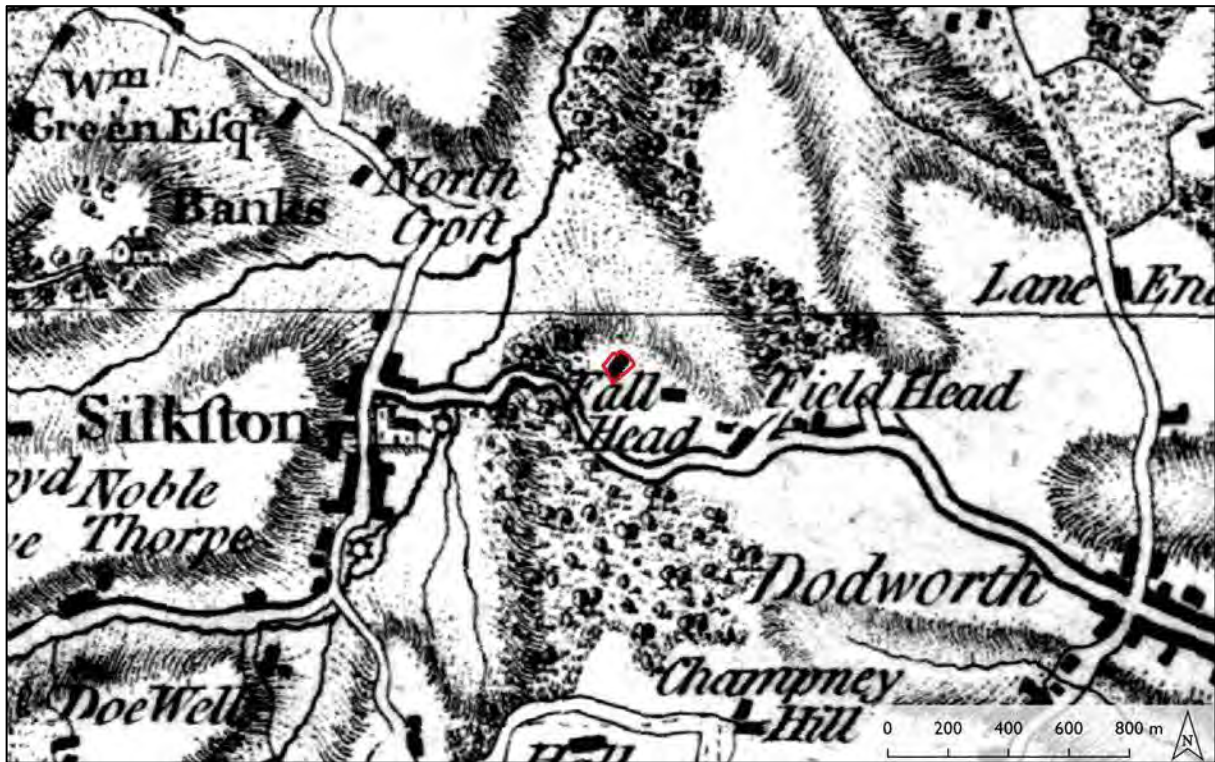
Appendix I.1: 1771 Jeffreys map of the West Riding

Fall Head is named on the Thomas Jeffry's 1767 map of Yorkshire (**Appendix 1.1**), with two rectangular buildings shown possibly correlating to Lees Hall Farm and Fall Head Farm. A deed of exchange from 1752 records the transfer of a close called Nar Over Lees, a dwelling, and a threshing floor to Francis Burdett, a tanner of Lees or Fall Head, to Robert Fretwell, tanner of Potterton, in exchange for Hollings close, a watercourse in Long Close for the supply of Fretwell's tanyard, and a barn north of the threshing floor, all near Lees (Sheffield Archives: COAL/Y1/12/7). Notably, Hollings survived as a field name into the 1840s with the tithe survey of 1845 recording it immediately west of Fall Head Farm (plot 398). The same survey records a tannery within the woods immediately north of Fall Head Farm, comprising a tanyard, croft and orchard (included under plot 376). It is likely that Burdett's address was Lees Hall Farm, to the east of the site, for which deeds potentially survive covering the period 1699-1832 ("The Lees of Fall Head"; Sheffield Archives: COAL/Y1/12).

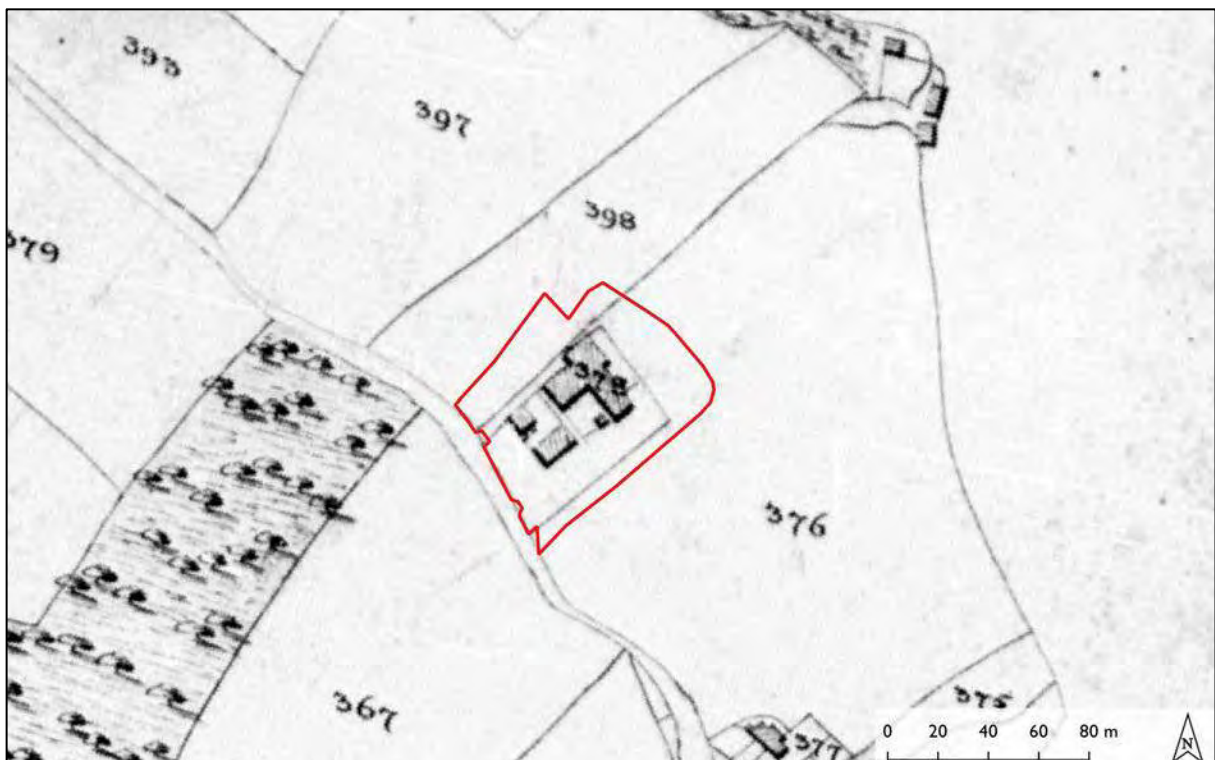
Appendix I.2: 1845 Silkstone tithe map  
(© The Genealogist)

The tenancy was subsequently taken up by George Hinchliffe, who is recorded as occupying the farm in the 1845 tithe survey, with the owner identified as John Spencer Stanhope. This was possibly the same George Hinchliffe who was recorded as a woodsman at Barnaby Furnace in 1824 (Leeds Intelligencer 19 February 1824, 2), and then in the 1841 poll book at Low Mill, Dodworth. The tithe map (**Appendix 1.2**) shows Fall Head Farm to comprise two detached buildings to the south

(presumably the farmhouse and **Building A**), an L-shaped range to the north (**Buildings B-D**), and a small building to the east (on the site of the pigstys).

By the time of the 1845 tithe map (**Appendix I.2**) the farm is shown to occupy its current basic form, with **Building B-D** shown to the north-east and north-west, the house to the south, and smaller buildings on the sites of **Building A** and the pigsties. Additional ranges, potentially lean-tos are shown to the west and north of **Building C**. The present pigsty range was likely built within a few decades of the tithe map and structural joints indicating it represented a discrete stage of development within the latter half of the 19<sup>th</sup> Century, predating the buildings of Phase 4.

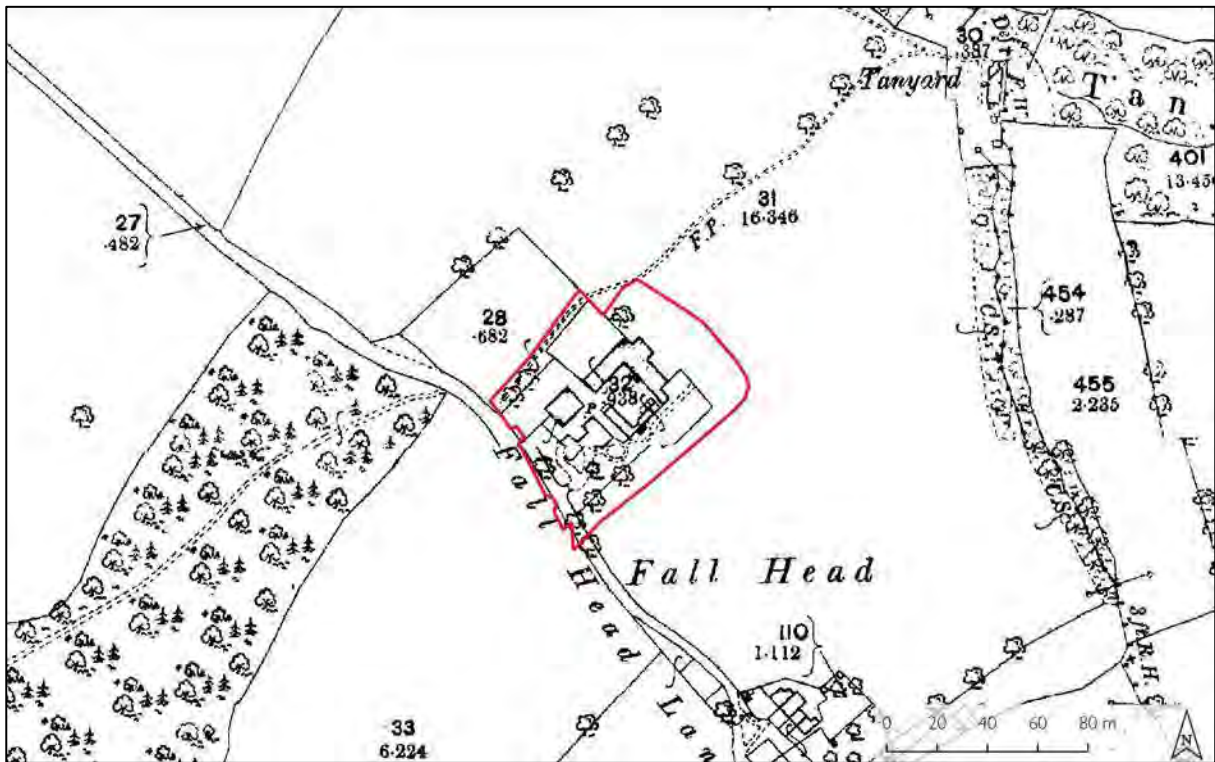
Appendix I.3: 1893 Ordnance Survey

The 1893 Ordnance Survey (**Appendix I.3**) shows the farm had been extended since the 1850s, with the addition of **Building E** and the adjoining perpendicular range to its east containing pigsty's. An extension is also shown to the rear of **Building D**.

By the production of the 1893 OS map (**Appendix I.3**) the farm had been extended, with: a new wing to the west of the house; **Building A**; the midden and outhouse to the east of **Building D**; the pigsties; and **Building E**. These additions are characterised by the use of yellow brick in forming quoined jambs to openings, and rock faced sandstone for quoins, lintels and sills. The style of these buildings is suggestive of a late 19<sup>th</sup> Century date, potentially in the 1870s or 1880s.

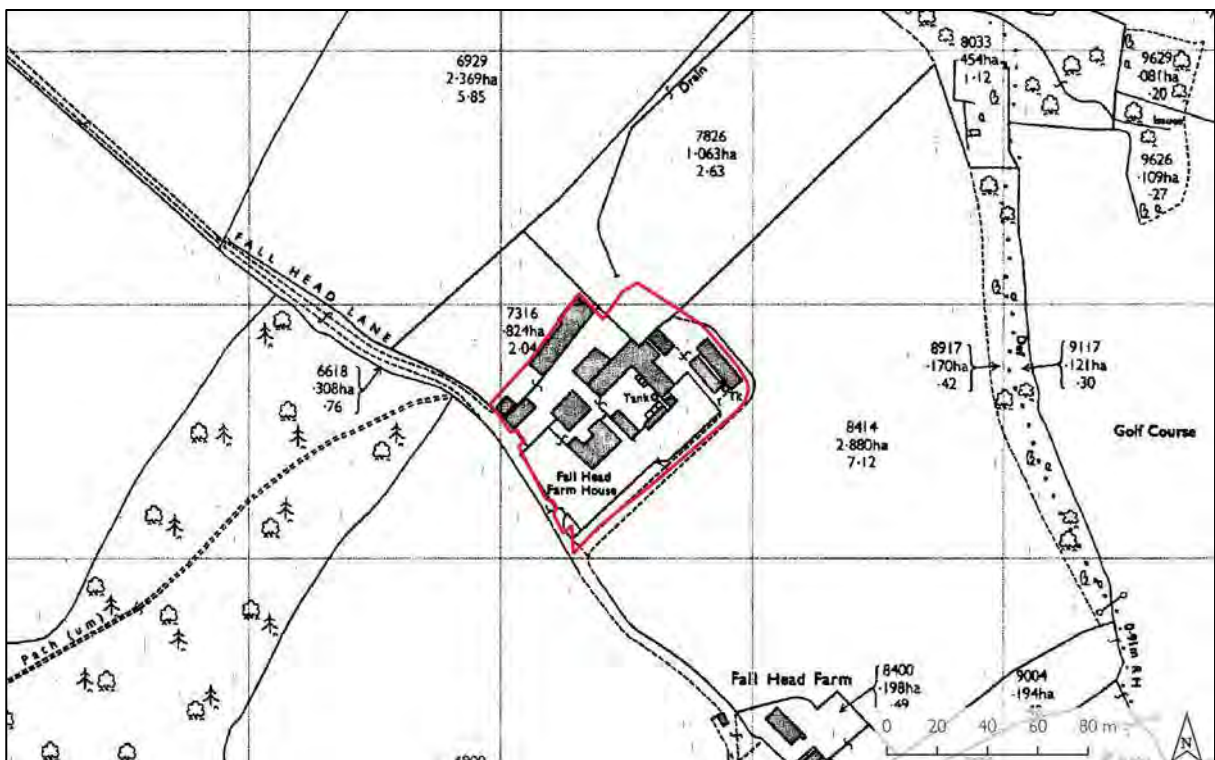
Appendix I.4: 1971 Ordnance Survey map

Subsequent Ordnance Survey maps of 1907, 1931, 1955 and 1961 show no changes to the layout of the farm. With the publication of the 1971 edition (**Appendix I.4**) various additions had been made including several detached buildings to the west and north of the earlier buildings.
