Report No: C312  
Date: February 2019

**PRELIMINARY INVESTIGATION  
of land at  
COCKLE EDGE FARM, INGBIRCHWORTH, Nr PENISTONE,  
SOUTH YORKSHIRE**

| <b>REPORT TYPE:</b> | Preliminary Investigation | | |

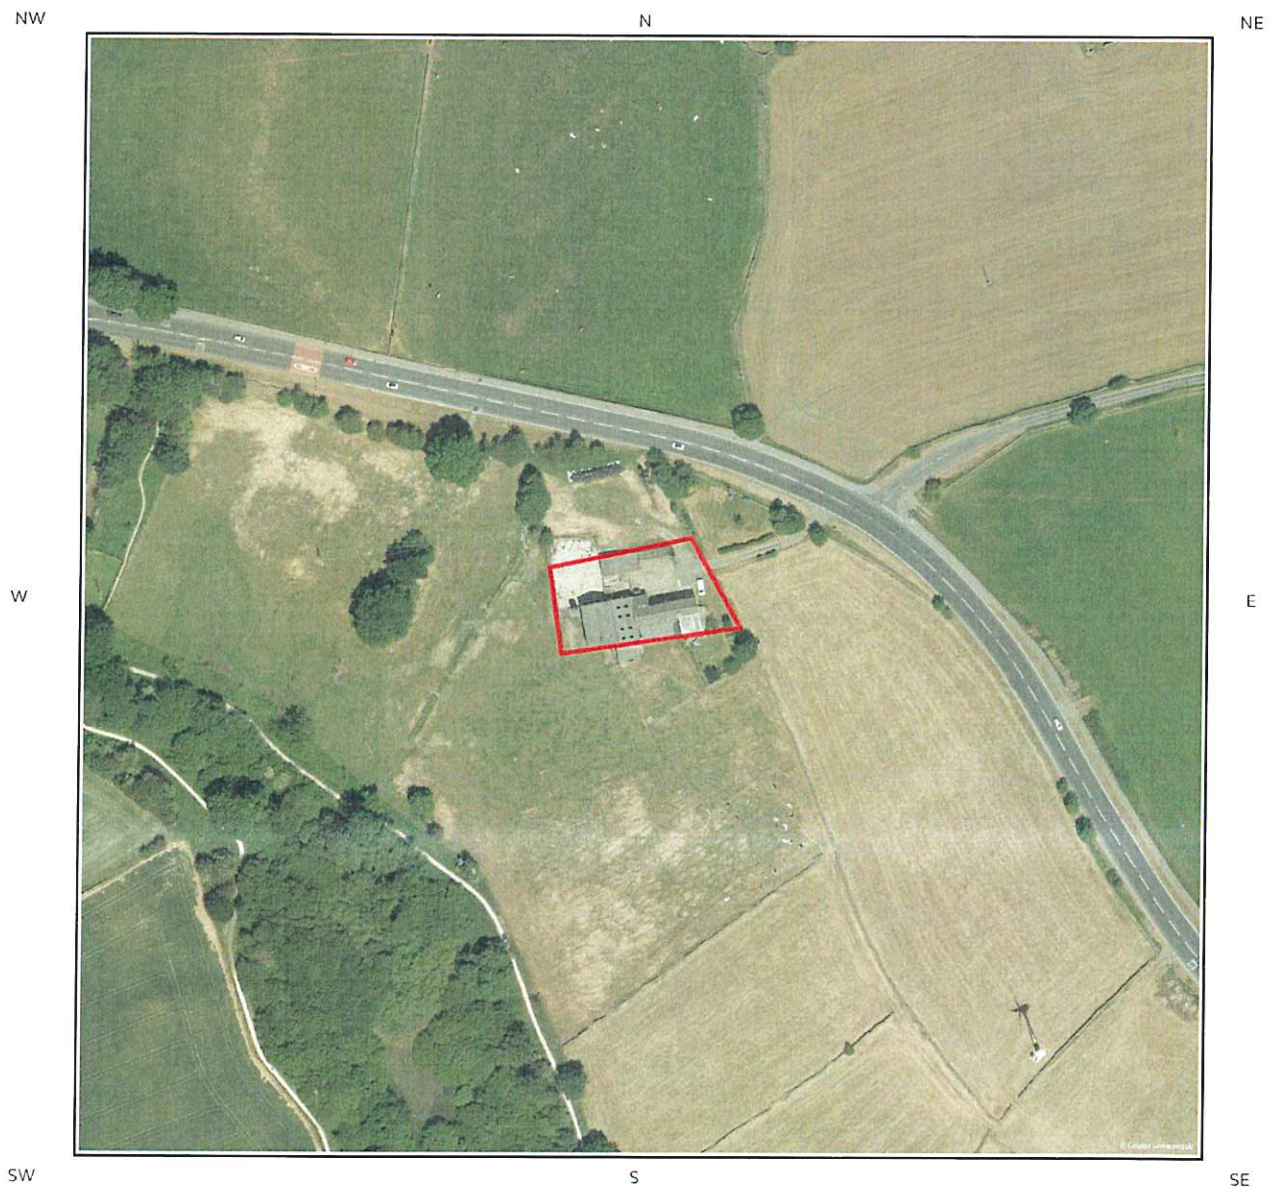
Aerial Photograph Capture date: 07-Jun-2013  
Grid Reference: 422920,405559  
Site Size: 0.16ha
