Arboricultural Impact Assessment

Watermill Gardens

Penistone

Job Ref: 22037

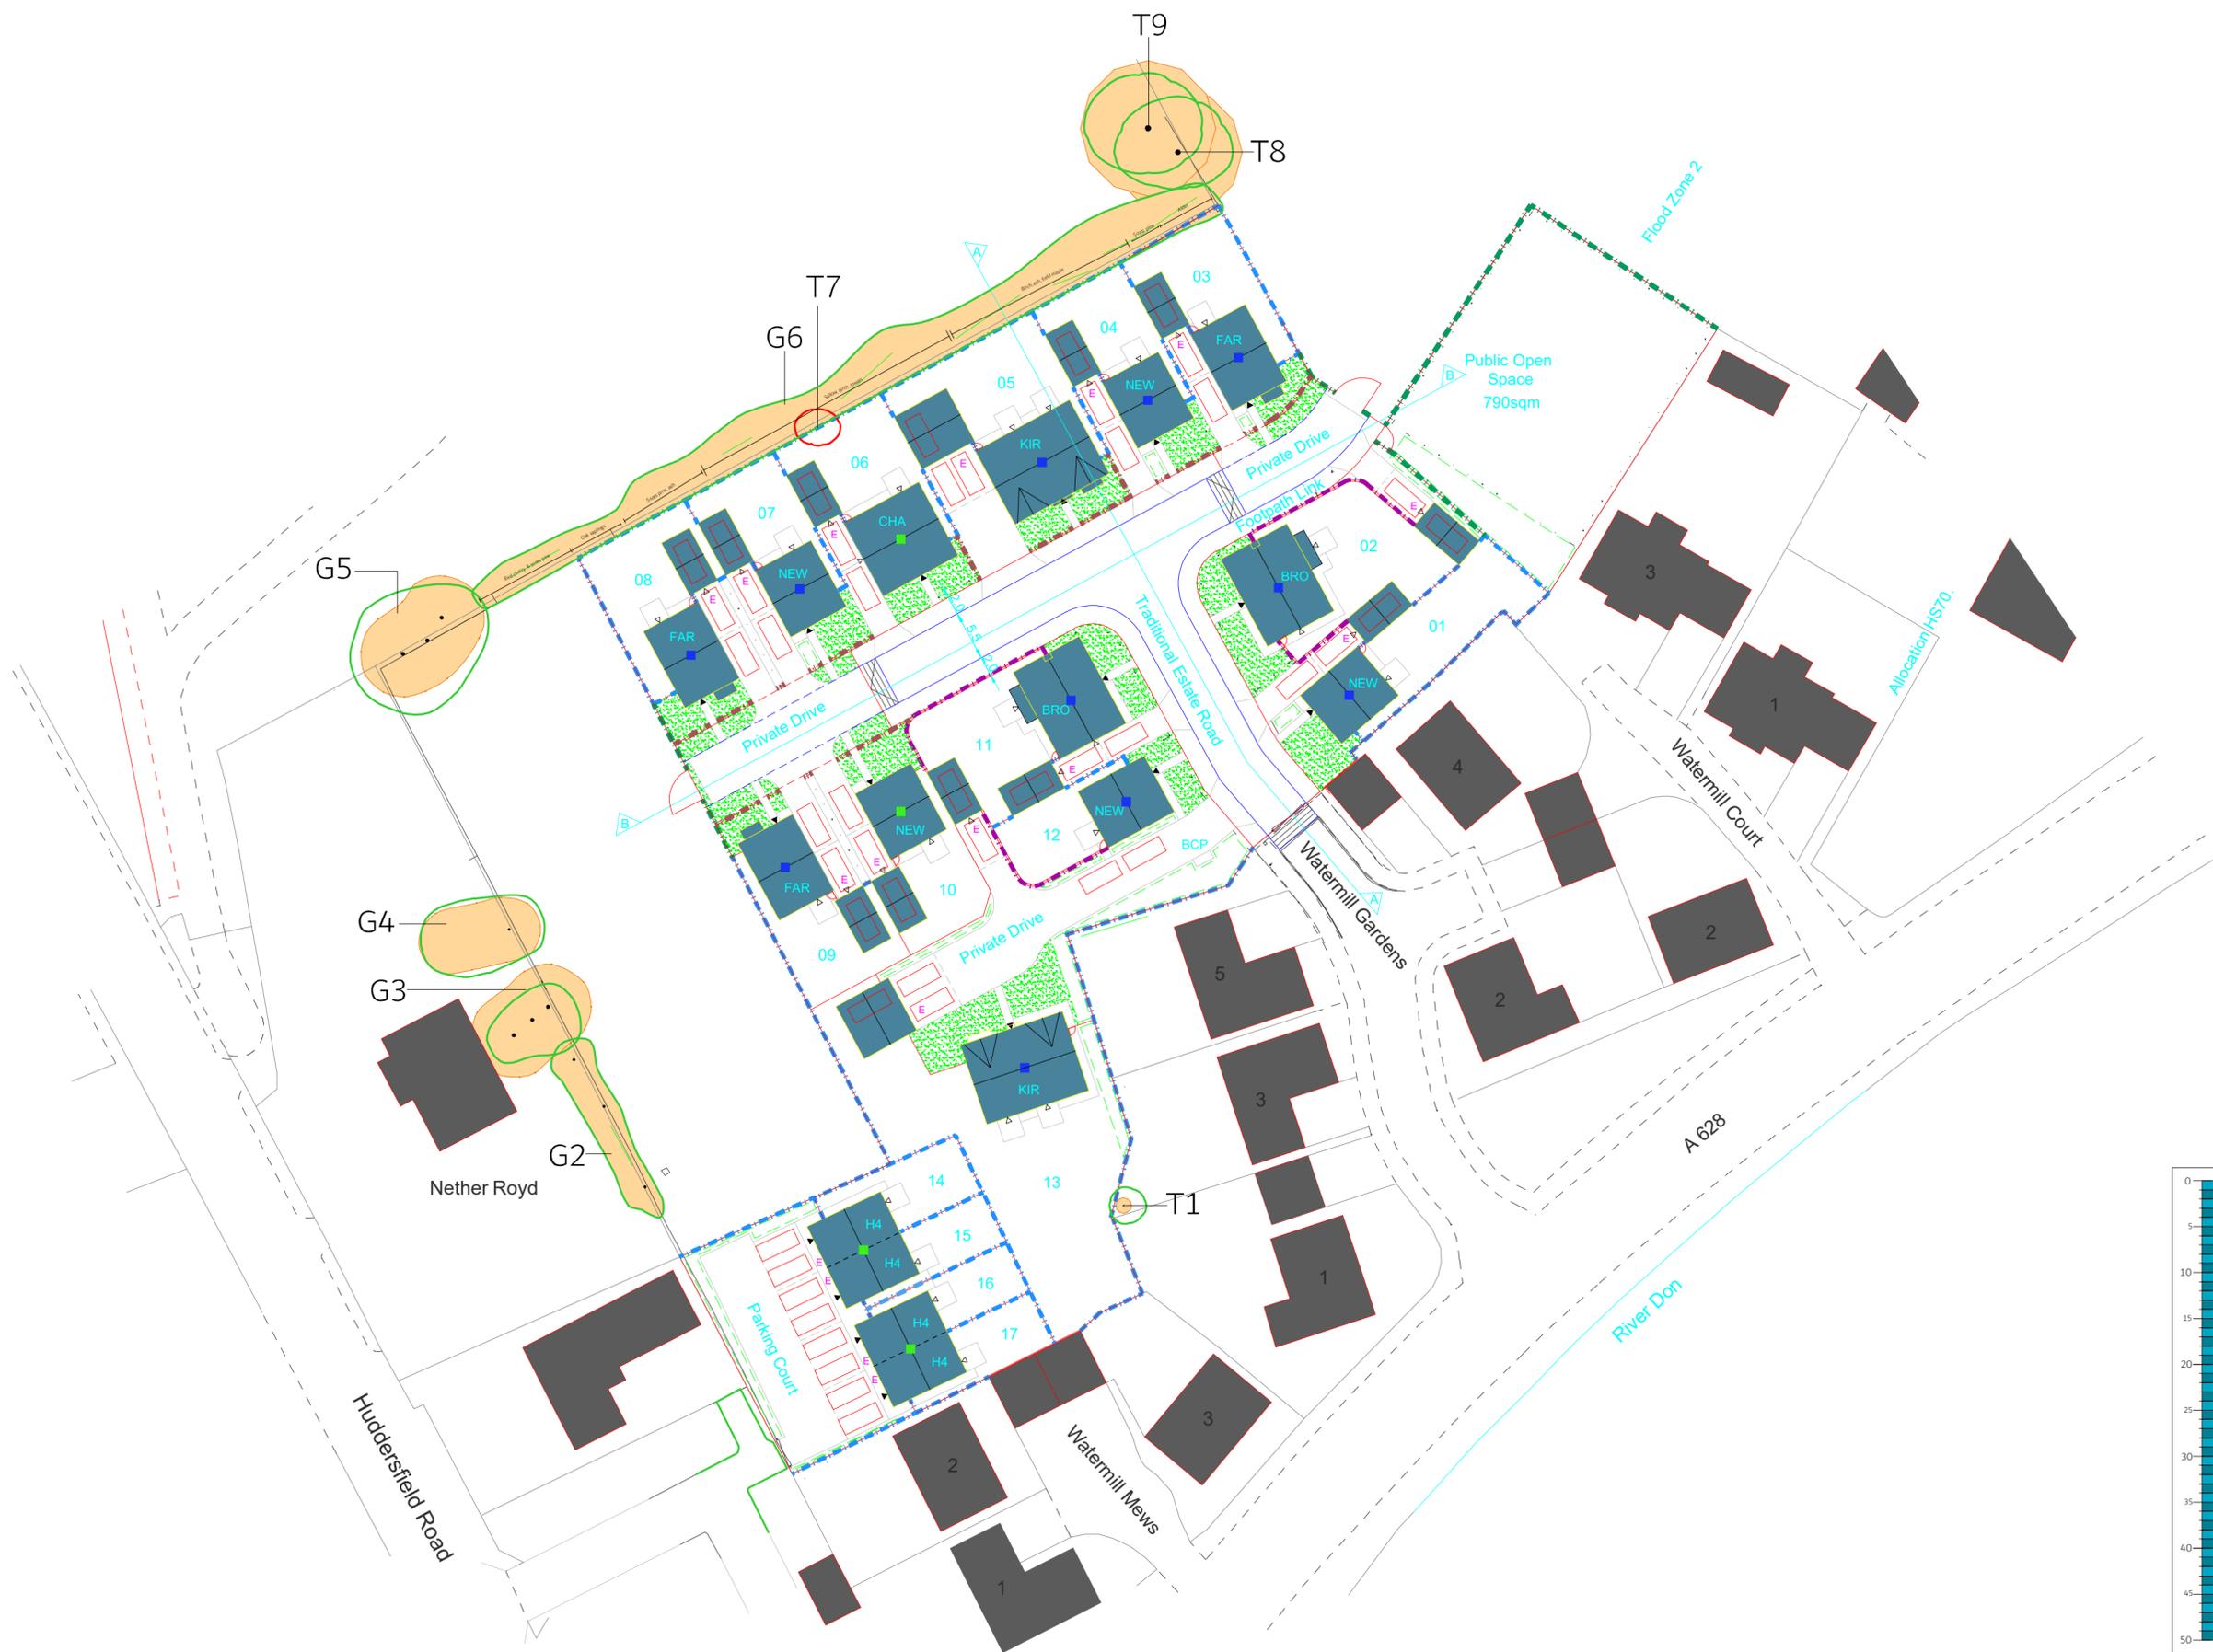
Appendix 2: Tree Impact Plan

Site: Watermill Gardens, Penistone, Sheffield, S36 8AJ.

Project Ref:	22037	Drawing Ref:	002
Scale:	1:500	Printing size:	A2

T1 Tree reference number. Sequential number preceded by item type: T=individual tree, G=group, H=hedge, W=woodland group.

- 1.3 The Tree Schedule at **Appendix 1** includes all the data gathered during the survey. The Tree Impact Plan at **Appendix 3** overlays this information with the proposals and shows what the impacts are on the existing trees.

- 2.1 Tree Survey Solutions (T.S.S) have been instructed by the client to provide an Arboricultural Impact Assessment (AIA), including a Tree Impact Plan.
- 2.2 In order to conduct the assessment, we have been supplied with a copy of the proposals (drawing ref: 1286.04 REV 0) which, along with any discussions we have had with design team members and/or local authority officers forms the basis of the Tree Impact Plan at **Appendix 2**.

- 12.1 The retained trees are located sufficiently far from proposed structures that no protective measures are deemed necessary in this case. Off-site trees along the northern boundary will be protected by the existing dry-stone wall which is to remain in place. This is considered sufficient as no RPAs extend into the site beyond the line of the dry-stone wall.
- 12.2 No arboricultural mitigation or compensation is considered necessary for this scheme. However, the Detailed Landscape Proposals (Drawing ref. 4015/1) specifies a range of new planting including 26 trees 251 shrubs and a number of hedgerows throughout the site. With no trees requiring removal to facilitate the development, all of these represent a net gain in tree/shrub numbers for the site.
