**LAND AT WHAMS ROAD,  
CROW EDGE, HEPWORTH,  
SOUTH YORKSHIRE, S36 4HE**

**PHASE 2 GEO-ENVIRONMENTAL INVESTIGATION REPORT**

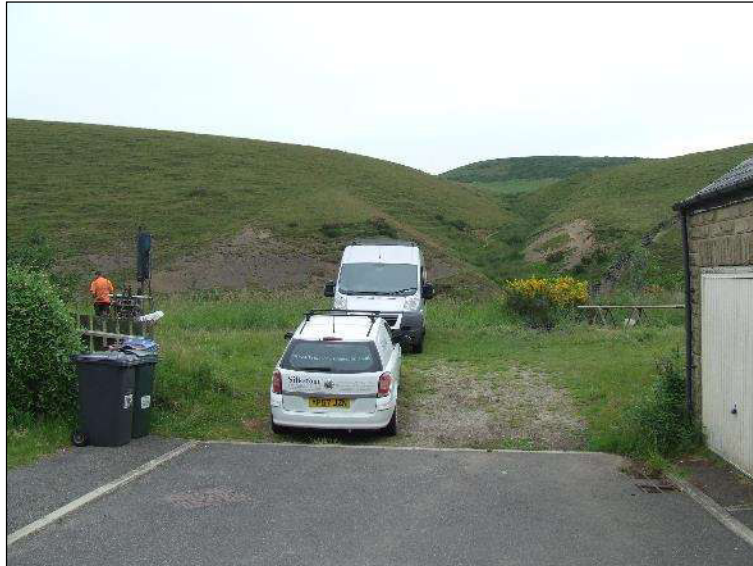
Photo 1: Current Site Condition – Site access from Pennine Edge (road), looking north east (window sampling rig is set up on WS03).

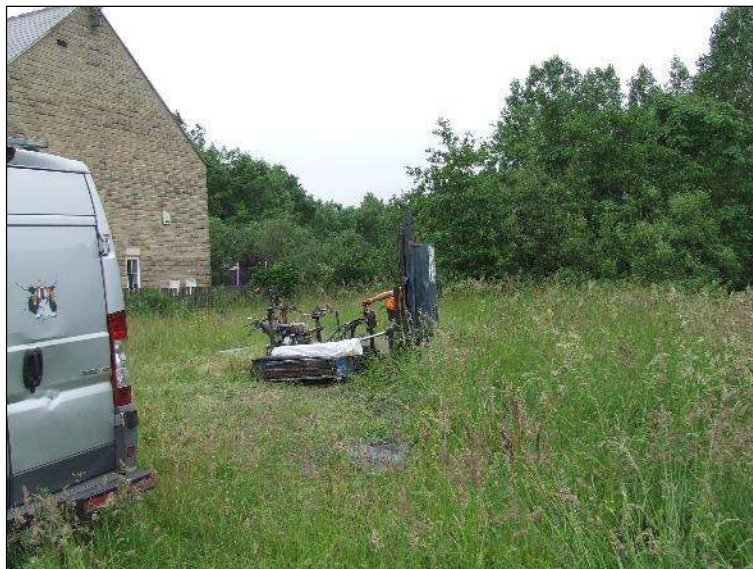
Photo 2: Current Site Condition – View of north western end of site looking west (window sampling rig is set up on WS03).

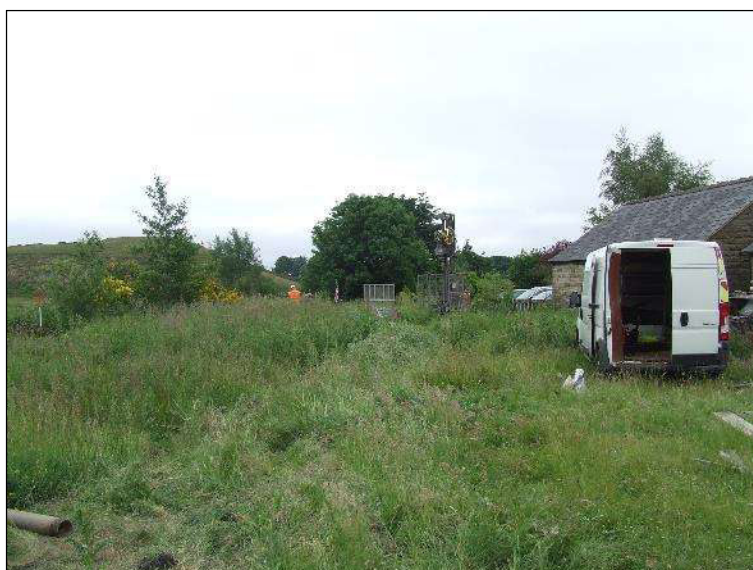
Photo 3: Current Site Condition – View across the site looking south east towards WS01 (near orange hi vis), also showing rotary rig set up on RBH03.

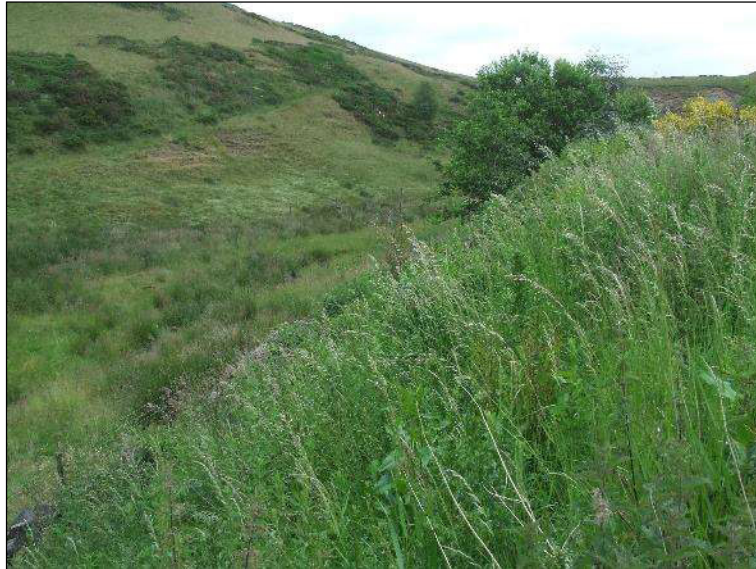
Photo 4: Current Site Condition – View north east along the top of the embankment extending along the north eastern edge of the site.

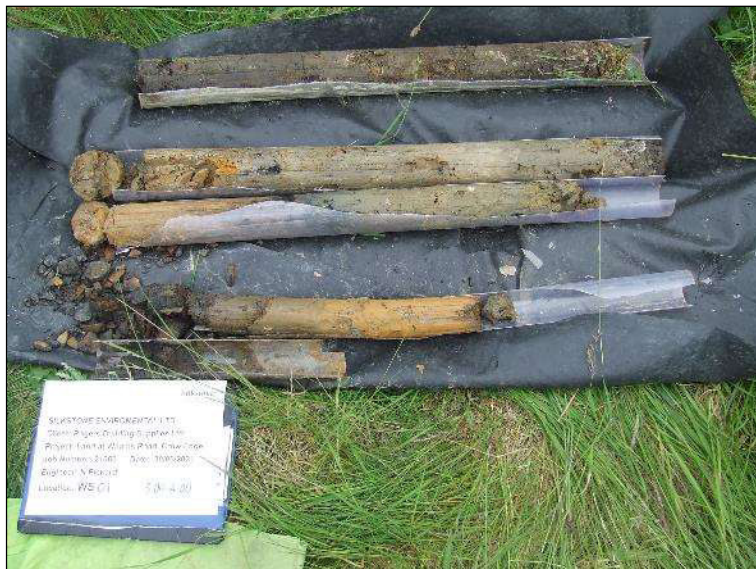
Photo 5: WS01 – Retrieved sample tubes following penetration to 4.00m begl (depth progressing from right to left and from top (1.00-2.00m) to bottom (3.00-4.00m)).
