BARNSELEY CIVIC PHASE 1

**DESIGN & ACCESS STATEMENT**

Incorporating Heritage Impact Assessment

Rev P01 - July 2026

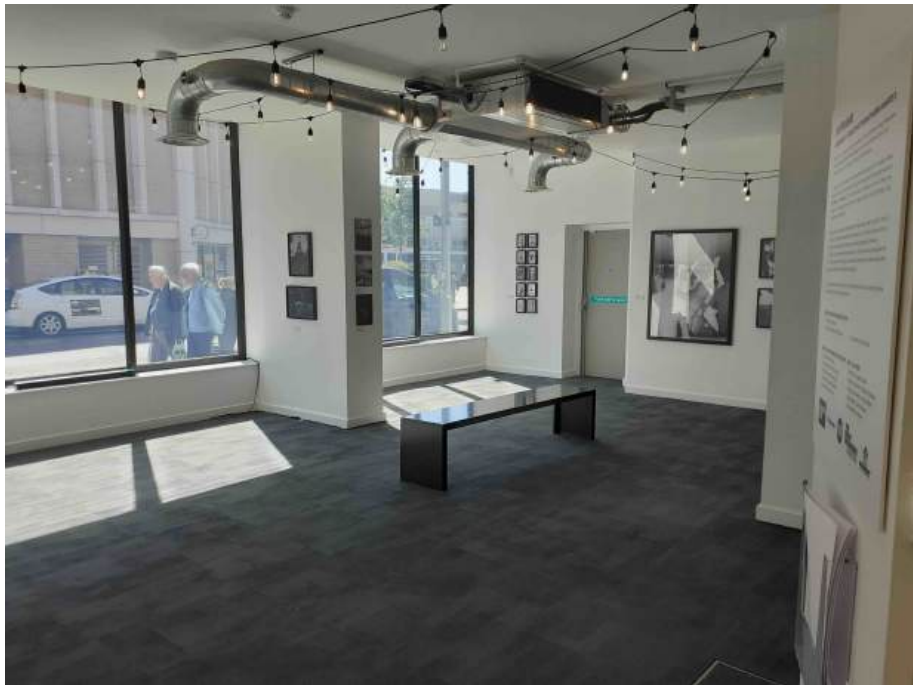
Flexible spaces fronting onto Eldon Street either side of entrance hall.

Cafe/bar and retail uses are proposed for the ground floor of the Eldon Street frontage and will contribute to a more animated and inviting street scene.

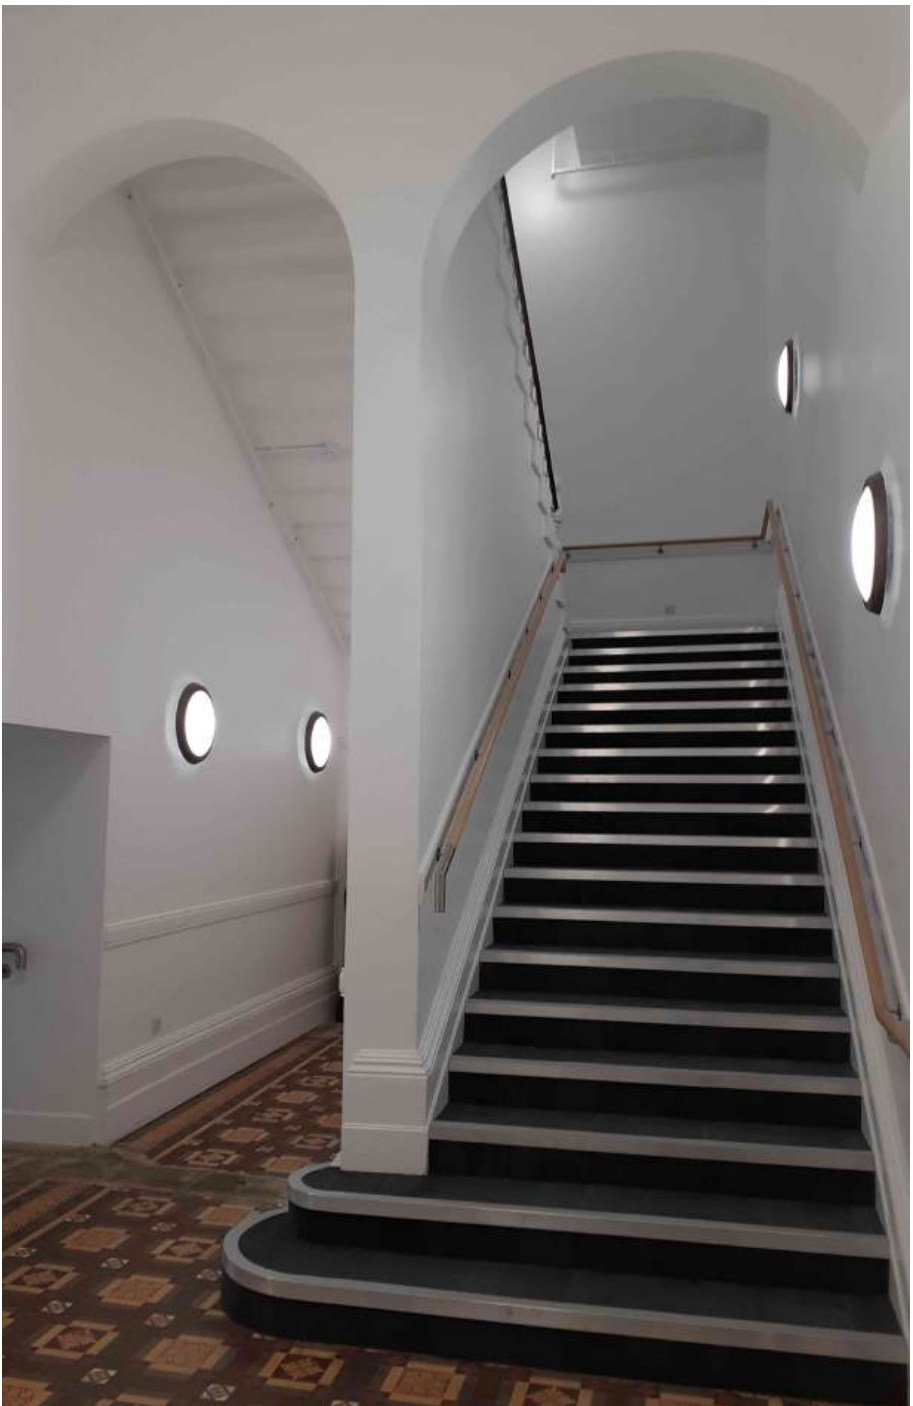
Main stairwell (south) - stair behind partition with original encaustic floor tiles visible.

Works to restore and reinstate the original encaustic floor tiles at ground floor level are included under the previously approved application no. 2022/0543. Further information will therefore be submitted to discharge the associated condition.

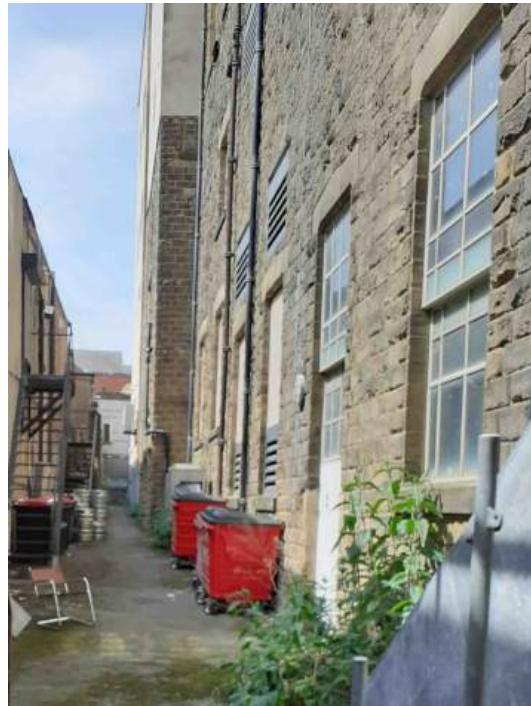
Top - view of south elevation down alleyway showing glazed, infilled and vented openings to hall spaces.

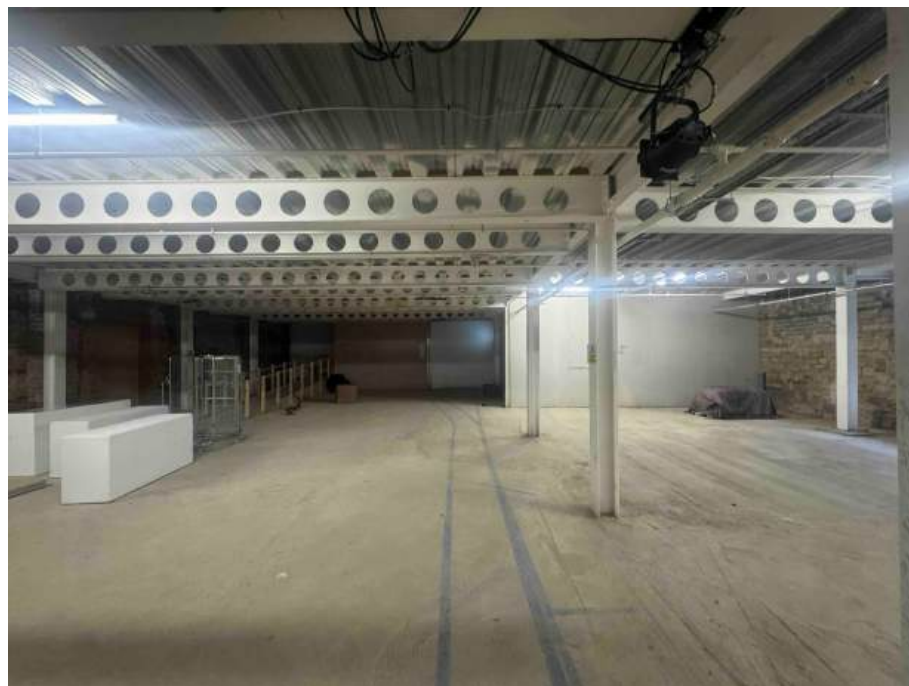
Above - ground floor hall space looking east with existing WC block, exposed slab and steel frame visible.

A new floor will be installed over the current exposed slab to provide some insulation and to match the adjacent space levels for step free access. Entry will be from the foyer space to the north by creating doorways where current openings have been partitioned off. A sculpted floor plane element including a ramp is proposed in the foyer space to make a feature of navigating a large and step free level change for visitors arriving from the main stairwell. Removal of the ground floor stair and escalator in the foyer space will create a more generous entry sequence and transition space. Access and the connection to and from Mandela Gardens is reinforced by consolidating double doorways in the curtain walling to make a wider direct route opposite the central entrance to the venue.

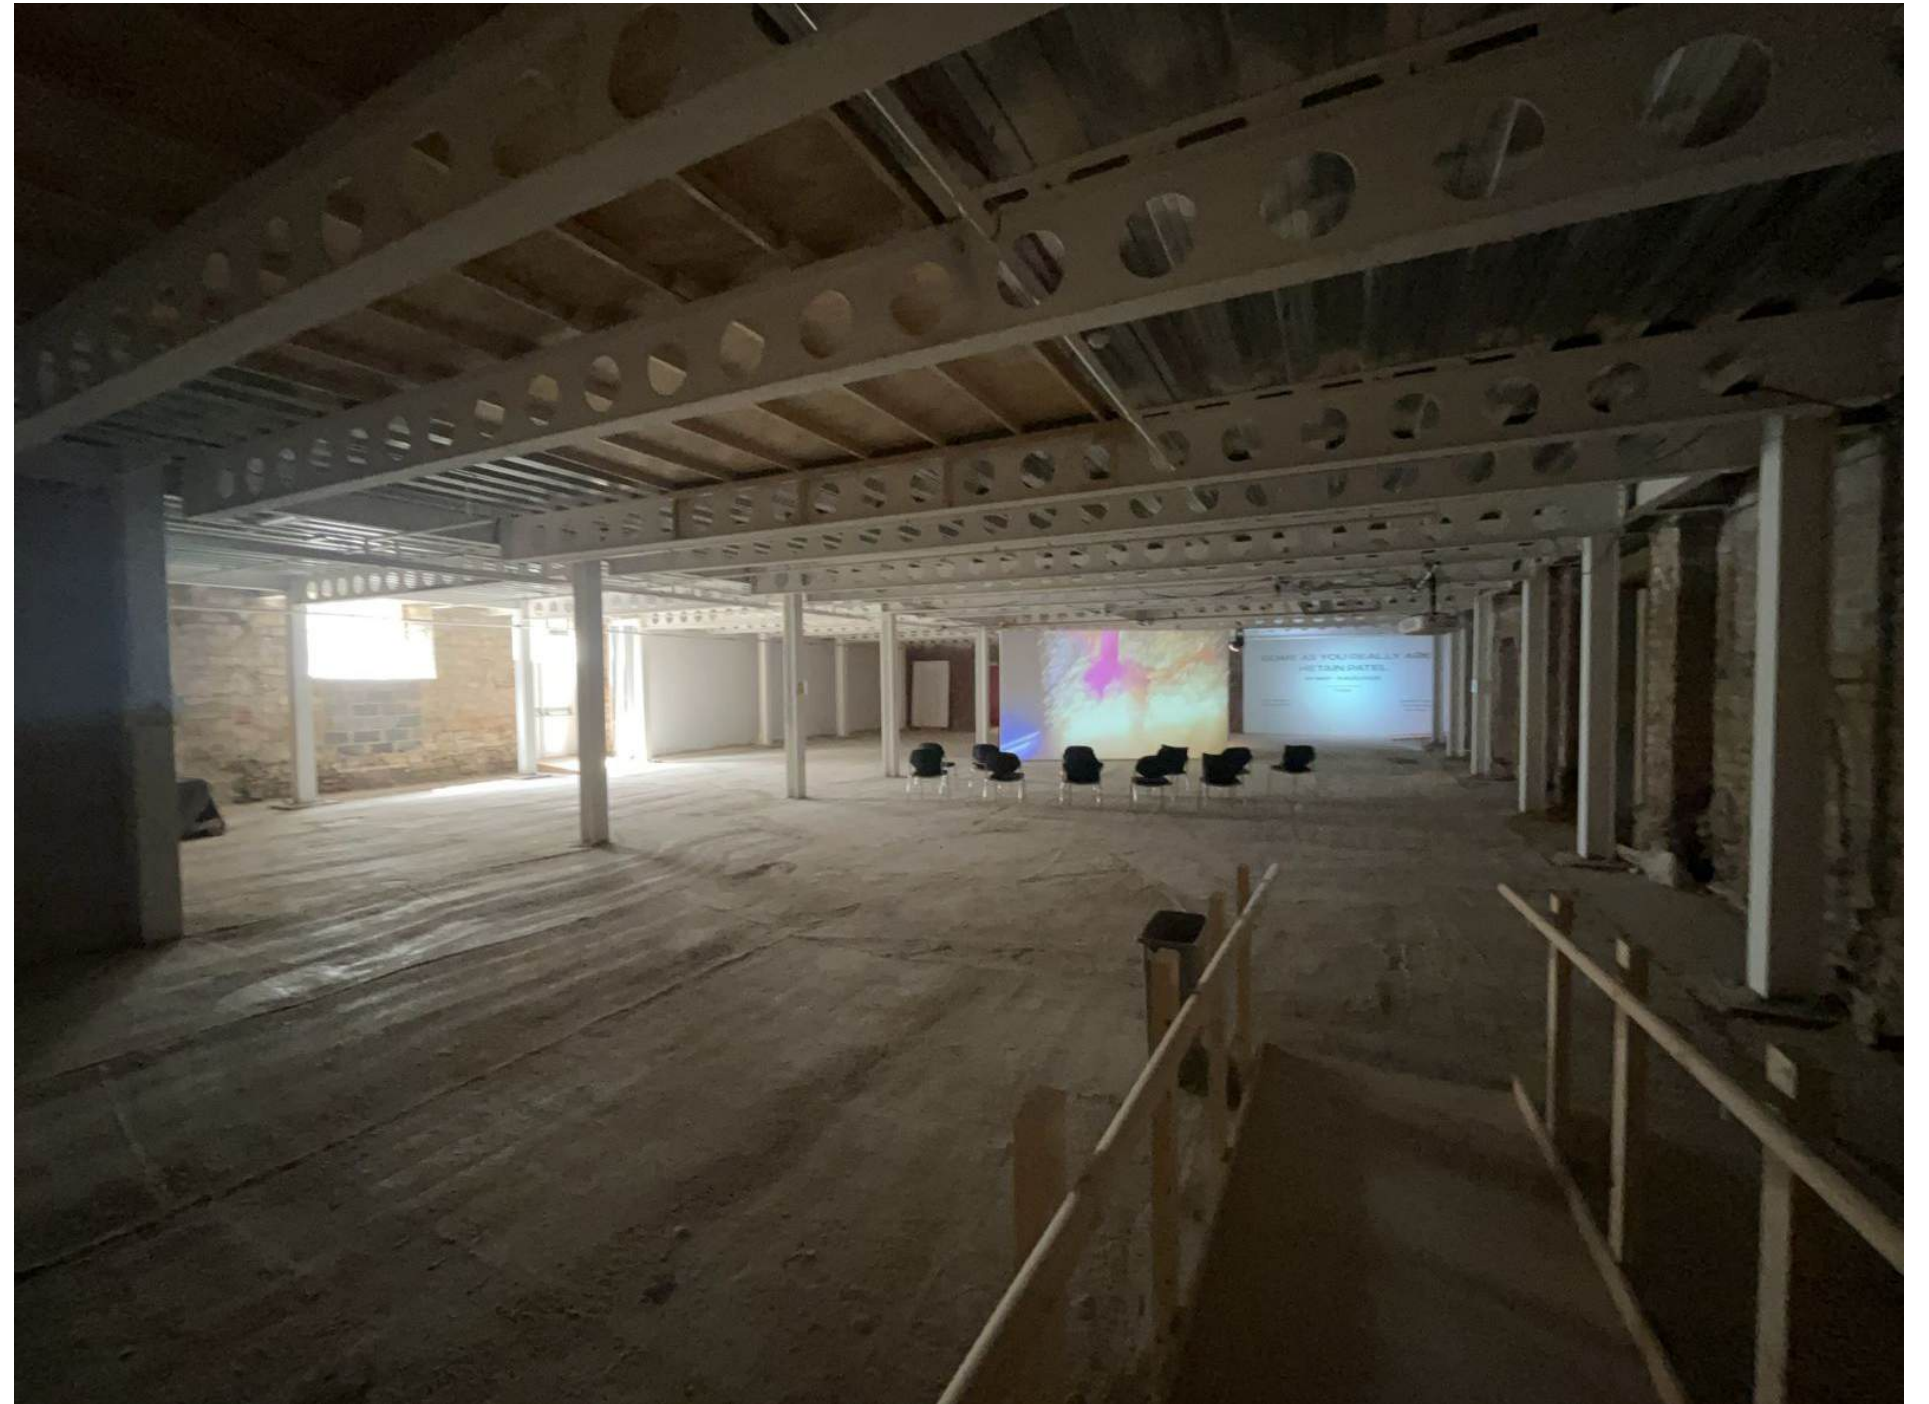
Ground floor hall space looking west with temporary event. Internal side of south elevation visible including window, external door and wall lining concealing infilled and vented openings.

| Location | Intervention | Description of work | Historical Value | Significance Assessment | Magnitude of Change | Resultant Impact | Justification or Mitigation (when impact requires) |
|---|---|---|---|---|---|---|---|
| | P1-GF-HL-07: | Remove internal wall lining and replace ventilation grilles in original openings with windows at ground floor level. | MEDIUM | Modern ventilation grilles in original openings in external wall on secondary elevation. | Moderate - reinstating windows in original openings. | Postive | Reinstating original openings and compensates for window lost as a result of intervention P1-GF-HL-03. |
