**Project:** 23\_PRA\_08\_28  
**Site:** 25-27 Millhouses Street, S74 9BQ  
**Client:** Sam Shaw

Project Number:	23_PRA_08_28
Report Type:	Preliminary Bat Roost Assessment Report [PRA]
Site Address:	25-27 Millhouses Street, S74 9BQ

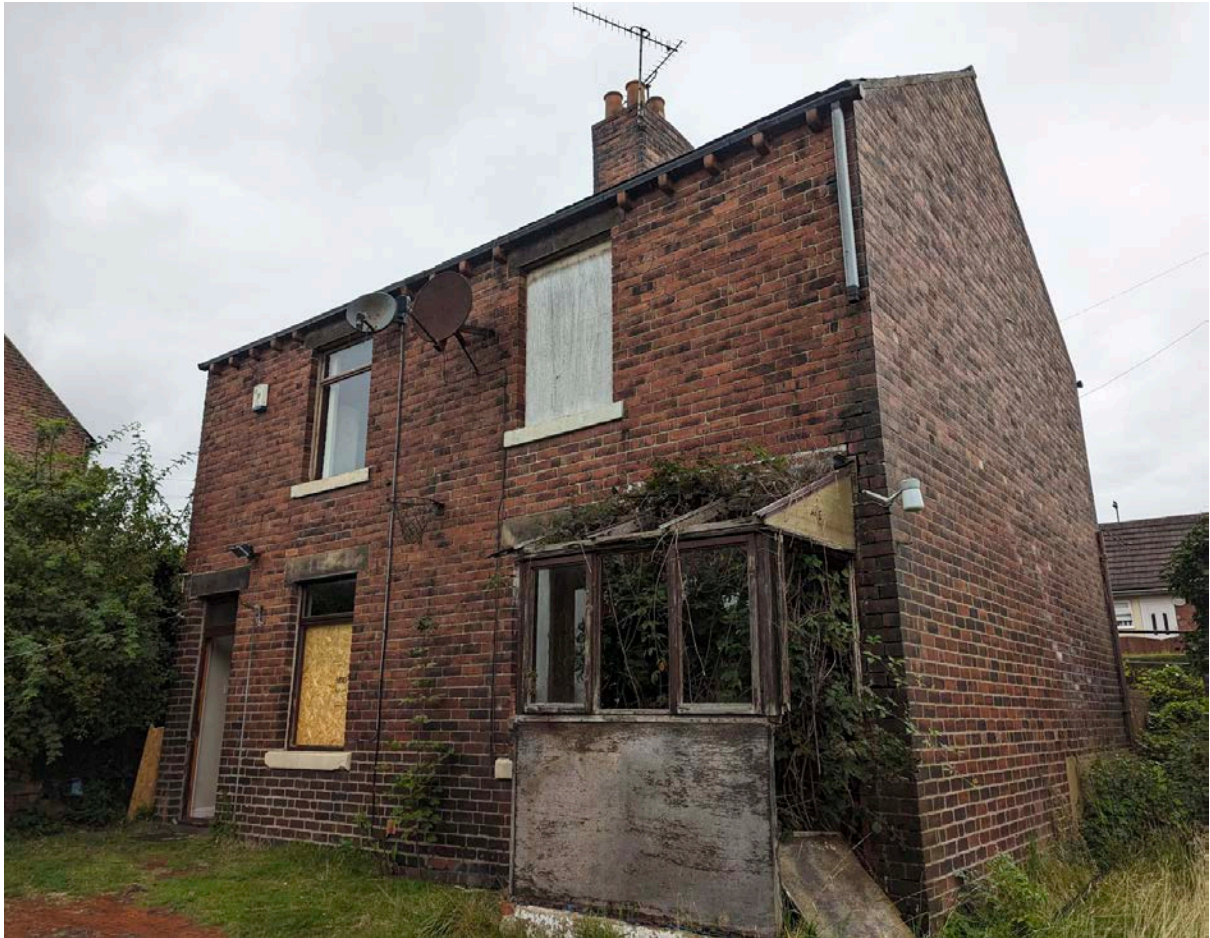
Building B1 is a detached two storey residential dwelling house that is dilapidated. It has a pitched roof covered with slate tiles. The loft void is unlined and there is no boarding in the loft. Some windows are missing and the property is only partially glazed. Mortar is missing from the eaves and there are no soffits or bargeboards present. There are some slipped and missing tiles on the northern and southern elevations.

*Plate 1: The southern elevation of B1.*

- 5.4 To determine whether roosting bats are using the building, further bat emergence/re-entry surveys should be carried out. This would require 2 separate survey visits by 2 surveyors at dusk supported by night vision aids and thermal cameras. The visit should be carried out between May and August inclusive as the optimal period. September is considered sub-optimal.

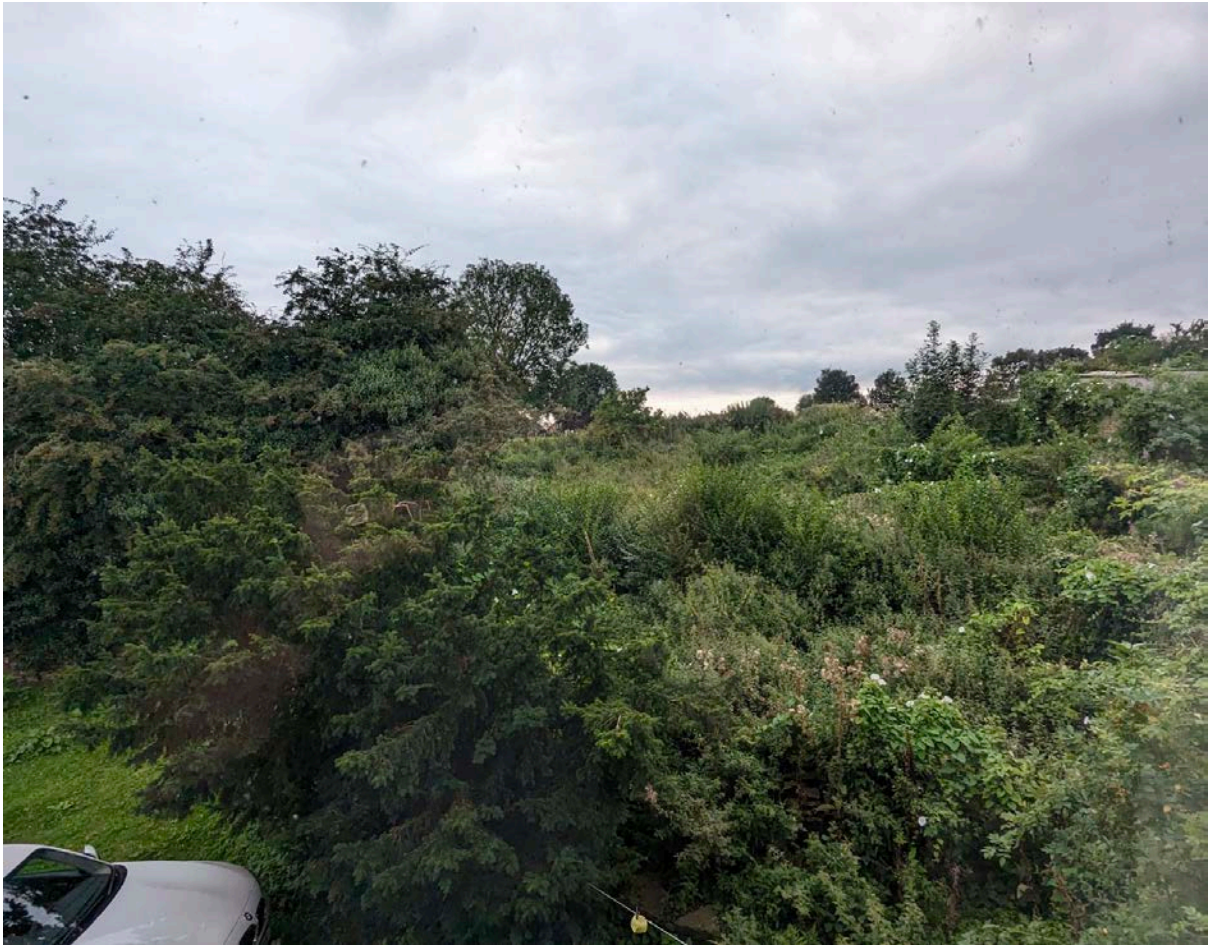
The landscape immediately adjacent to the property supports patchy scrub, hedgerows and broadleaf trees that provides excellent foraging habitat for bats in calm conditions.

*Plate 2: Foraging habitat to the south of B1.*

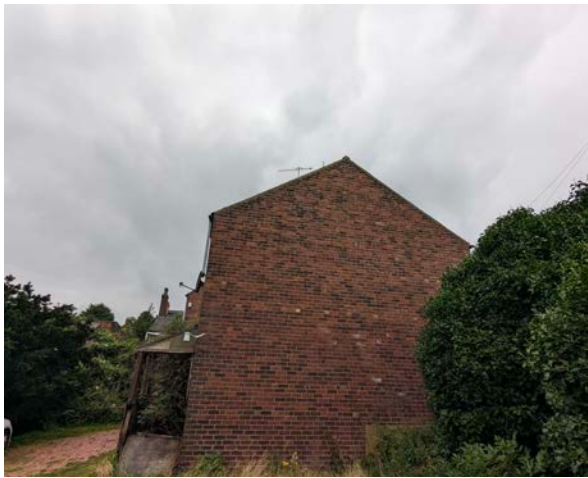
Detail	Photograph
<p><i>Plate showing the eastern elevation</i></p>

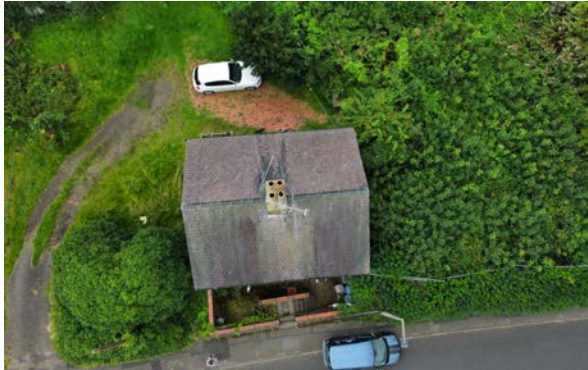
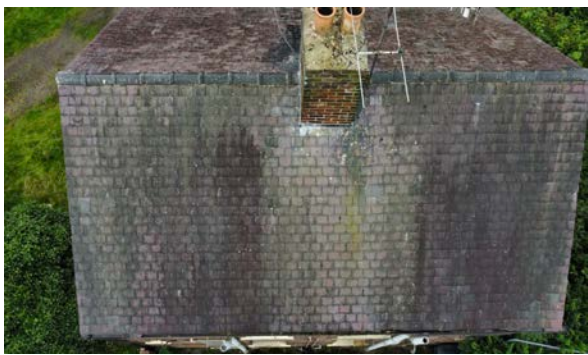
<p>An aerial photograph showing the roof of the property. The roof is dark and appears to be made of slate or similar material. A white car is parked on a path to the left of the building, and a blue car is parked on a road to the right.</p>
<p><i>Aerial plate showing the roof of the property</i></p>

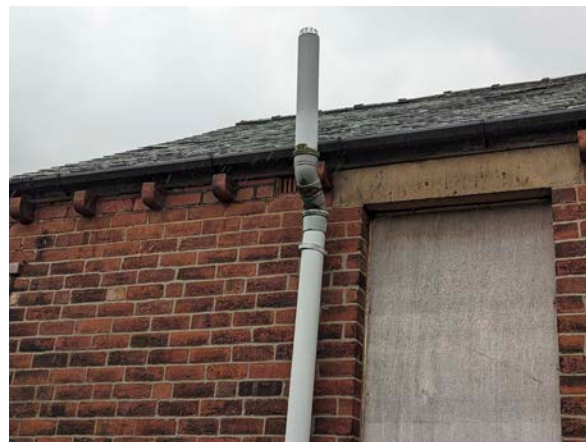
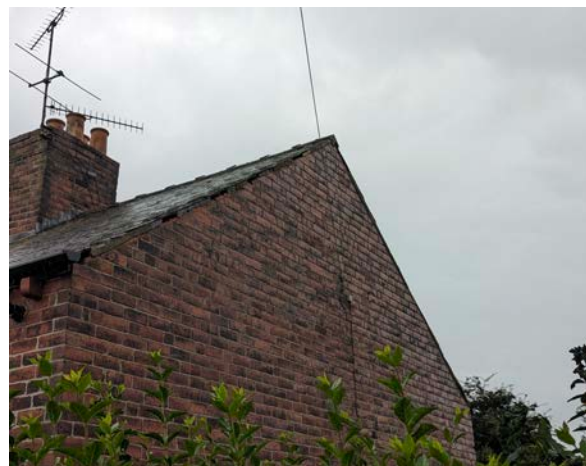
- 5.3 The missing mortar beneath the eaves and ridges provide roosting potential for crevice dwelling bats species such as Common and Soprano Pipistrelle species which are known to be present in the local area. Therefore, based on this information and the guidance outlined by the Bat Conservation Trust, the building has been assessed as having moderate suitability for roosting bats.

*Plate showing the eaves of the property and missing mortar*

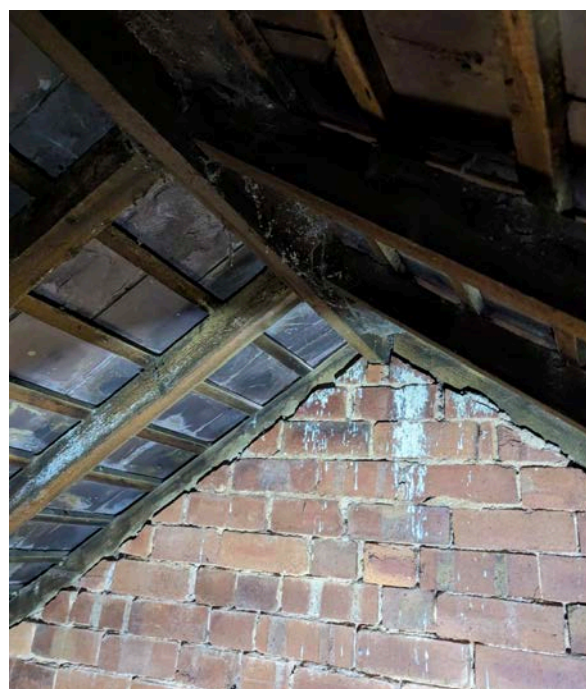
*Plate showing the loft void which is unlined and with a large number of suitable cracks and crevices*

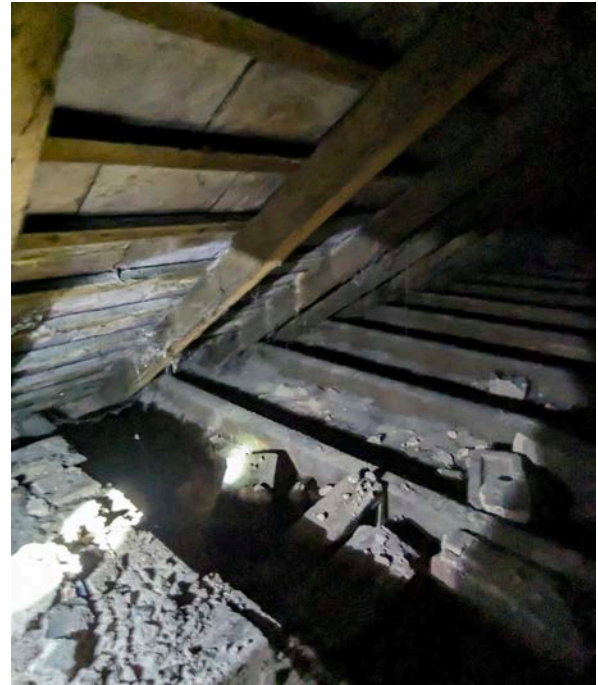
*Plate showing the loft void floor which is not lined.*
