# Bat Survey Report

**Liley Farm, Millhouse Green**  
**29th August 2024**

TG Report No. 16598\_R02\_DP

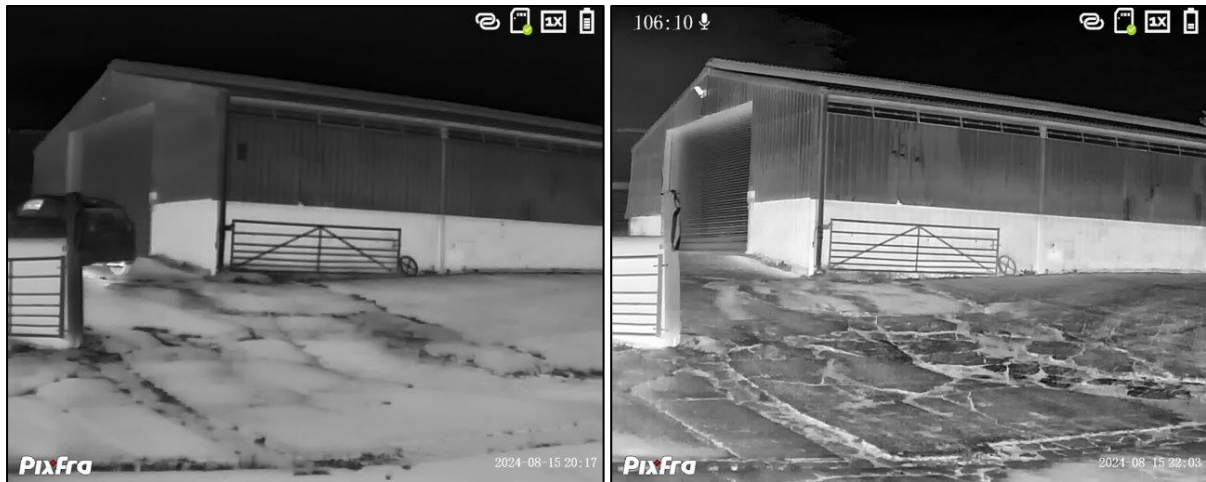
- 3.1. No bats were confirmed to be emerging from or re-entering the any of the buildings throughout the nocturnal surveys.
- 3.2. Footage captured using NVA cameras was analysed in full, and during the analysis, no bats were seen emerging from or re-entering the building.

Figure A2.1 / Figure A2.2 – Start and finish screenshots from NVA footage.

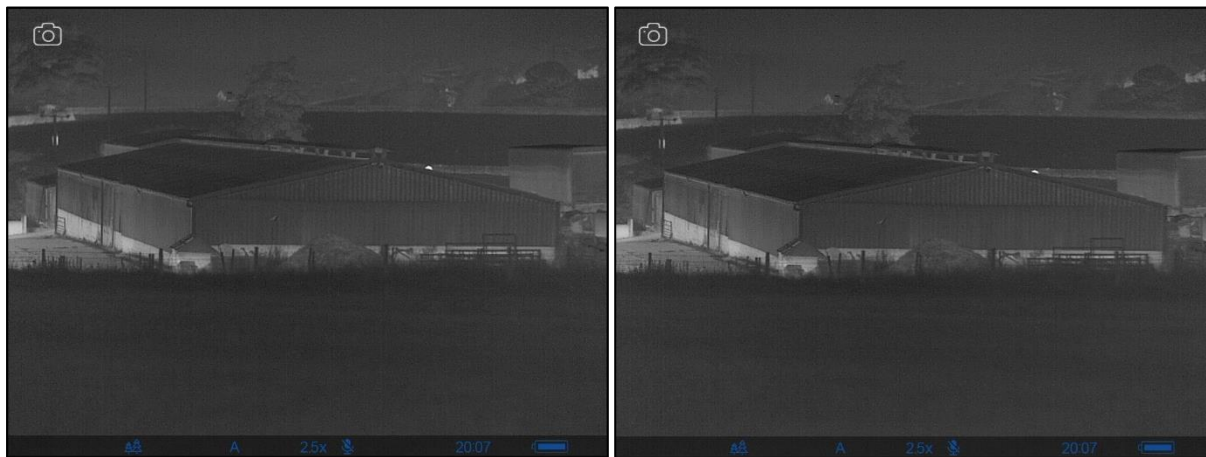
Figure A2.3 / Figure A2.4 – Start and finish screenshots from NVA footage.

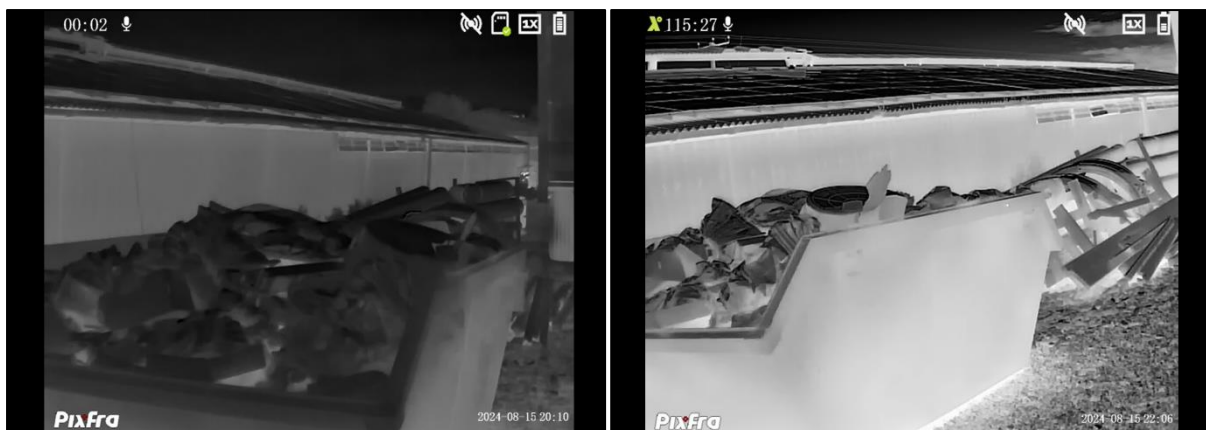
Figure A2.5 / Figure A2.6 – Start and finish screenshots from NVA footage.

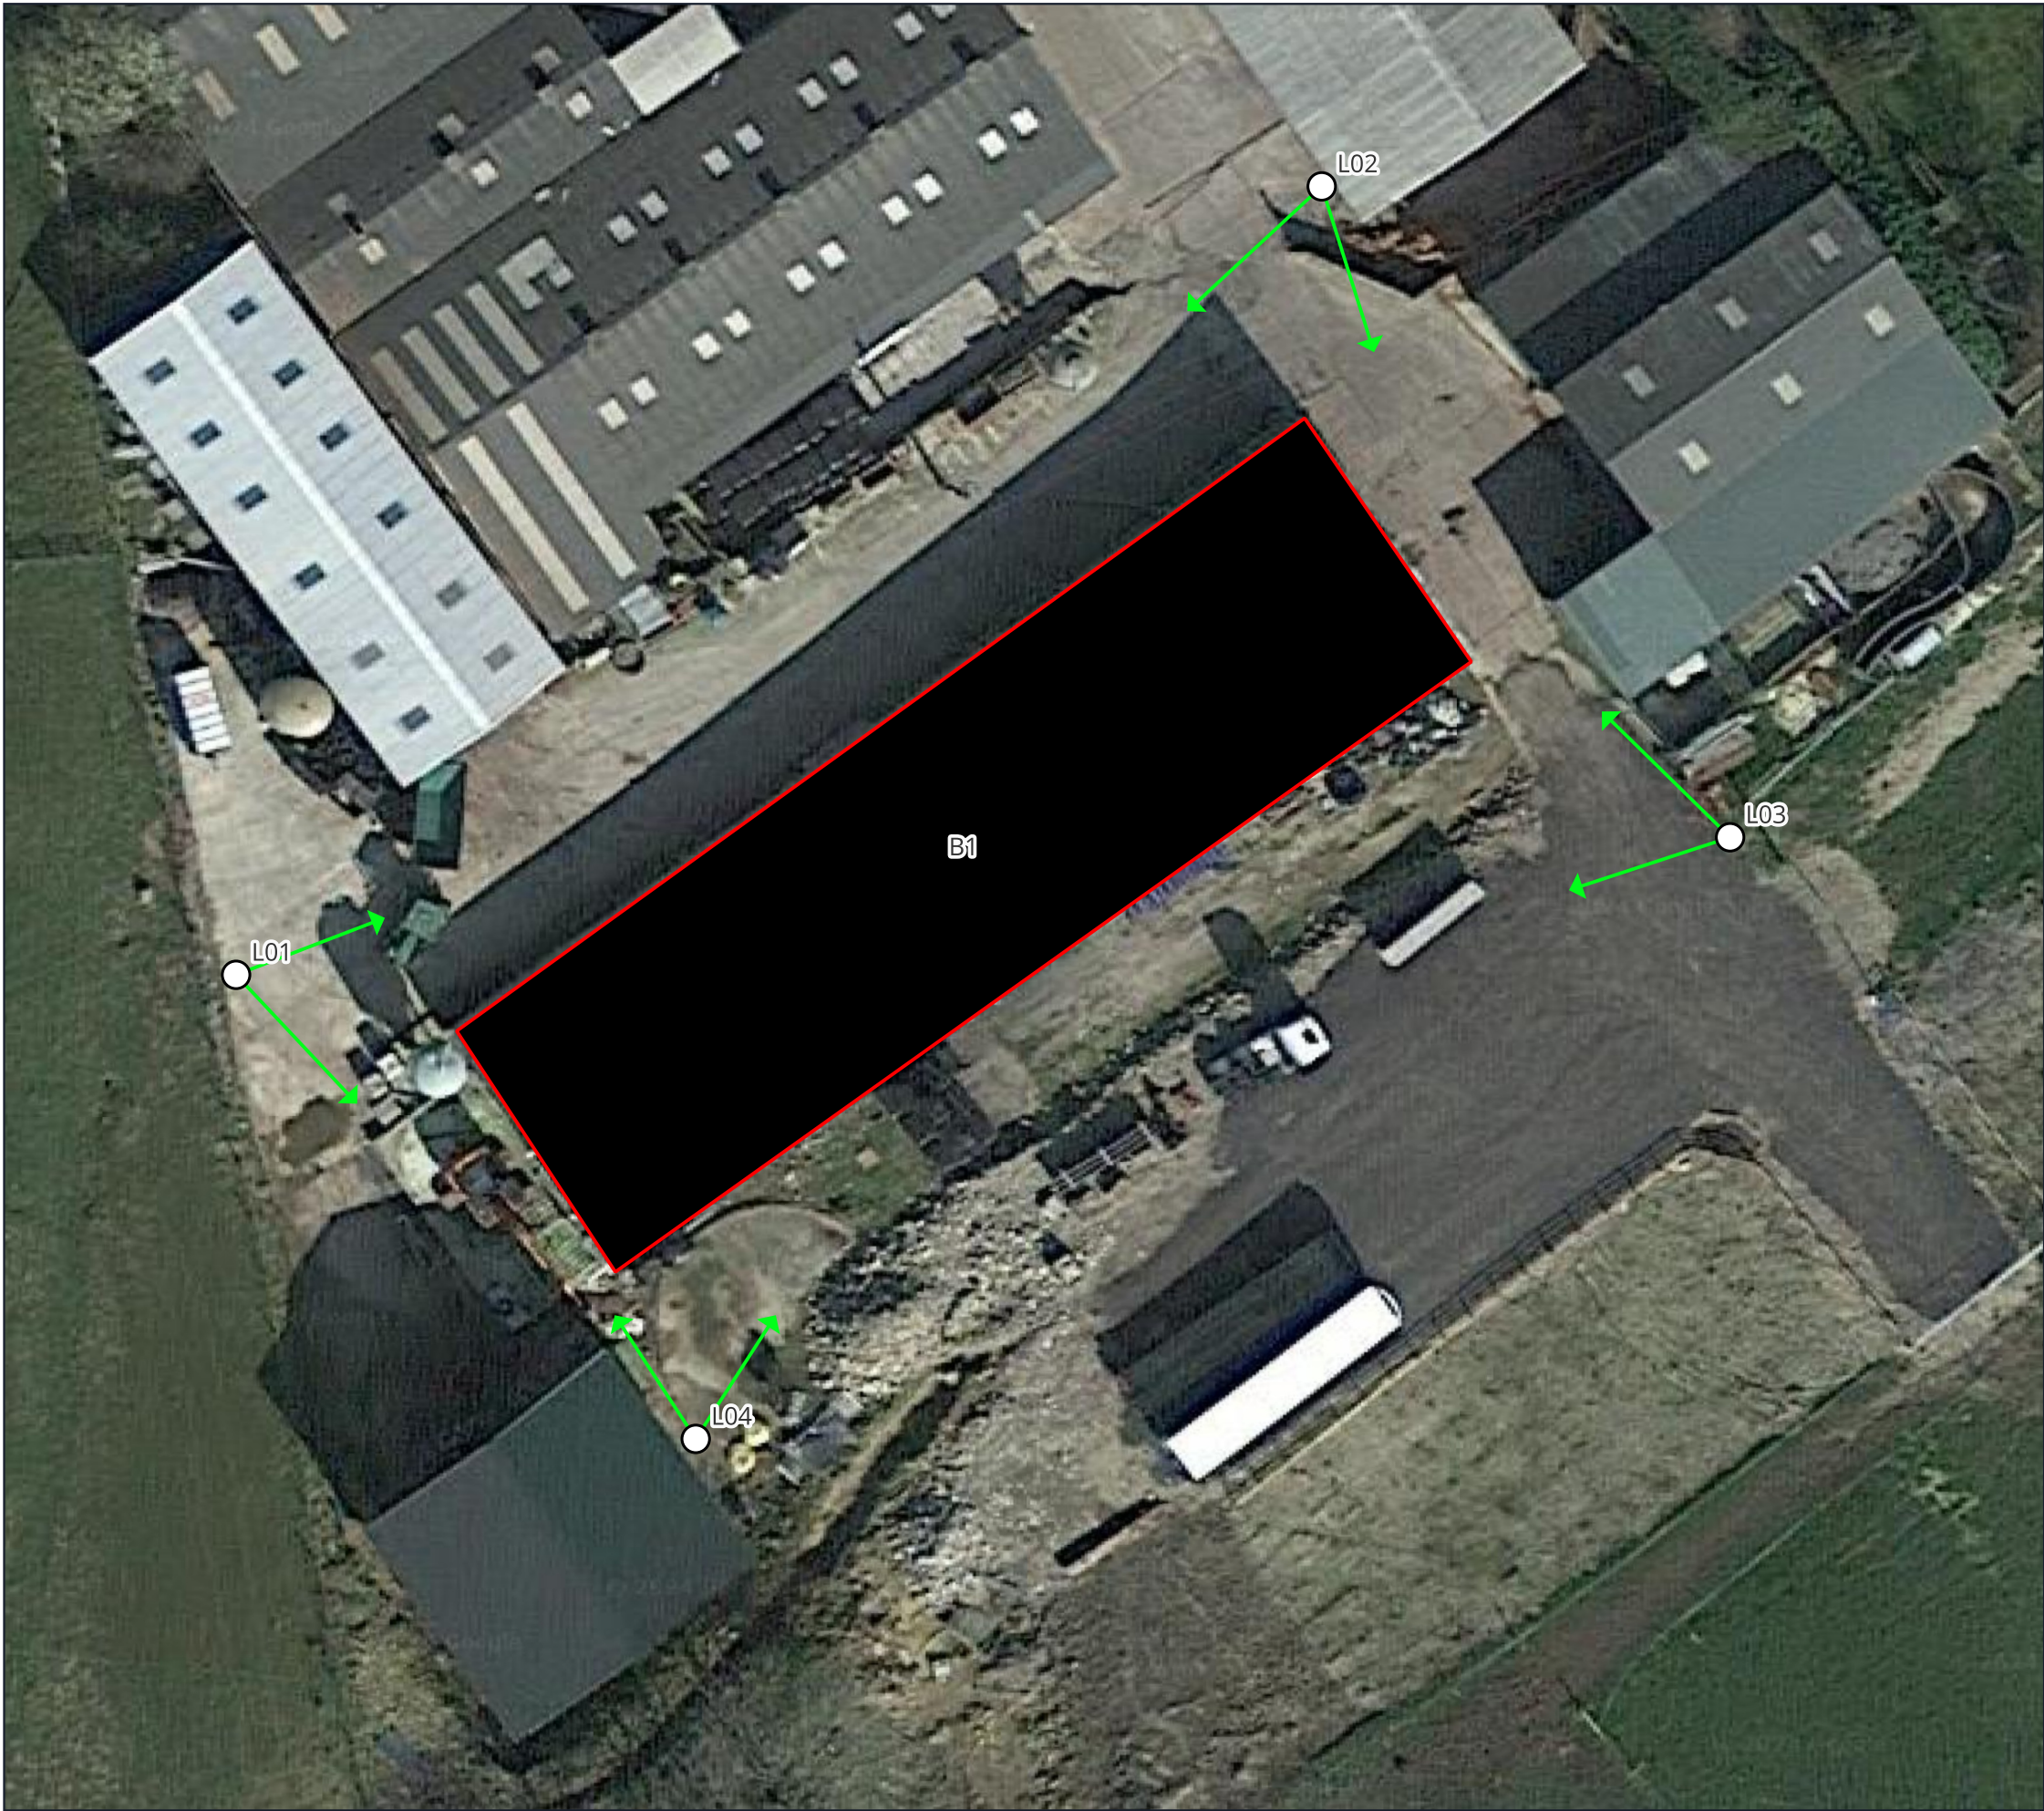
Plan 2: 16598/P03 – Emergence Survey Results Plan

- 3.3. Bats were observed and recorded from all surveyor positions shown on plan **16598/P03**. Common pipistrelle *Pipistrellus pipistrellus* was the most commonly detected species, and other species detected include soprano pipistrelle, noctule bat, and Myotis bat species *Myotis sp.*

- 3.4. It was noted that throughout the survey, little activity was seen around all surveyor positions, with the most concentrated bat passes being behind position 4, shown on plan **16598/P03**, where multiple pipistrelle bats were seen foraging within the open barn to the south-west of the building shortly after sunset. None of the bats observed at this time were noted to fly close to the building on site however.

No bat emergences were observed from Building 1 throughout the survey and analysis of NVA footage.

- 2.10. Surveyors were positioned around the buildings to provide adequate coverage of all suitable features during visits – see plan **16598/P03** for surveyor locations. Surveyors used a combination of visual observation, echolocation devices and night vision aid (NVA) cameras with infra-red torches and floods to identify and bats emerging from the building, assisted by two-way radios in order to correlate bat movements between surveyors.
