Barnburgh Lane, Goldthorpe, South Yorkshire

Phase 2

Archaeological Assessment

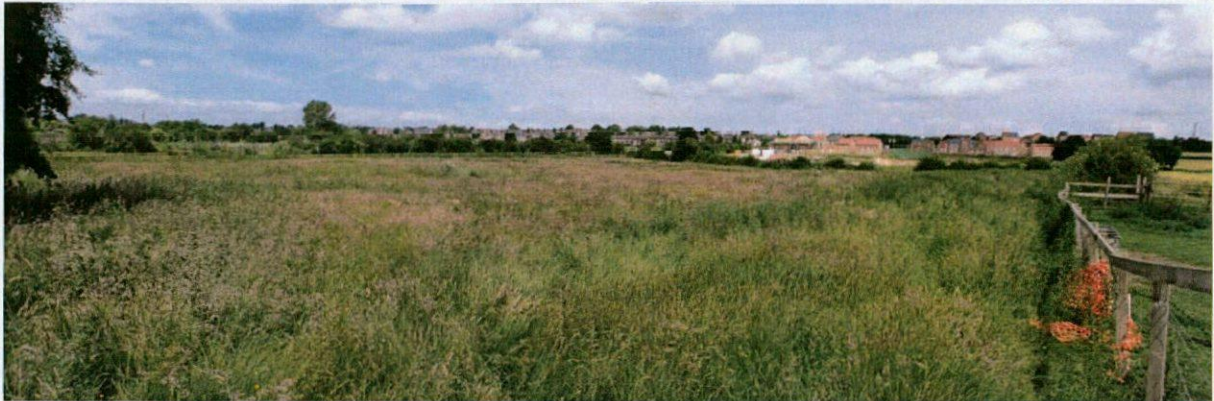
When the site was inspected on June 29th 2015 it was heavily overgrown with tall scrub permitting the identification of only very general changes in level and vegetation. The ground slopes down gently from north to south with a raised area in the south-east corner (Viewpoint 1, Figure 6).

Figure 6
Viewpoint 1: General View Facing North of the Application Site from the South-East Corner

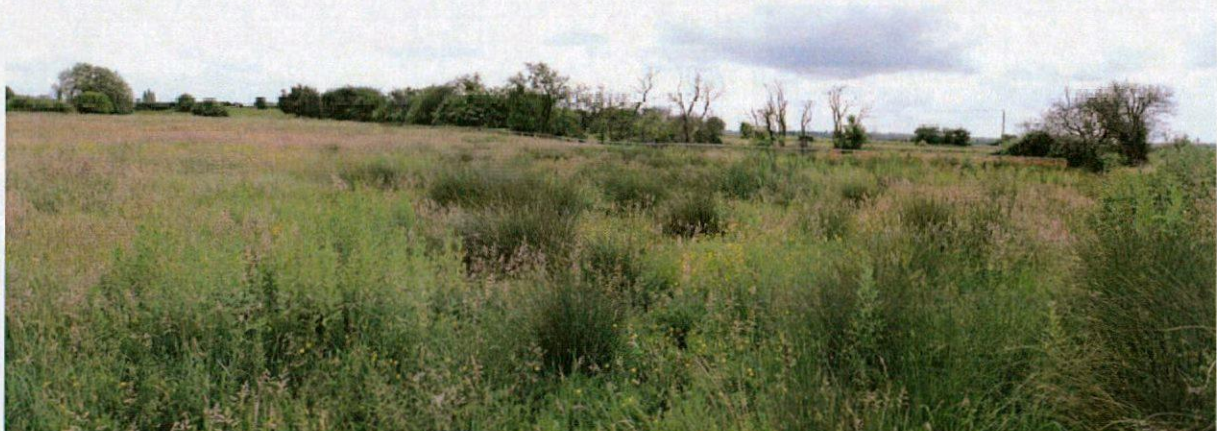
Ridge-and-furrow cultivation, orientated north-east to south-west was possibly sensed during the walkover in the centre of the site, but could not be seen due to the undergrowth. A hedge of brambles was noted on the western side, enclosing a recent ditch adjacent to the western boundary of the application site, and an area of wet ground (Figure 2; Viewpoint 2, Figure 7) indicated by vegetational changes was noted in the south-western corner.

Figure 7
Viewpoint 2: View Facing South-East of Wet Ground Area (Centre and Right) in the South-West Corner of the Application Site

An area of wet ground may have been subject to long-term waterlogging and may thus contain enhanced environmental potential.

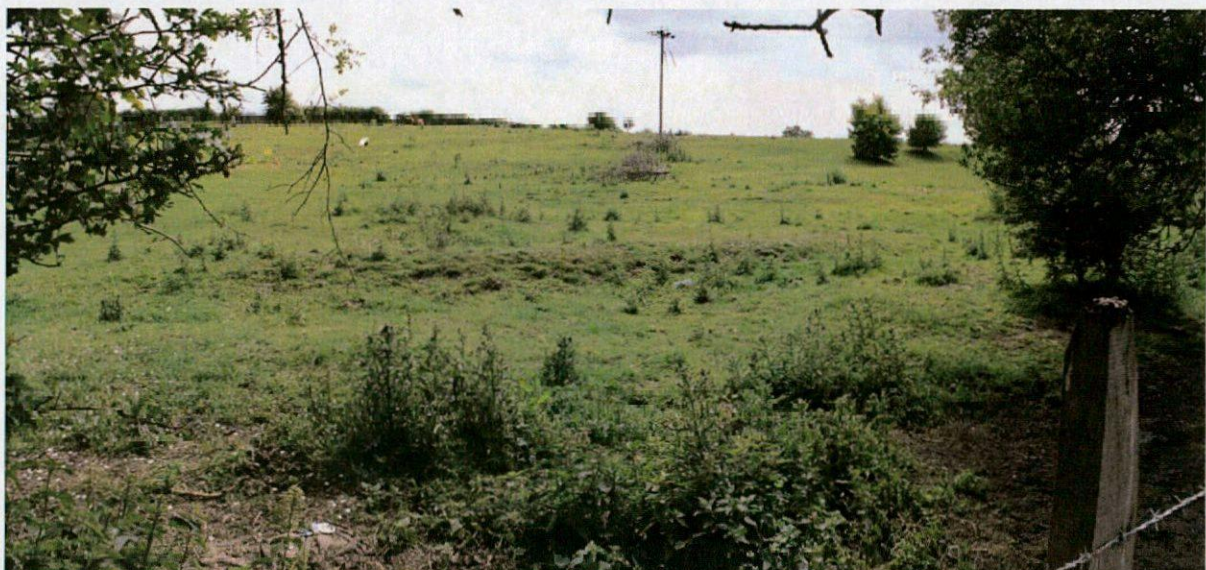
Earthworks were noted beyond the south-east corner of the application site (Viewpoint 3, Figure 8). They appear to include the remains of a building, intruding on the ridge-and-furrow which is preserved further to the east. As the location does not correspond with the map evidence for the fire engine this may be an agricultural or another industrial building. It was

sufficiently important to have Engine Lane made to provide access but is not shown on the 1840 Tithe Map or later Ordnance Survey mapping. There is no visible indication that remains extended into the application site.

Figure 8
Viewpoint 3: Facing East Showing the Possible Building
