Higham Lane Retaining Wall, Dodworth

## Combined Statement of Intent and Preliminary Sources Study Report

Doc. Ref.: 2971-BEL-XX-XX-RP-Y-0001

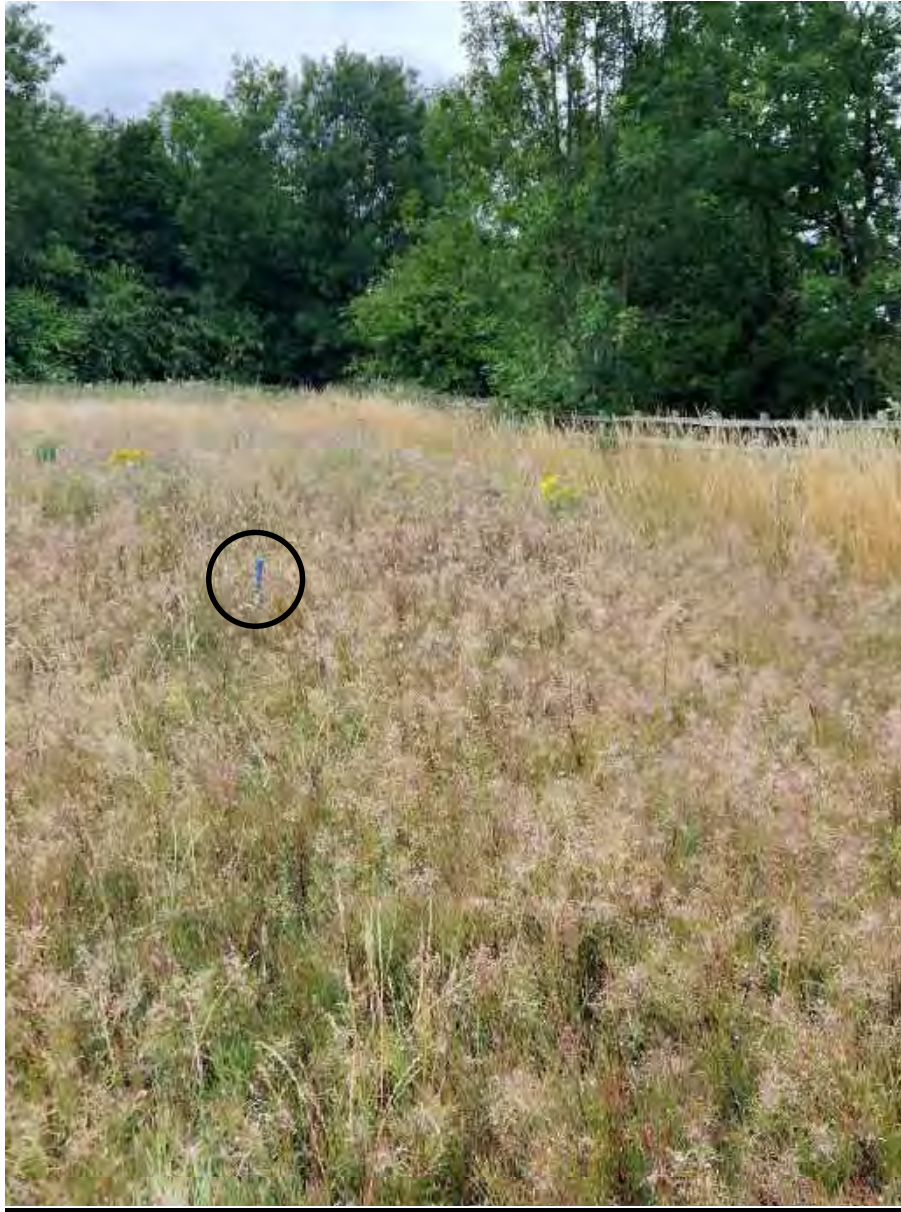
**Site Photograph 1 - View to the North from the Proposed Location of the Retaining Wall:** The blue flag (circled) denotes the position of north-east corner of northern building with the highway fence line visible to the right.

The proposed location of the wall was noted as being close to the highway fence line. The fence itself was in good condition although the field and vegetation were overgrown. Although the highway was not accessed, a walkway with stairs descending along the cutting to the motorway was noted in the north and a motorway communications installation was observed slightly to the south. In both cases, the width of the level area/platform between the fence line and the crest of cutting was assessed to be 2 - 5m approximately.

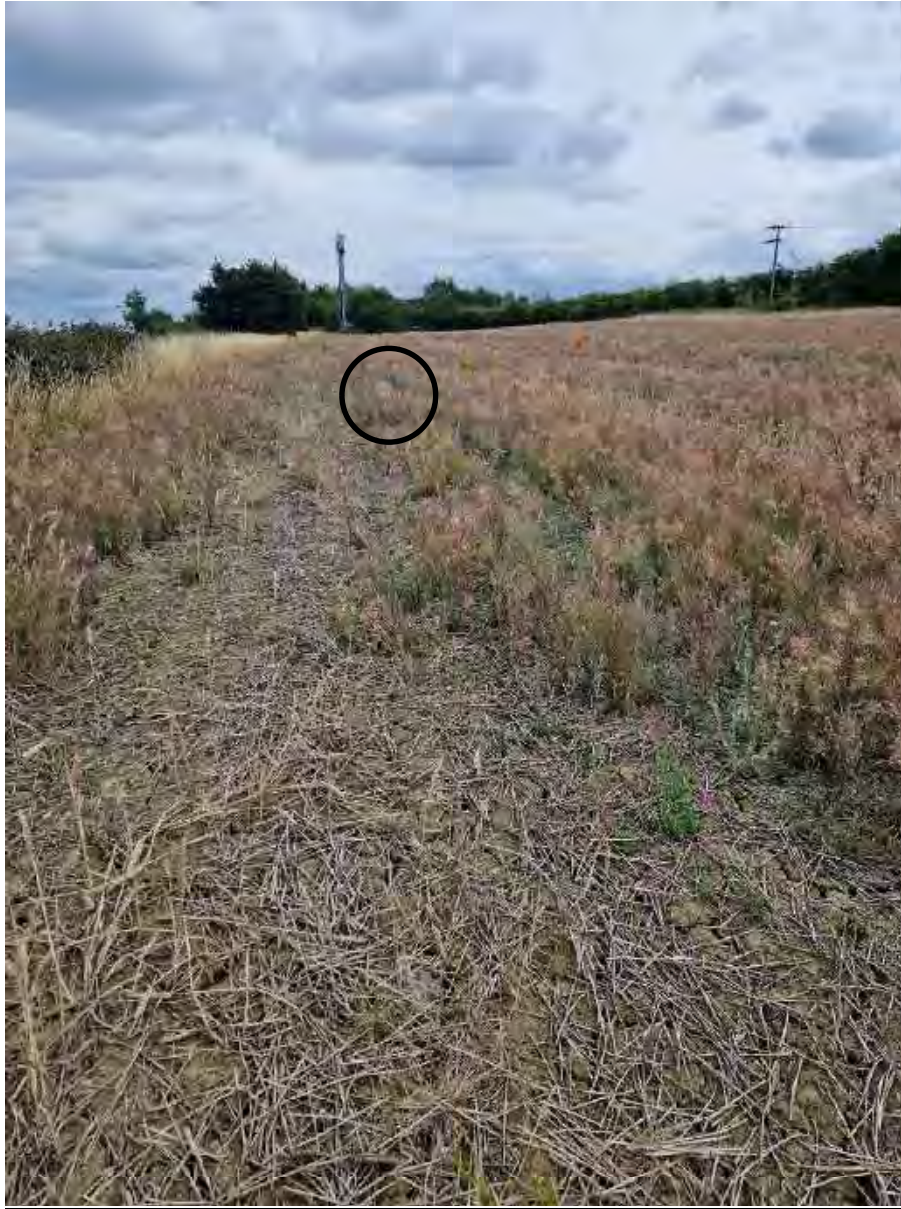
**Site Photograph 2 - View to the South from the Proposed Location of the Retaining Wall:** The blue flag (circled) denotes the position of south-east corner of northern building with the highway fence line covered in vegetation to the left.

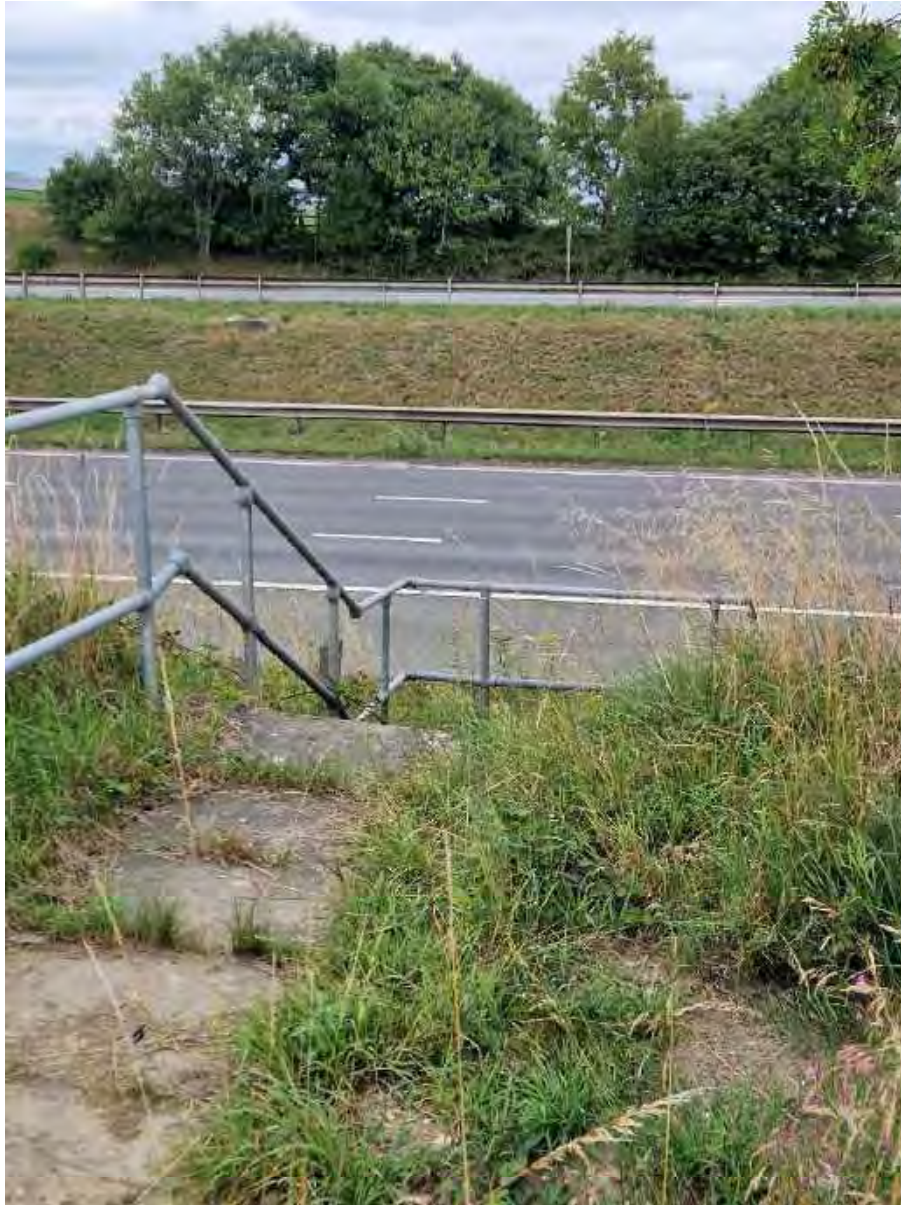
**Site Photograph 4 - View to the East over the Highway Fenceline (North):** A highway maintenance walkway and stairs was identified leading to the motorway. Note the horizontal platform prior to the cutting.

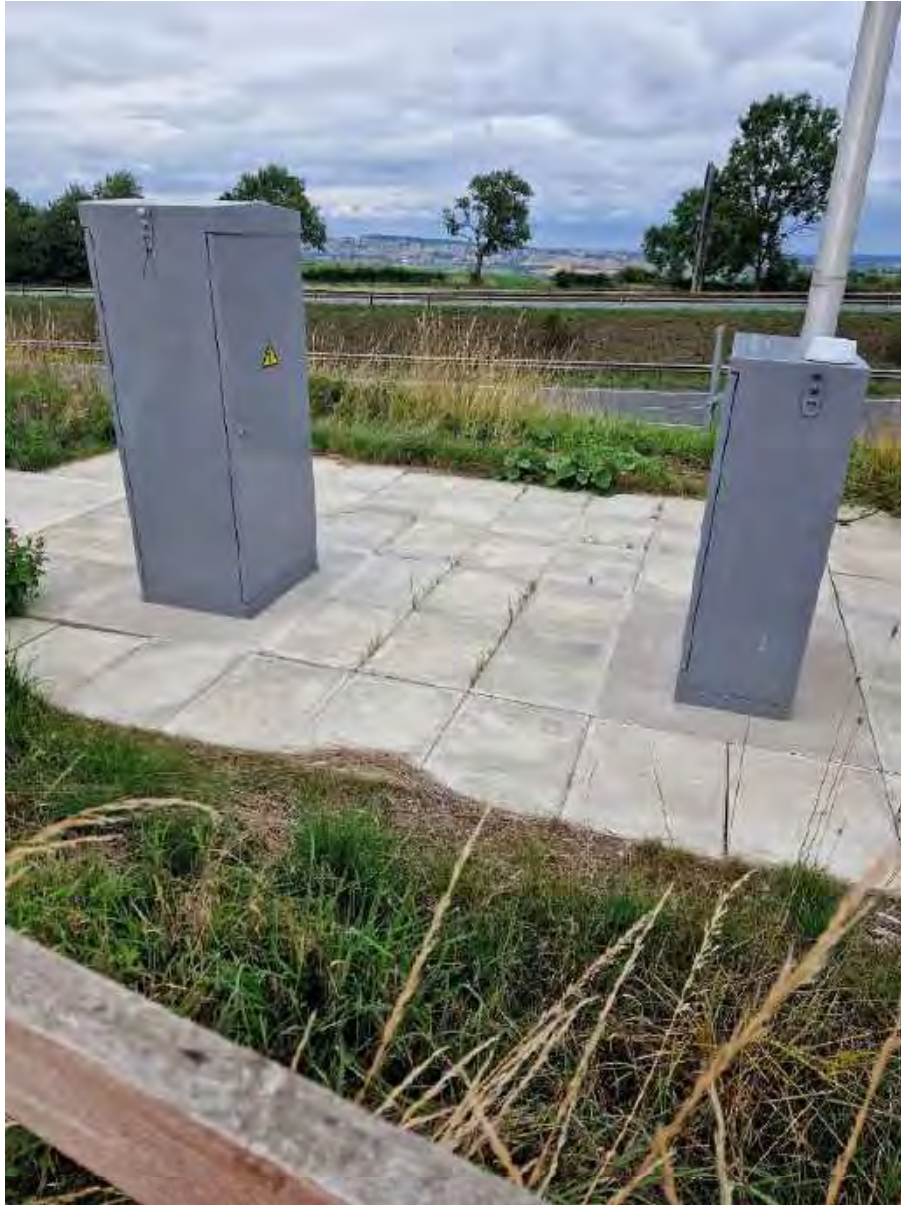
**Site Photograph 5 - View to the East over the Highway Fenceline (South):** A motorway communications installation was identified adjacent to the motorway. Note the horizontal platform of several metres prior to the cutting.
