# **ARBORICULTURAL REPORT**

## **& Impact Assessment**

*Land at*  
***Greenside Lane,  
Hoyland,  
Barnsley,  
South Yorkshire,  
S74 9PZ***

Reference: *AWA1953*

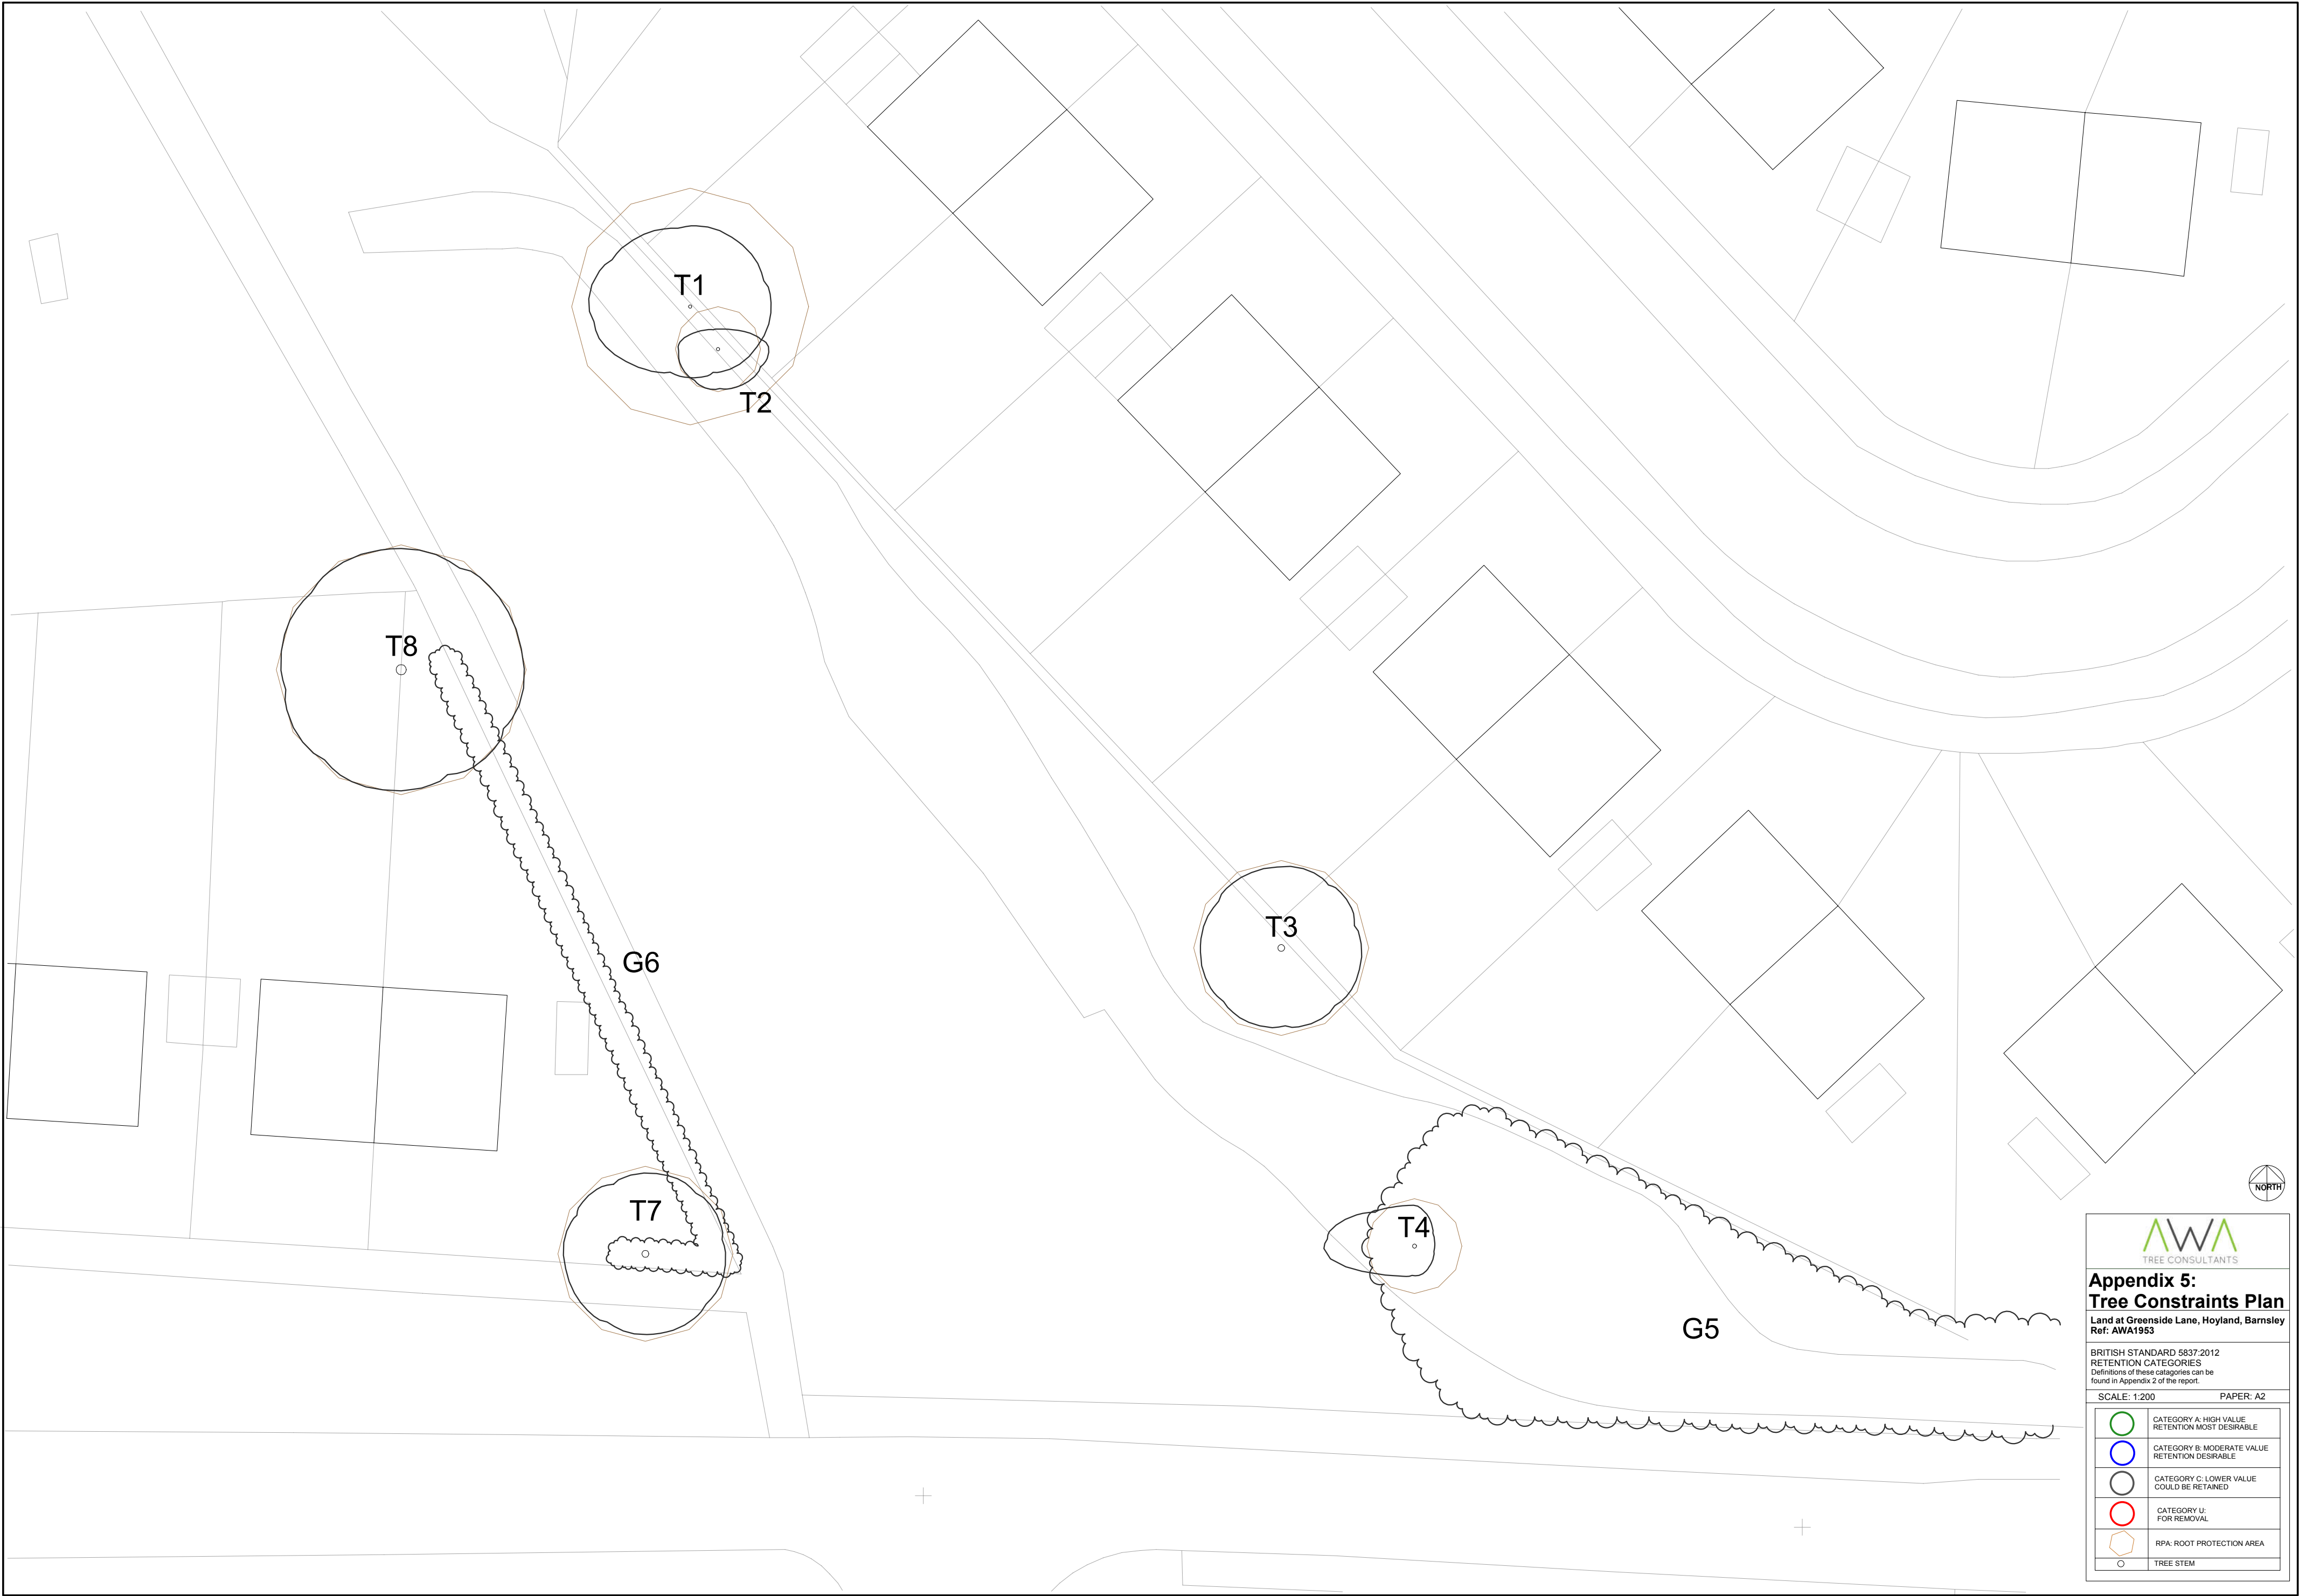
**Appendix 5:**  
**Tree Constraints Plan**  
Land at Greenside Lane, Hoyland, Barnsley  
Ref: AWA1953

- 3.2.8 The tree Root Protection Area (RPA) is detailed on the Tree Constraints Plan at Appendix 5. The RPA for each tree has been plotted as a polygon centred on the base of the stem. Due to the presence of roads, structures, topography (and past tree management) the RPA is likely to be a simplified representation of the tree roots actual morphology and disposition.

- 4.3.1 The tree Root Protection Area (RPA) detailed on the Tree Constraints Plan at Appendix 5, has been used as a layout design tool, to inform on the area around a tree where the protection of the roots and soil structure is treated as a priority. As such, no significant negative indirect impact impacts have been identified.
- 4.3.2 The design of the new development has considered the tree crown positions in relation to the new dwellings. Some shade from trees may be beneficial. In particular, deciduous trees give shade in summer but allow access to sunlight in winter. However, the design proposals avoid excessive shading, and give adequate provision for future tree growth.
- 4.3.3 The buildability of the proposed has been assessed in terms of access, adequate working space and provision for the storage of materials, including topsoil, in relation to the trees.

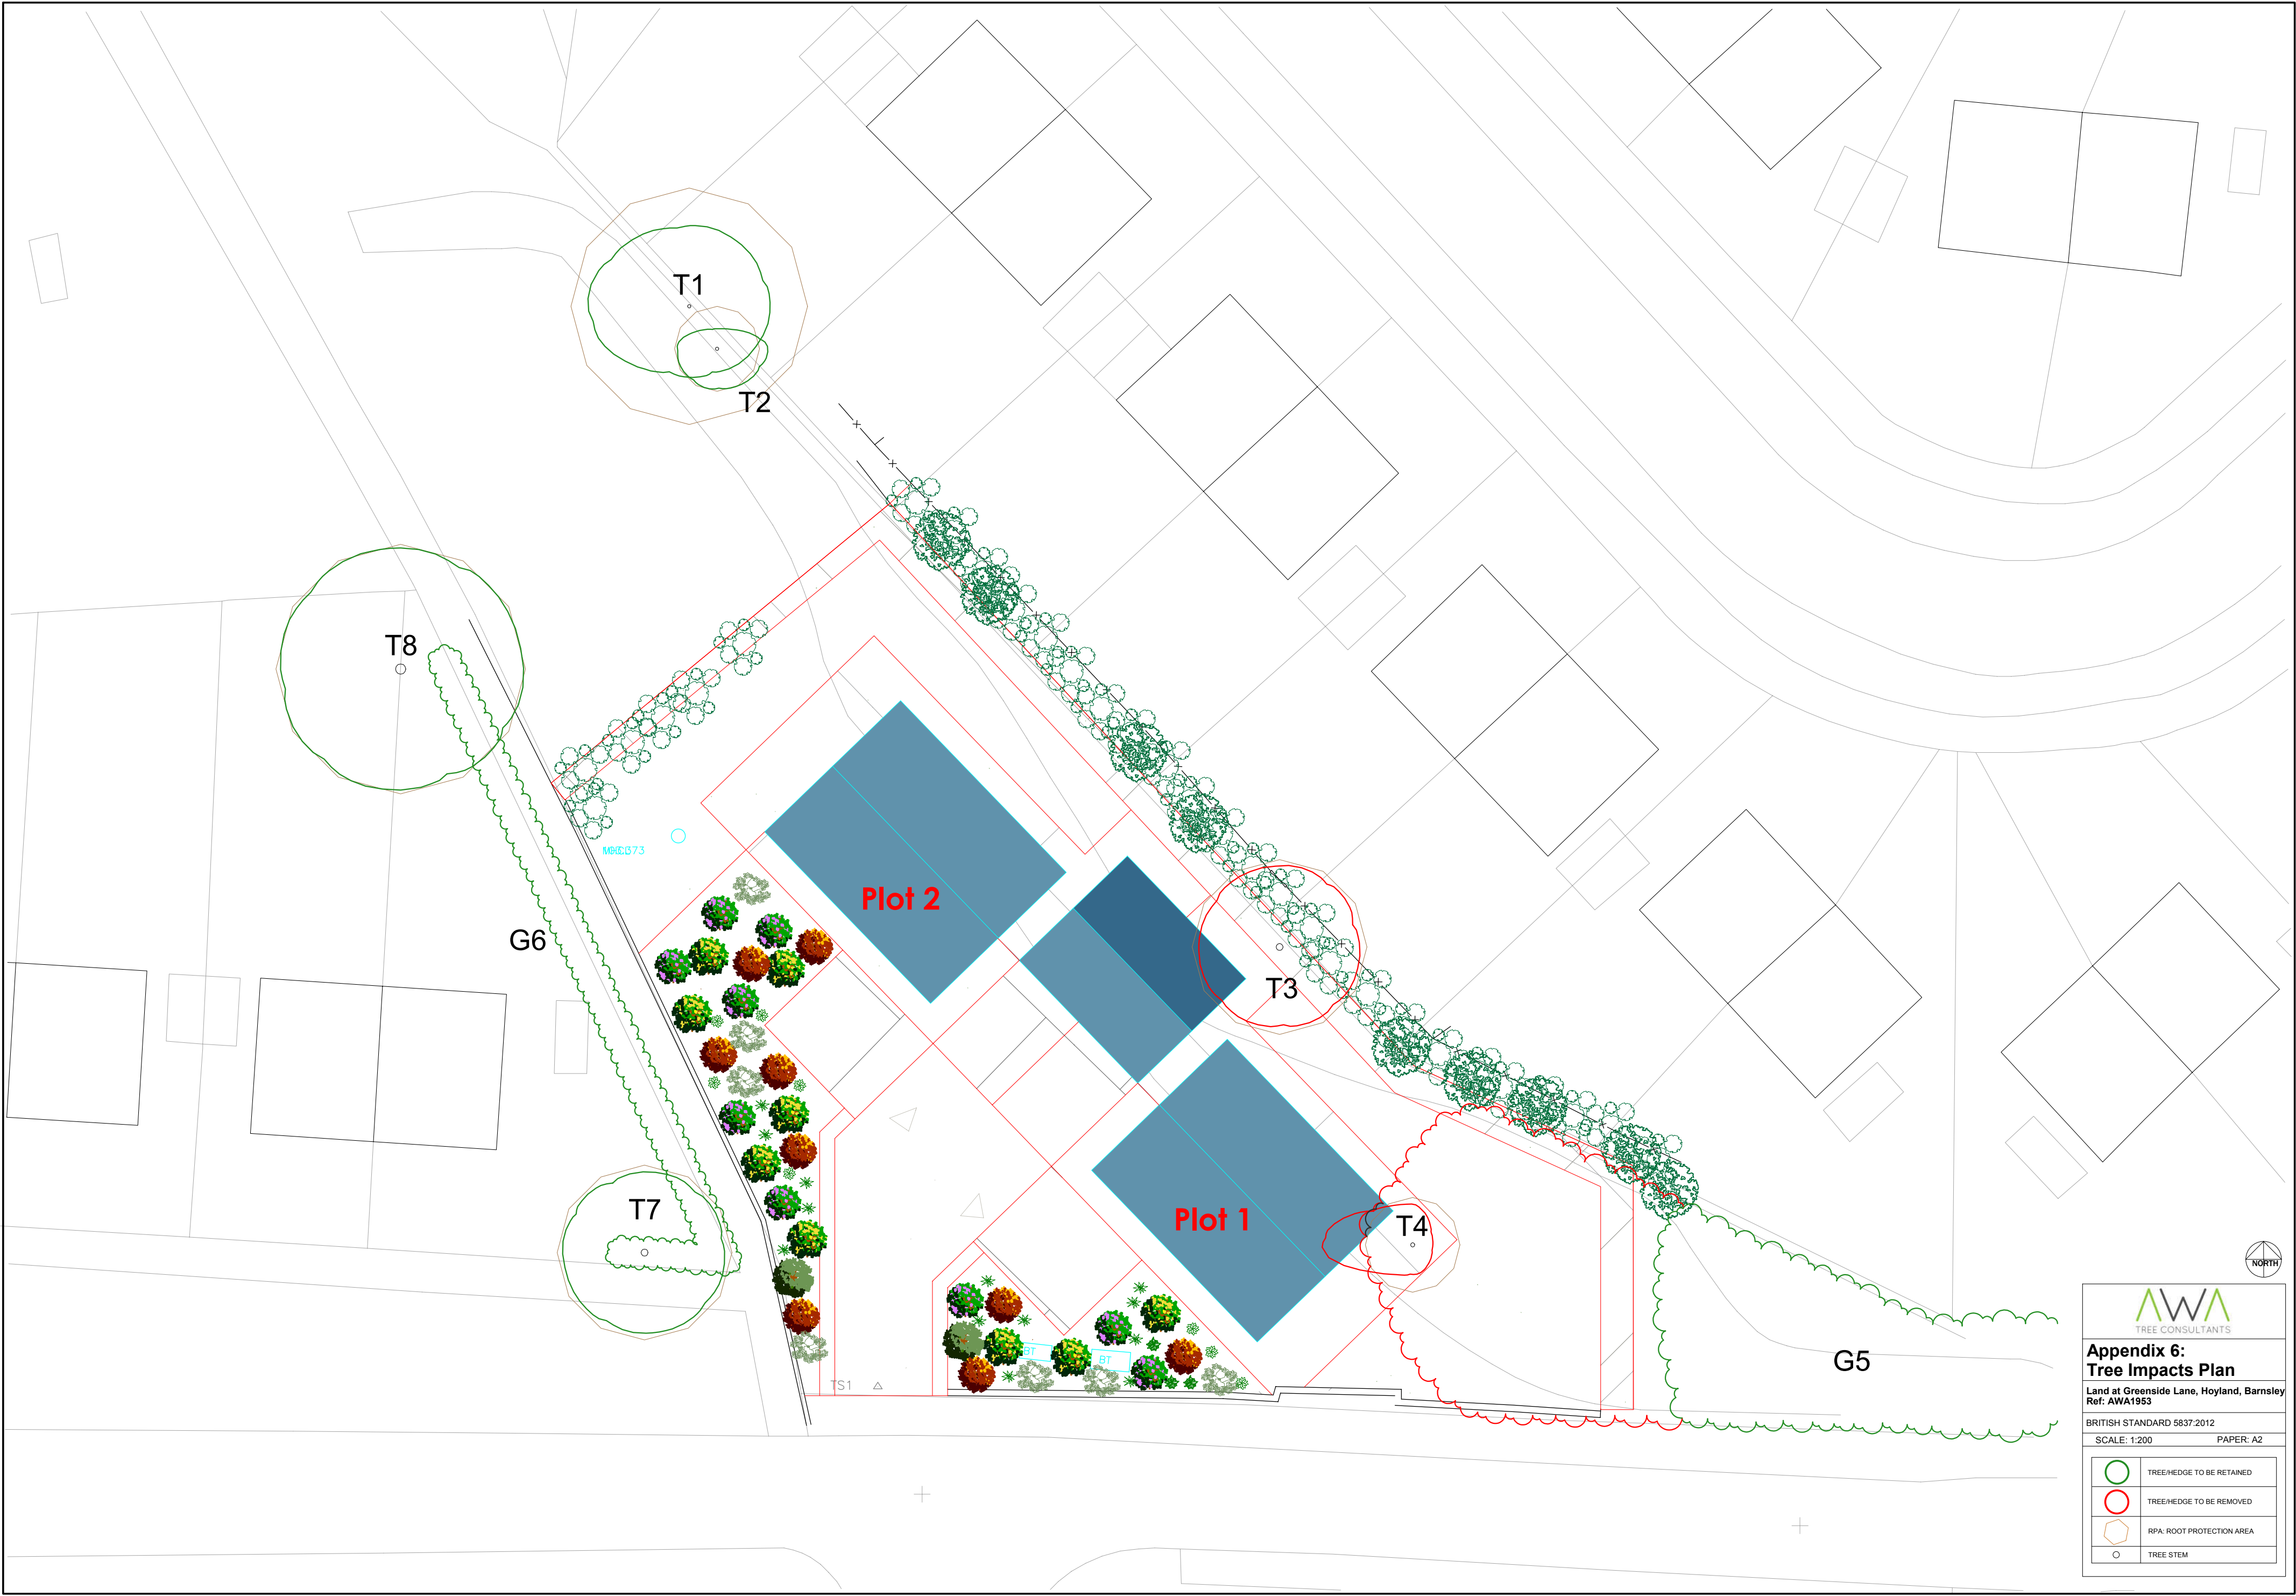
**Appendix 6:  
Tree Impacts Plan**  
Land at Greenside Lane, Hoyland, Barnsley  
Ref: AWA1953

- 4.1.1 It is proposed to build 2 new residential properties with associated garages, access and facilities. The development proposals have been provided by my client and inform this arboricultural impact assessment and the Tree Impacts Plan at Appendix 6.

- 4.2.1 From assessing the new development proposals, 2 trees and a section of one group will require removal as they are situated in the footprint of the structures or their retention and protection throughout the development is not suitable.
- 4.2.2 The trees that require removal are T3 Ash, T4 Ash and a section of the shrub group G5. They are all lower value, retention category 'C' and their removals will have only a negligible negative arboricultural impact at the site.
- 4.2.3 New landscape plantings are proposed as part of the new development which will mitigate for the trees removed, and will improve the site's tree cover in the long term.

- 4.4.1 The retained trees may require protection by fencing in accordance with BS 5837: 2012, during the development phase.
- 4.4.2 If required by the Local Planning Authority, an associated Arboricultural Method Statement, detailing protective fencing specifications and construction methods close to the retained trees can be provided.
