Root Barrier Design

Innovation File No.: IFS-LBG-SUB-22-0100956
Policyholder: Mrs Janet Ivermee
Address: 51 Lund Avenue, Barnsley, S71 5NW

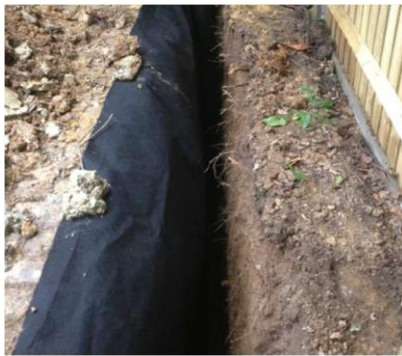
This solution is multipurpose and ideally suited to the current application. Traditional impervious barriers divert rather than stop roots and may block moisture movement. Also roots getting under such barriers can grow back to the surface. Therefore, the use of this permeable barrier stops roots either by engaging and constricting them or by chemically inhibiting them.

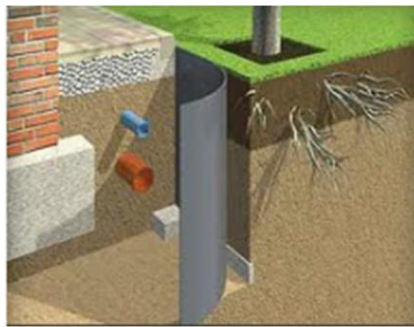
The benefits of such a shield are its dual protection both physical and biological. The multi layered sheets can be welded together whilst retaining its flexible qualities, i.e. can be cut and effectively resealed to fit round services and foundations, inert with a 50-year service life expectancy. Equally the solution inhibits root growth on the barrier face which is often problematic with conventional barriers where increased moisture levels can cause root growth to become more prolific on the face of a traditional barrier. Research has shown that the use of the recommended style of copper-based screening has greatly reduced the effects of root growth when compared to other traditional physical barrier installations

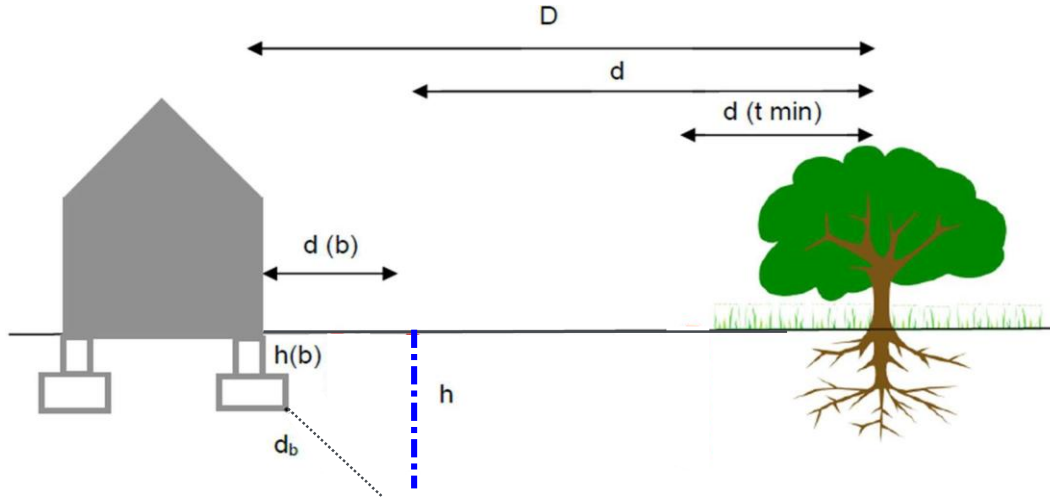
Figure A2: Typical Section Considering shortest distance between implicated Vegetation and Affected Property

The calculations then check the required depth of the barrier against two criteria:

1. What the depth of a traditional foundation would need to be, in the preferred location of the barrier, based on Chapter 4.2 of the National House Building Council (NHBC).
2. 500mm below the deepest roots recovered during the Geotechnical Site Investigations.

The calculations also check that the proposed barrier depth (h) will not undermine the foundations (d_b).

Location	Tree Species	Type & Water Demand	Mature Height H (m)	D (m)	D/H	d(b) (m)	h(b) (m)	Root Depth from SI (m)	d _b (m)	Depth due to Roots from SI	NHBC Foundation Depth Required (m)	h (m)	Check h < d _b
T1	English Oak	Broad Leaf High	20	17.5	0.875	3.0	0.4	1.2	3.4	1.7	1.28	1.70	PASS
-	-	-	-	-	-	-	-	-	-	-	-	-	-
-	-	-	-	-	-	-	-	-	-	-	-	-	-
-	-	-	-	-	-	-	-	-	-	-	-	-	-
-	-	-	-	-	-	-	-	-	-	-	-	-	-
-	-	-	-	-	-	-	-	-	-	-	-	-	-
-	-	-	-	-	-	-	-	-	-	-	-	-	-
-	-	-	-	-	-	-	-	-	-	-	-	-	-
-	-	-	-	-	-	-	-	-	-	-	-	-	-
