## Belle Vue Extended Phase 1 Habitat Report and building inspection

Barnsley College  
June 2014

| <b>Project:</b> | Belle Vue Extended Phase 1 Habitat Report. | | |
| <b>Location:</b> | Belle View, Cockerham Lane, Barnsley, S75 1AT. | | |

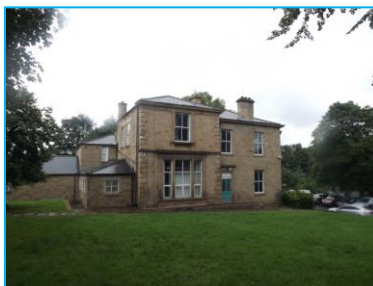
There are a number of buildings on site. A large Georgian period building (Belle Vue House), an electricity substation and a maintenance block. Building descriptions are detailed in Table 2.

**Figure 2 - Georgian building**

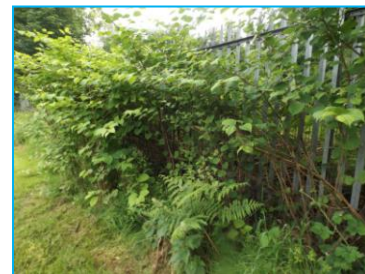
The species present in these areas include perennial ryegrass *Lolium perenne*, dandelion *Taraxacum*, common daisy *Bellis perennis*, ribwort plantain *Plantago lanceolata*, meadow buttercup *Ranunculus acris* and cat's ear *Hypochaeris radicata*. An approx. 5m stand of Japanese Knotweed stands in the southern section of amenity grassland, adjacent the palisade fencing (TN1).

**b) - Stand of Japanese Knotweed (TN1)**

It is recommended that the methods of working for the site are designed to avoid spreading these species, particularly where there is a risk that these could be spread into the semi-natural habitats located to the north of the site.

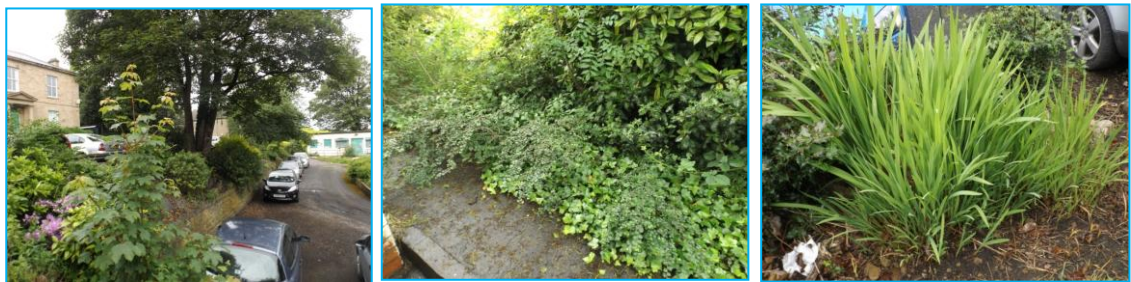
Non-native, invasive plant species *Cotoneaster* occurs to the north of site, bordering the maintenance block (TN2). Non native, invasive plant species *Montbretia* occurs in the centre of site, adjacent the car park (TN3).

**Figure 8 a) - Introduced shrub bordering the car park, b) - Cotoneaster (TN2), c) - Montbretia (TN3)**

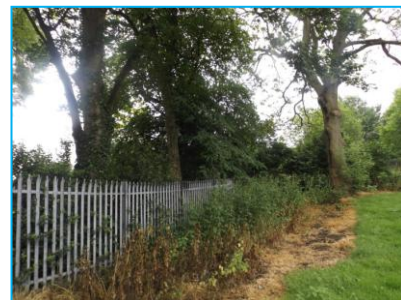
**Figure 10 - Steel palisade fencing south of the car park**

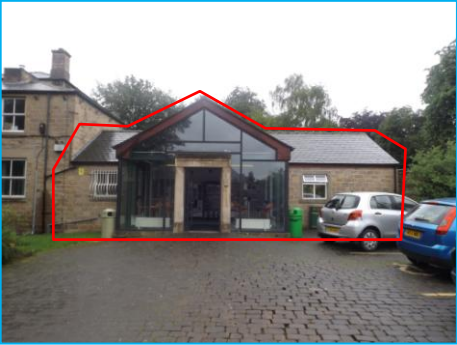
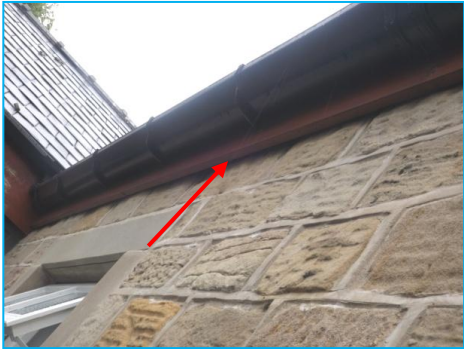
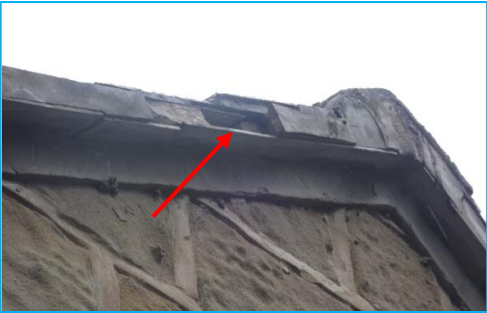
| Building Number | Description |
|---|---|
| Belle Vue House<br><br>Building 1 | <p><b>External:</b> Building 1 is a brick, single storey construction with wooden fascia boards. The roof is pitched with slate roofing tiles and is modern and intact. There is a glass walled foyer that extends out to the north. There are gaps under the fascia boards and a gap under the roof tiles at the west facing aspect, but is otherwise well sealed.</p> <p>Figure 11 - North face of Building 1</p> <p>Figure 12 - Gaps under fascia boards</p> <p>Figure 13 - Gap under roof tiles</p> <p><b>Internal:</b> The roof is bitumen felt lined with exposed modern wooden beams. The fascias and general roof space is tightly sealed and the floor is</p> |

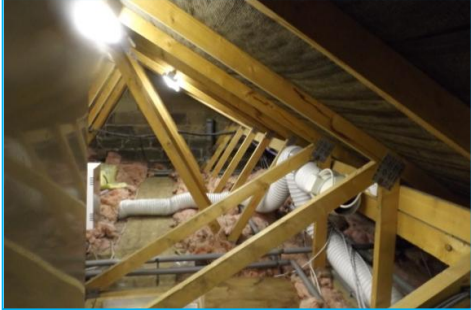
| Building Number | Description |
|---|---|
| | <p>boarded for regular access.</p> <p><b>Figure 14 - Roof space</b></p> <p><b>Bat Evidence:</b> None.</p> <p><b>Status:</b> Moderate potential for supporting bat roosts. Due to potential access points and roof structure and age of the property The gap at the apex does not lead into the loft space.</p> |

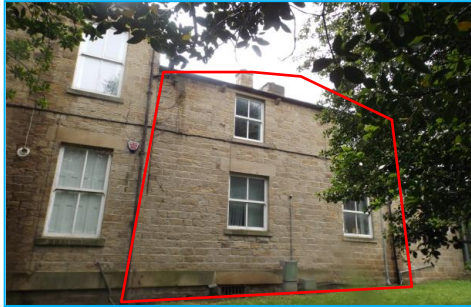
| Building Number | Description |
|---|---|
| <p><b>Belle Vue House</b></p> <p><b>Building 2</b></p> | <p><b>External:</b> Building 2 is the same stone, pitched slate roof construction as Building 1, but with two storey's. The building is well sealed.</p> <p><b>Figure 15 - Building 2, north face</b></p> <p><b>Internal:</b> The roof space could not be accessed due to a lack of obvious access point.</p> <p><b>Bat Evidence:</b> None.</p> <p><b>Status:</b> Moderate potential for supporting bat roosts. The roof tiles and general building are well sealed, which reduces possibility of bat access into the loft space. However, the loft space could not be accessed for assessment and considering the roof structure and age of the building, the status is considered to be moderate.</p> |

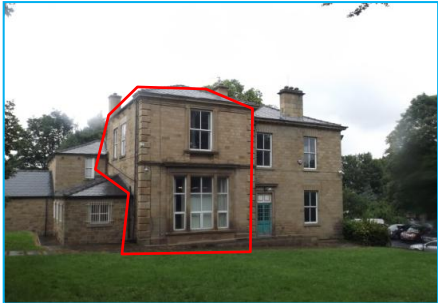
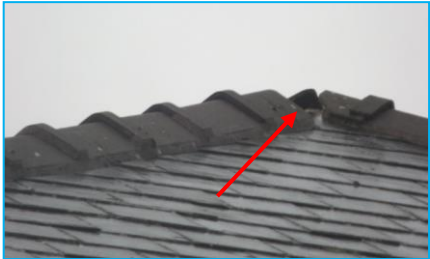
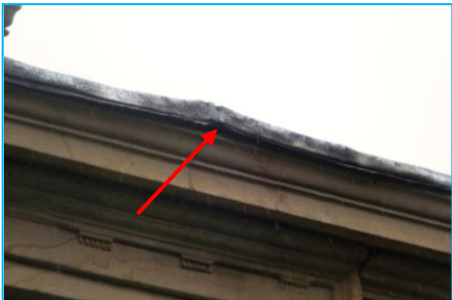
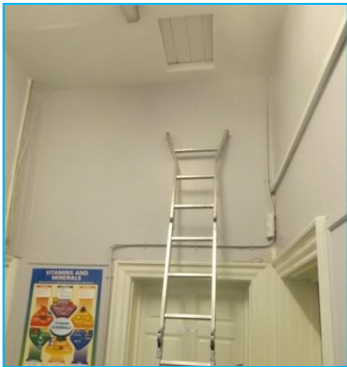
| Building Number | Description |
|---|---|
| <p><b>Belle Vue House</b></p> <p><b>Building 3</b></p> | <p><b>External:</b> Building 3 is the same stone, pitched slate roof construction as Building 2, though the two floors have higher ceilings. A number of roof tiles and lead flashing sections were raised and there was damage to the ridge tile at the apex.</p> |

| Building Number | Description |
|---|---|
| | <div data-bbox="722 499 1161 801"></div> <div data-bbox="491 801 911 837"><p><b>Figure 16 - Building 3, south face</b></p></div> <div data-bbox="726 871 1157 1128"></div> <div data-bbox="491 1128 906 1164"><p><b>Figure 17 - Gap at apex ridge tile</b></p></div> <div data-bbox="715 1196 1168 1494"></div> <div data-bbox="491 1494 895 1529"><p><b>Figure 18 - Raised lead flashing</b></p></div> <div data-bbox="491 1561 1150 1597"><p><b><u>Internal:</u></b> The lofts pace was inaccessible due to height.</p></div> <div data-bbox="767 1626 1115 1991"></div> |

| Building Number | Description |
|---|---|
| | <p><b>Figure 19 - Loft space inaccessible</b></p> <p><b>Bat Evidence:</b> None.</p> <p><b>Status:</b> Moderate potential for supporting bat roosts due to potential access points, roof structure and age of the building. The loft space could not be accessed for assessment.</p> |

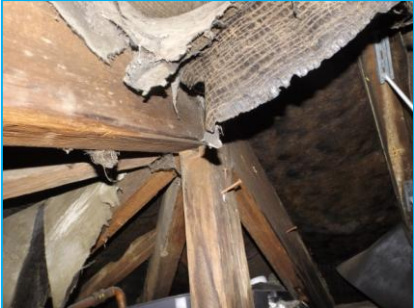
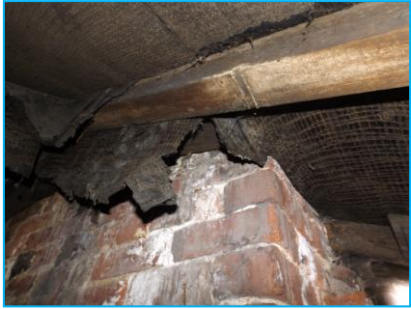
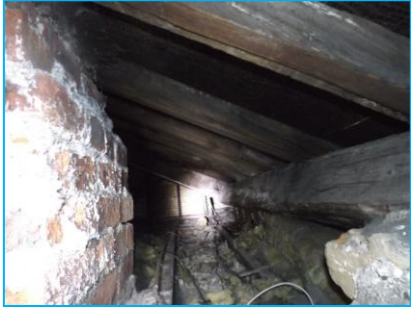
| Building Number | Description |
|---|---|
| <p><b>Belle Vue House</b></p> <p><b>Building 4</b></p> | <p><b>External:</b> Building 4 is the same design as the other buildings. There are gaps between the roofing slabs and a possible bat dropping was identified on the windowledge to the left of the main door that leads in to the building.</p> <div data-bbox="721 725 1161 1055" data-label="Image"> </div> <p><b>Figure 20 - Building 4, east face</b></p> <div data-bbox="721 1124 1165 1424" data-label="Image"> </div> <p><b>Figure 21 - Possible bat dropping on east facing window (TN5)</b></p> <div data-bbox="721 1491 1165 1825" data-label="Image"> </div> <p><b>Figure 22 - Gaps in between roofing slabs</b></p> <p><b>Internal:</b> The roof space is a low crawl space consisting of original wooden beams. The bitumen roofing felt lining is damaged in places leaving open access into the loft space. The crawl space could not be fully explored due</p> |

| Building Number | Description |
|---|---|
| | <p data-bbox="491 439 1059 465">to the low height and lack of safe floor boarding.</p> <p data-bbox="491 815 778 842"><b>Figure 23 - Roof space</b></p> <p data-bbox="491 1193 778 1220"><b>Figure 24 - Roof space</b></p> <p data-bbox="491 1570 772 1597"><b>Figure 25- Roof space</b></p> <p data-bbox="491 1603 1225 1630"><b>Bat Evidence:</b> Possible bat dropping on window ledge (TN5).</p> <p data-bbox="491 1637 1326 1697"><b>Status:</b> High potential for supporting bat roosts. The original loft space contains lots of gaps in the lime mortar and the bitumen felt.</p> |

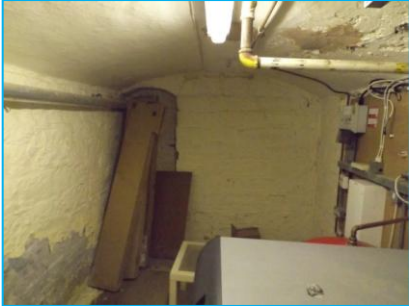
| Building Number | Description |
|---|---|
| <p data-bbox="333 1843 445 1899"><b>Belle Vue House</b></p> <p data-bbox="333 1937 445 1966"><b>Basement</b></p> | <p data-bbox="491 1843 1339 1872"><b>Internal:</b> The basement has a number of chambers with rounded roofs.</p> |

| Building Number | Description |
|---|---|
| | <p><b>Figure 29 - Basement</b></p> <p><b>Bat Evidence:</b> None</p> <p><b>Status:</b> Low potential for supporting bat roosts. There were no suitable access points for bats.</p> |

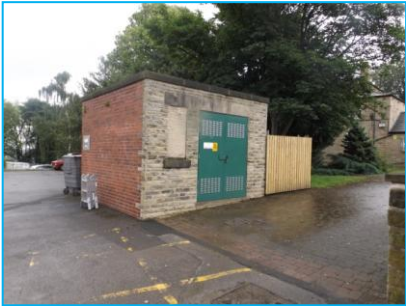
| Building Number | Description |
|---|---|
| <p><b>Building 6</b></p> <p><b>Electricity sub station</b></p> | <p><b>External:</b> The building is a modern, tightly sealed brick construction. The roof is flat bitumen felt.</p> <p><b>Figure 30 - Building 6, Electricity sub station</b></p> <p><b>Internal:</b> The internal could not be accessed for safety reasons.</p> <p><b>Bat Evidence:</b> None</p> <p><b>Status:</b> Low potential for supporting bat roosts. The building is well sealed, reducing available roosting areas for bats.</p> |

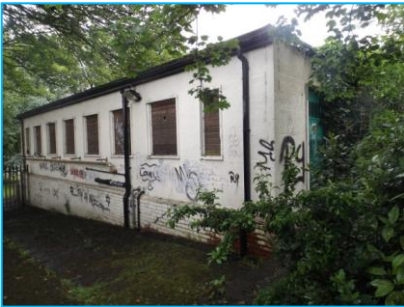
| Building Number | Description |
|---|---|
| <p><b>Building 7</b></p> <p><b>Maintenance block</b></p> | <p><b>External:</b> The maintenance block is an intact prefabricated concrete panel construction with a flat bitumen felt roof. The windows have been boarded over with wooden panels.</p> <p><b>Figure 31 - Building 7, maintenance block</b></p> |

| Building Number | Description |
|---|---|
| | <b>Internal:</b> The internal could not be accessed as no key was provided. |

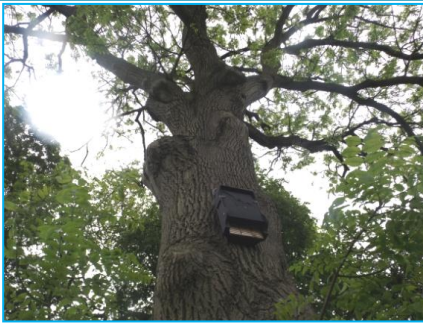
| Tree ID | Description |
|---|---|
| 1 | <p><b>Figure 32 - Ash tree with bat roosting potential, east of site (TN4)</b></p> <p><b>Description:</b> Mature Ash tree.</p> <p><b>Potential bat features:</b> Pruning scars and contained a bat box.</p> <p><b>Bat evidence:</b> None.</p> <p><b>Status:</b> High potential for supporting bat roosts.</p> |

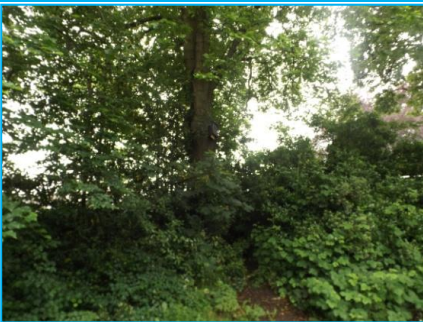
| Tree ID | Description |
|---|---|
| 2 | <p><b>Figure 33 - Beech tree with bat roosting potential, west of site (TN4)</b></p> <p><b>Description:</b> Mature Beech tree.</p> <p><b>Potential bat features:</b> Pruning scars and contained a bat box.</p> <p><b>Bat evidence:</b> None.</p> <p><b>Status:</b> High potential for supporting bat roosts.</p> |
