Arboricultural Method Statement

For Trees At

Retail Development -

The Former Foulstone School,

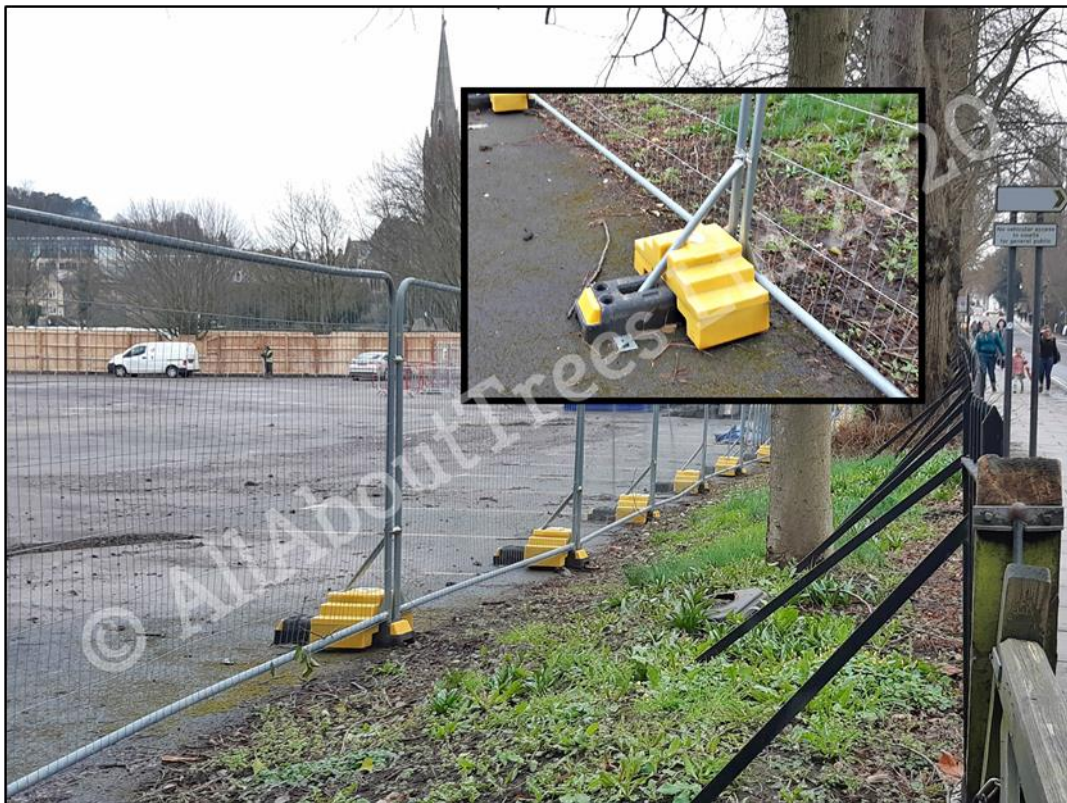
Figure 2 – An example of a barrier erected on a site.

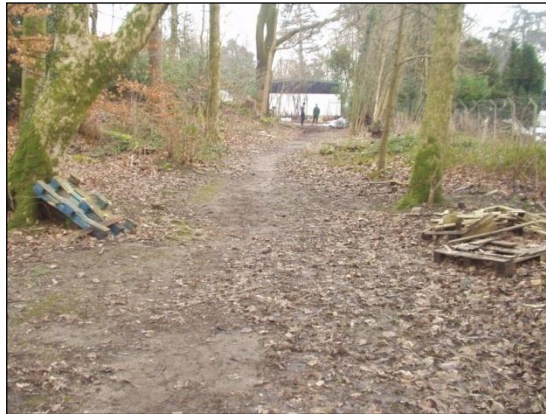
*Photo 1- line of new road prior to the commencement of works*

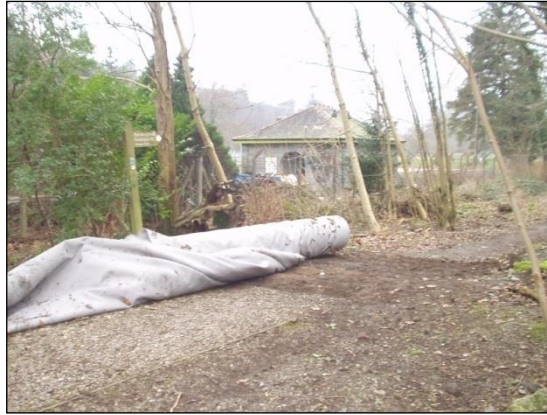
*Photo 2- laying of Fibretex material onto existing subgrade.*

- 1) Lay a Treetex T300 geotextile material directly on the existing subgrade. Overlap dry joints by 300mm.

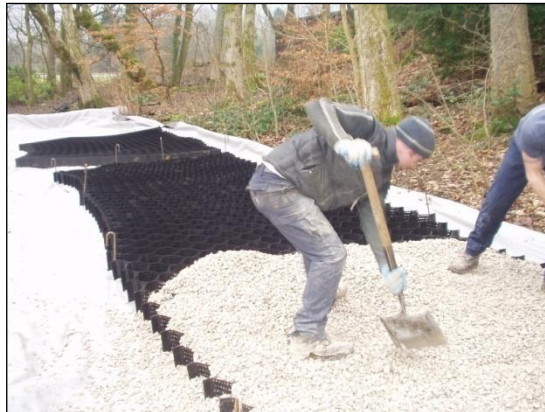
*Photo 3- expanding and filling the Cellweb system*

- 2) Lay and expand the cellular confinement system, Cellweb by Geosynthetics Ltd, and anchor open during infilling. As a general indication only, a depth of at least 100mm is required for domestic traffic up to approximately 3 tons. A 200 mm depth should accommodate vehicles up to approximately 8 tons. Footpaths and cycle ways generally require a depth of 75mm. Geosynthetics Ltd provide a free consultation, design and advisory service to help specify the exact depth and construction of the Cellweb system.

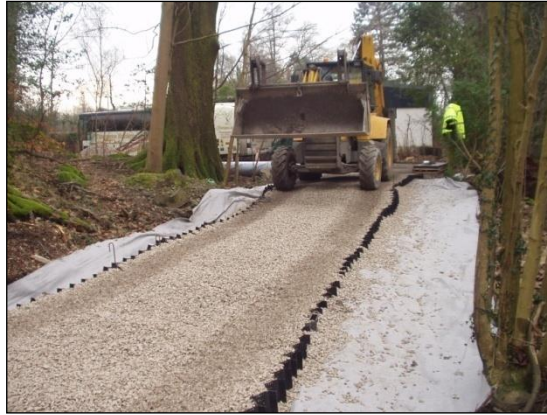
Photo 4- once filled the system can support plant to carry aggregate to the fill area

- 4) Fill the cellular confinement system with aggregate (the amount is dependent on the depth of the Cellweb employed). The aggregate should not contain any fines and be of an inert type material such as whinstone chips rather than any lime-based product. The angular particle dimensions should be 20-40mm. As most urban soils are already alkaline in nature, the use of dolomite, limestone or crushed concrete is not suitable for this application as it can react with rainwater with the potential to change the soil pH and form impenetrable layers which impede water movement and gaseous exchange
