Land at Woolley Colliery Road, Darton For Homes by Honey, Keith Wike & Brenda Wike, Christopher Wike & Sharon Wike

Report no: 5624/1A
Date: February 2026

Lithos were commissioned by Honey to provide a geoenvironmental appraisal of the site, which it is understood is to be redeveloped with residential dwellings. Lithos' investigation included a review of 3rd party reports, the site's history and environmental setting, and a ground investigation comprising 23 trial pits and 16 rotary probeholes.

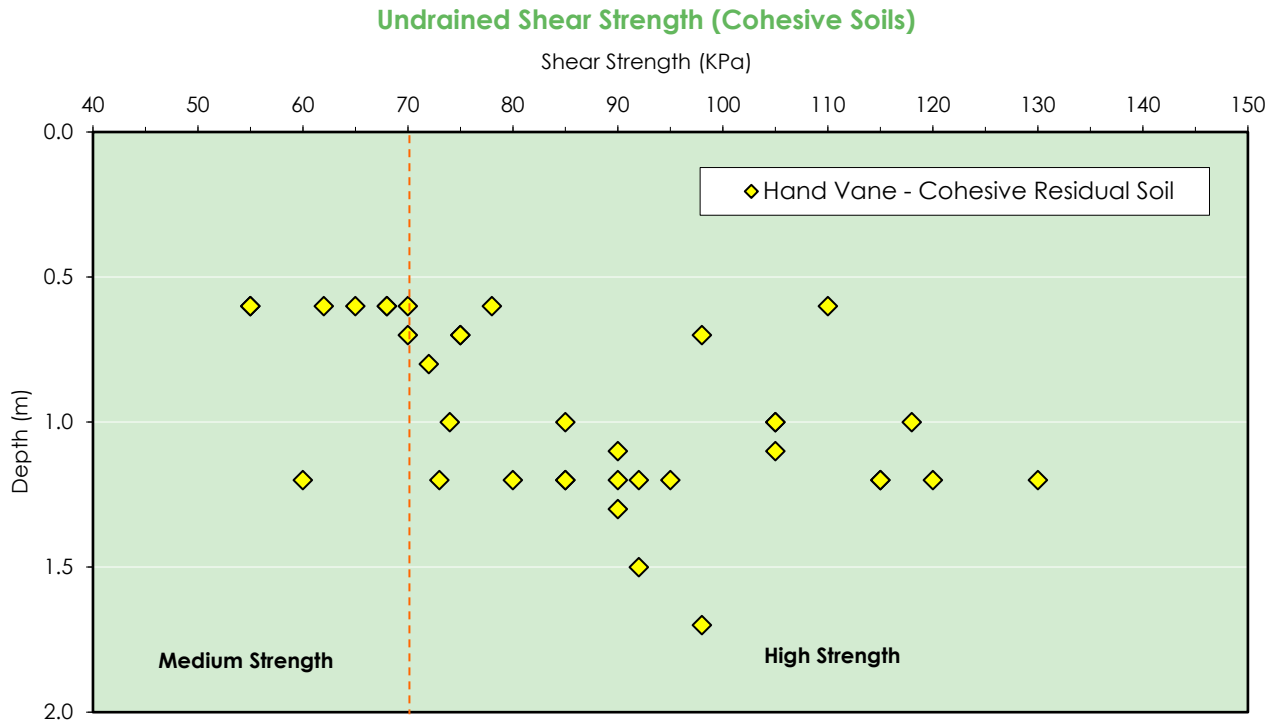
16.5.3 The plot below provides a summary of undrained shear strengths.

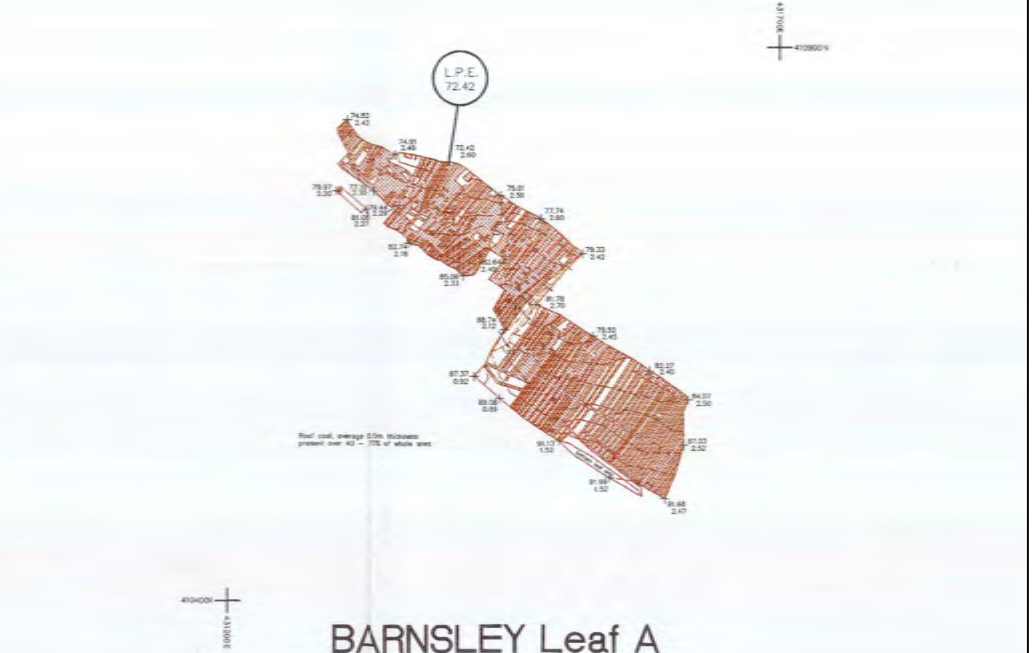
Vertical Sections

SEAM NAME LEVEL SEAM THICKNESS
BOTTOM OF COAL

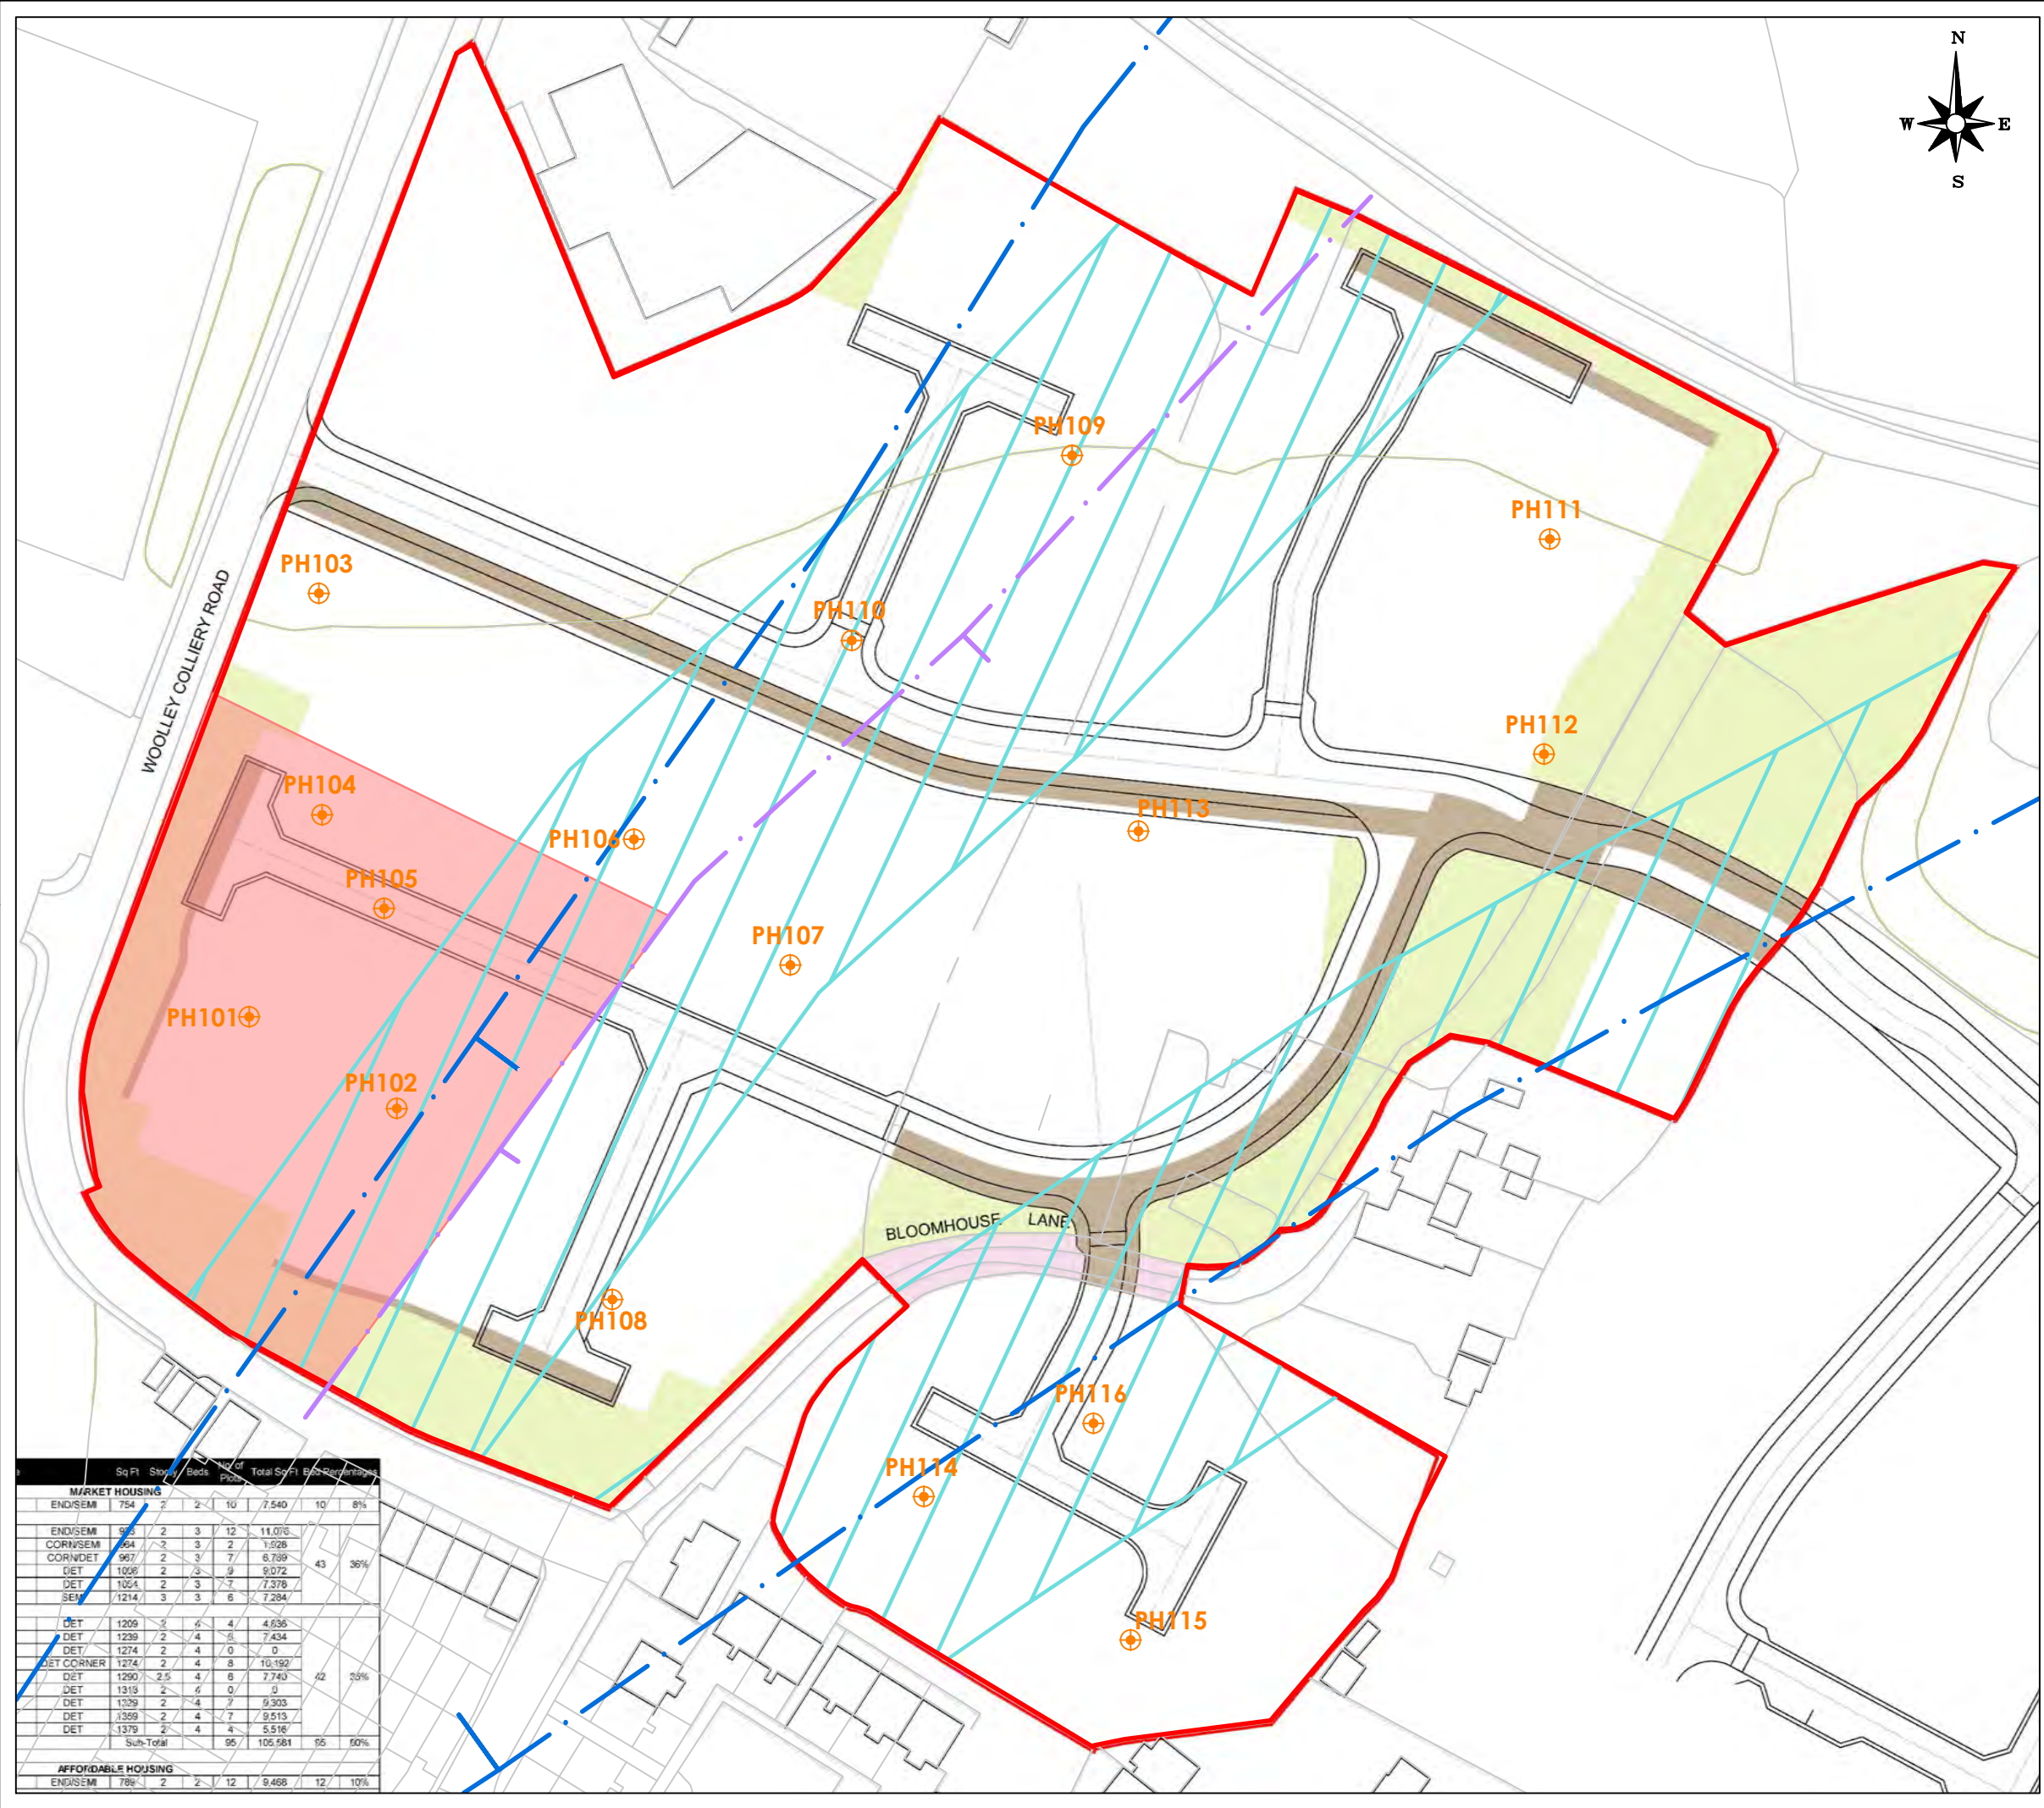
SCALE 1:1000	SHEET A3	DRAWING NO. 5624/ 13	REVISION
-----------------	-------------	-------------------------	----------

- NOTES
- PROBEHOLE LOCATION
 - APPROXIMATE AREA OF DRILLING AND GROUTING - LIKELY >5 - 10m OF ROCK COVER - THEREFORE STRIP FOUNDATIONS REQUIRE REINFORCEMENT AND THICKENING

- WITHIN 25m OF APPROXIMATE LINE OF FAULT
 - APPROXIMATE LINE OF GEOLOGICAL FAULT (LITHOS SI & ABANDONMENT PLANS)
 - APPROXIMATE LINE OF GEOLOGICAL FAULT (BGS)

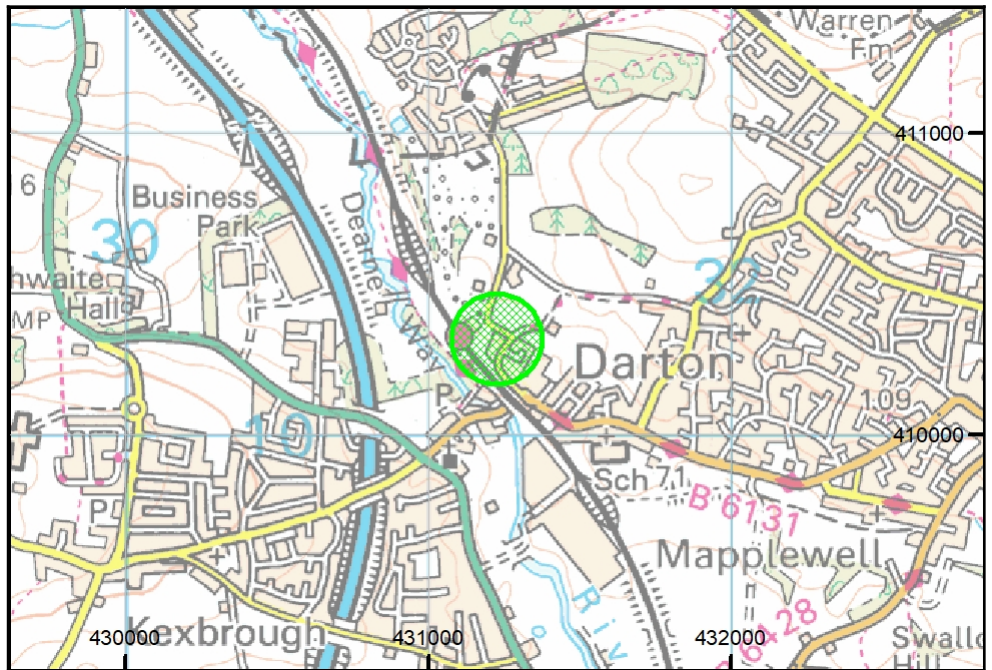
This plan shows the approximate location of the disused mine entry / entries referred to in the attached mining report. For reasons of clarity, mine entry symbols may not be drawn to the same scale as the plan.

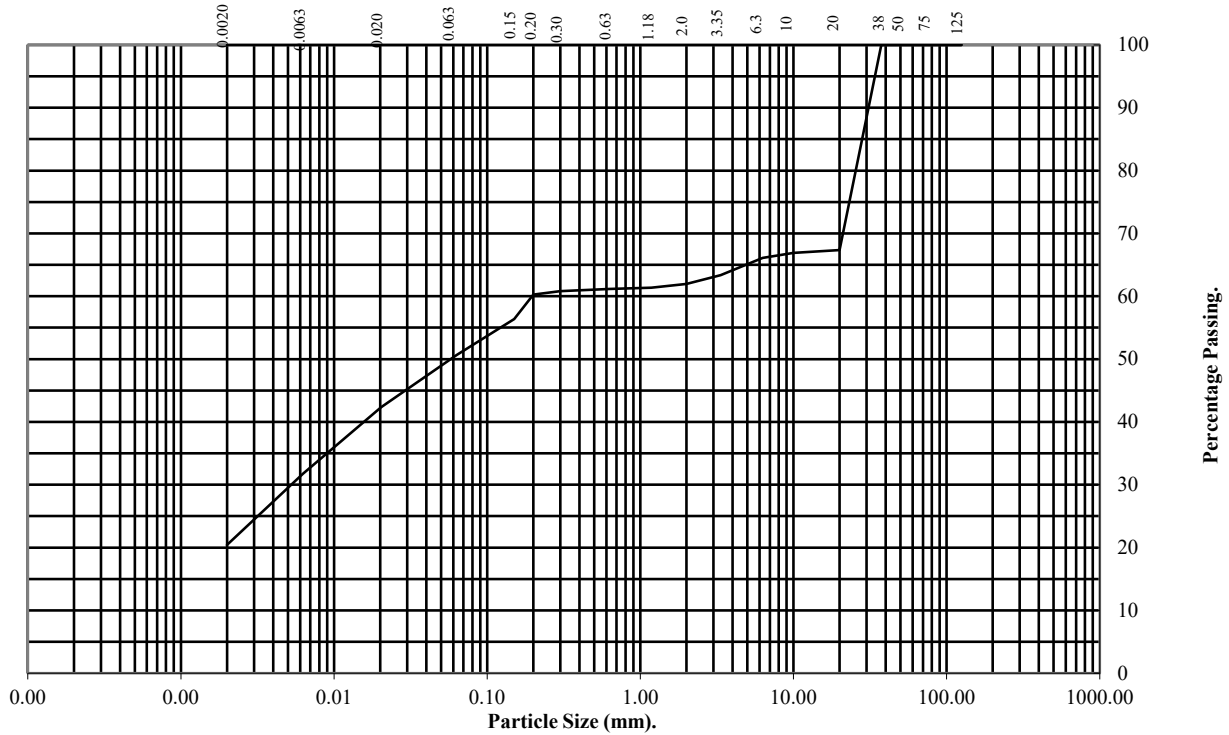
BS Test Sieve (mm)	Percentage Passing
125	100
75	100
50	100
37.5	100
20	67
10	67
6.3	66
3.35	63
2	62
1.18	61
0.63	61
0.3	61
0.2	60
0.15	56
0.063	51

Particle Diameter	Percentage Passing
0.020	42
0.0063	32
0.0020	20
<i>Particle Density - 2.65 Mg/m³ assumed</i>

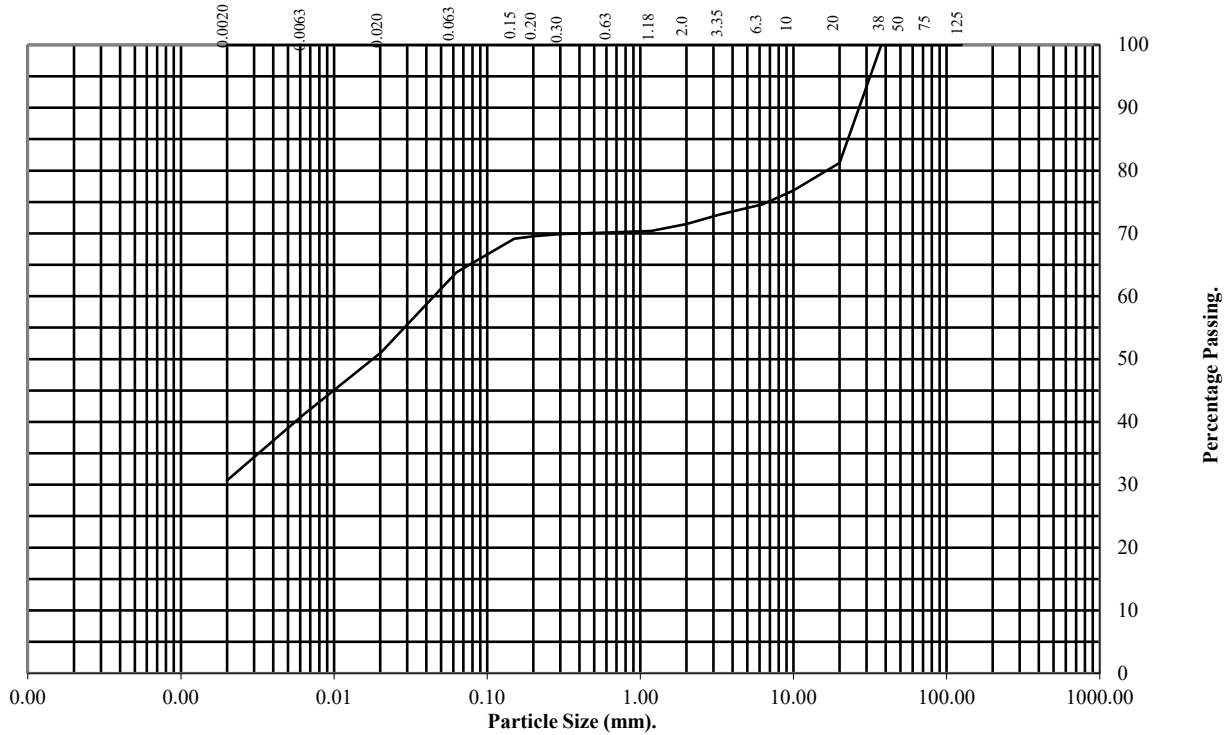
BS Test Sieve (mm)	Percentage Passing
125	100
75	100
50	100
37.5	100
20	81
10	77
6.3	75
3.35	73
2	71
1.18	70
0.63	70
0.3	70
0.2	70
0.15	69
0.063	64

Particle Diameter	Percentage Passing
0.020	51
0.0063	41
0.0020	31
<i>Particle Density - 2.65 Mg/m3 assumed</i>

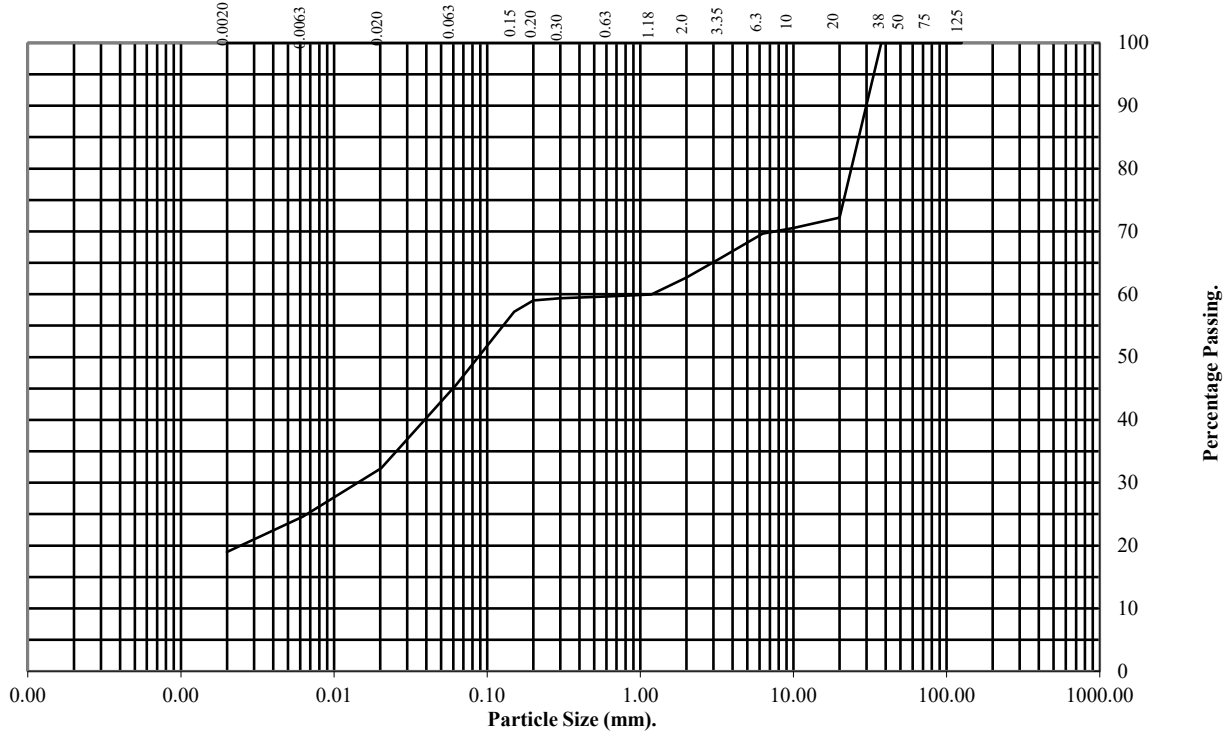
BS Test Sieve (mm)	Percentage Passing
125	100
75	100
50	100
37.5	100
20	72
10	71
6.3	70
3.35	66
2	63
1.18	60
0.63	60
0.3	59
0.2	59
0.15	57
0.063	46

Particle Diameter	Percentage Passing
0.020	32
0.0063	25
0.0020	19
<i>Particle Density - 2.65 Mg/m³ assumed</i>

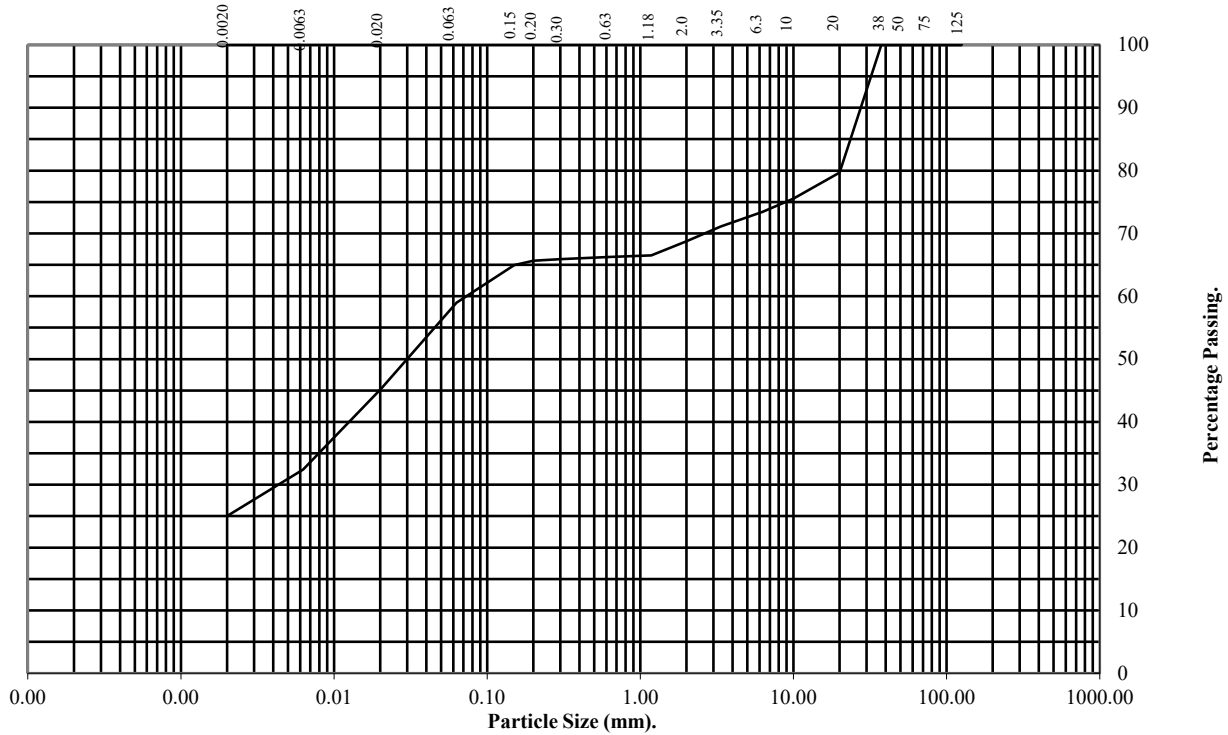
BS Test Sieve (mm)	Percentage Passing
125	100
75	100
50	100
37.5	100
20	80
10	76
6.3	73
3.35	71
2	69
1.18	66
0.63	66
0.3	66
0.2	66
0.15	65
0.063	59

Particle Diameter	Percentage Passing
0.020	45
0.0063	32
0.0020	25
<i>Particle Density - 2.65 Mg/m3 assumed</i>

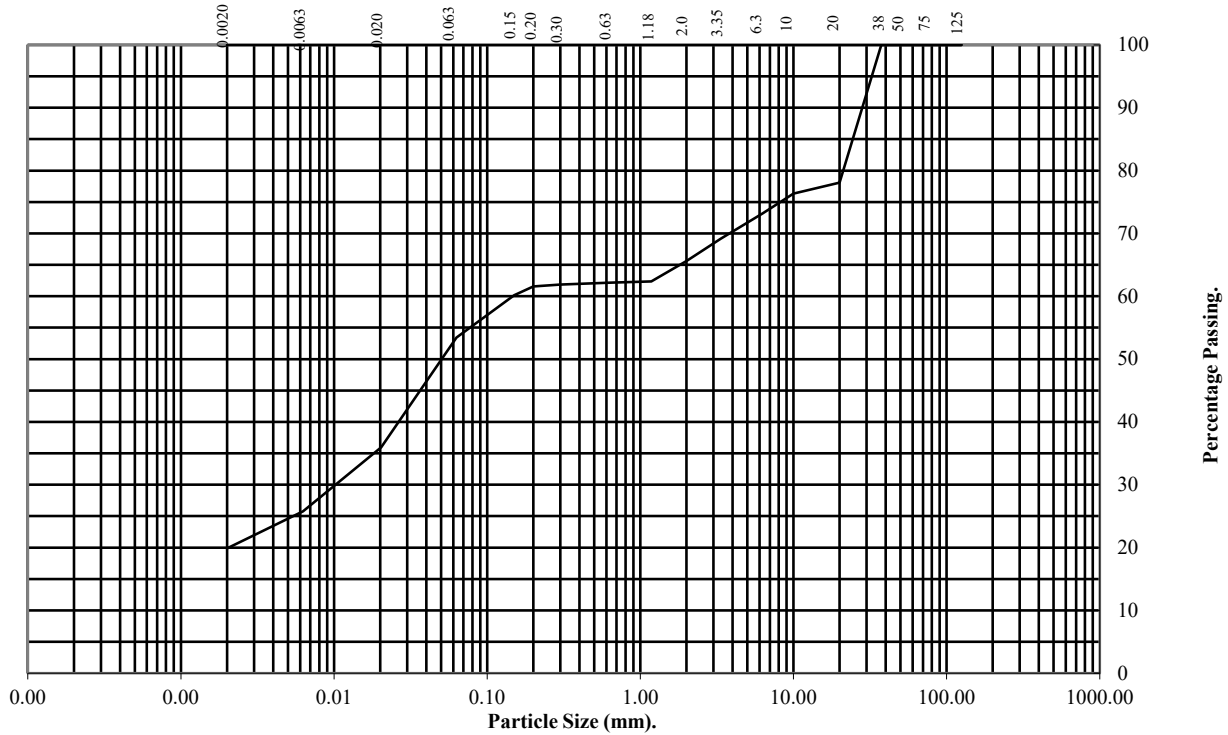
BS Test Sieve (mm)	Percentage Passing
125	100
75	100
50	100
37.5	100
20	78
10	76
6.3	73
3.35	69
2	66
1.18	62
0.63	62
0.3	62
0.2	62
0.15	60
0.063	53

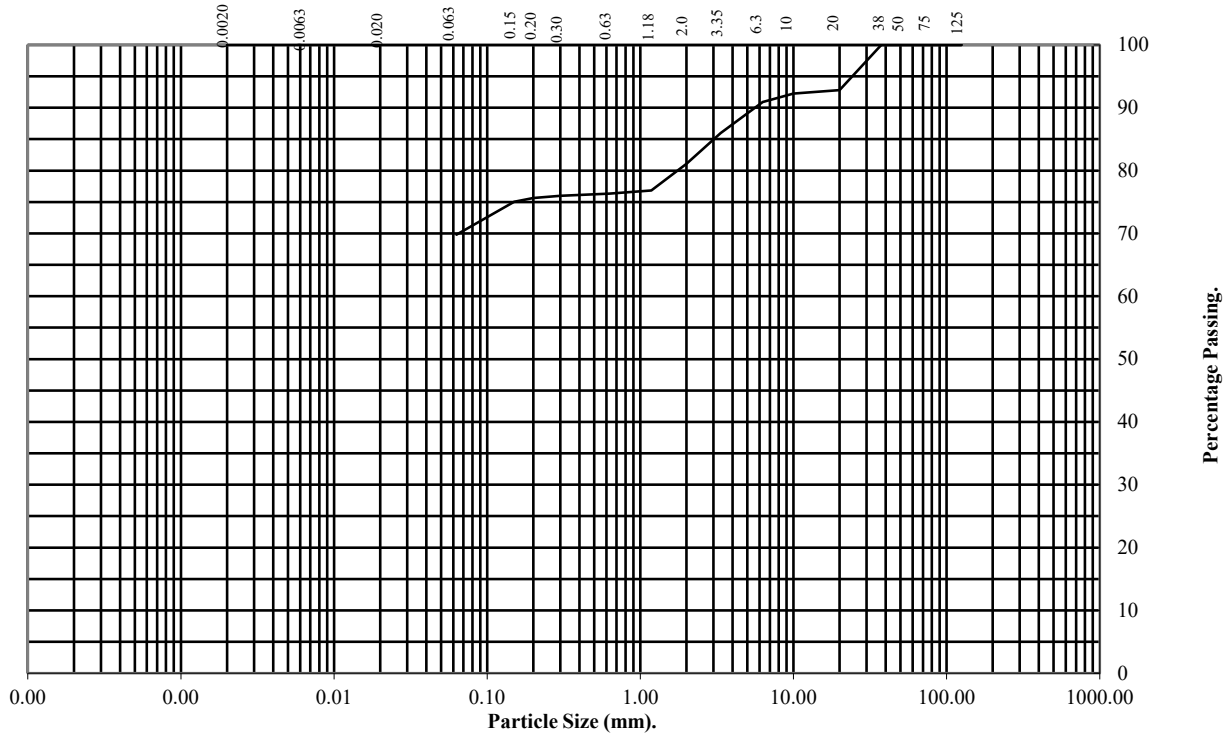
BS Test Sieve (mm)	Percentage Passing
125	100
75	100
50	100
37.5	100
20	93
10	92
6.3	91
3.35	86
2	81
1.18	77
0.63	76
0.3	76
0.2	76
0.15	75
0.063	70

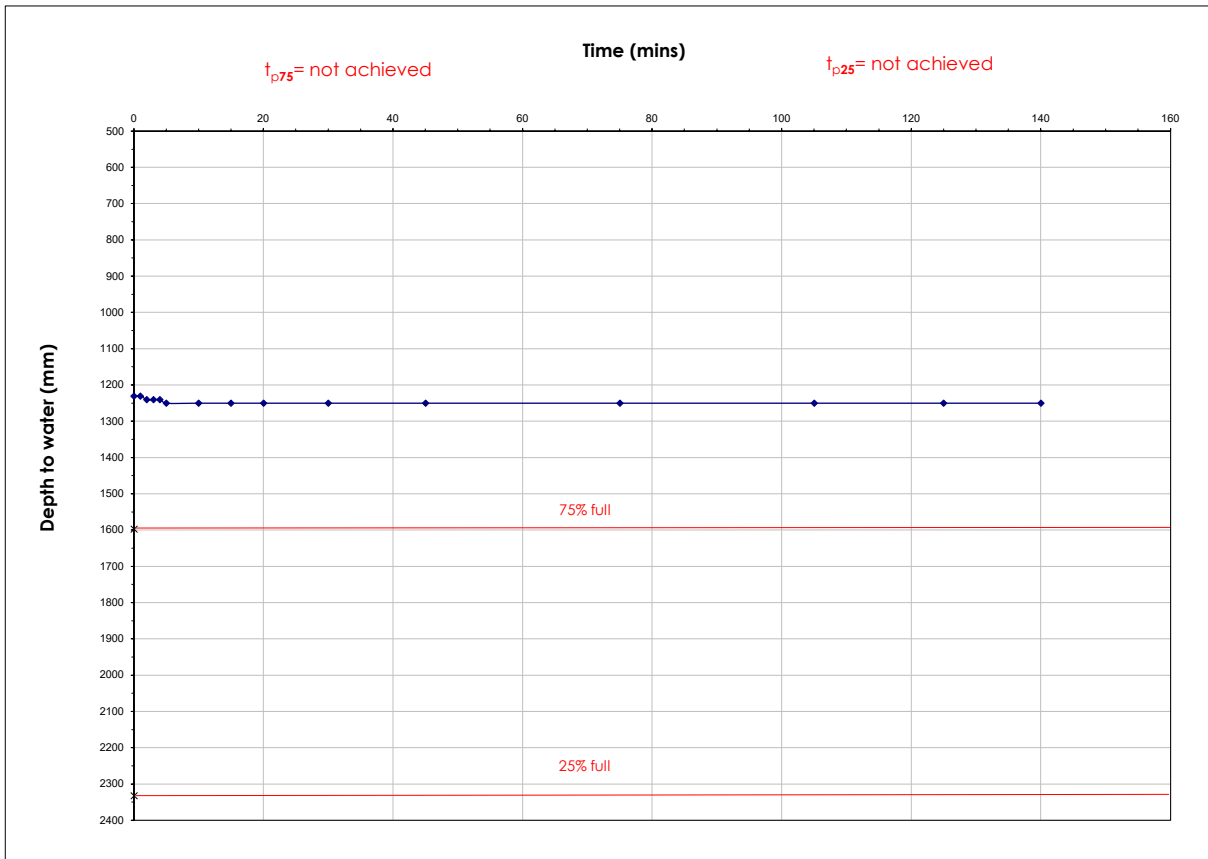
Read from the graph:		
t_{p75} (min)	=	n/a
t_{p25} (min)	=	n/a

Test did not attain 25% Effective depth. Unable to calculate soil infiltration rate

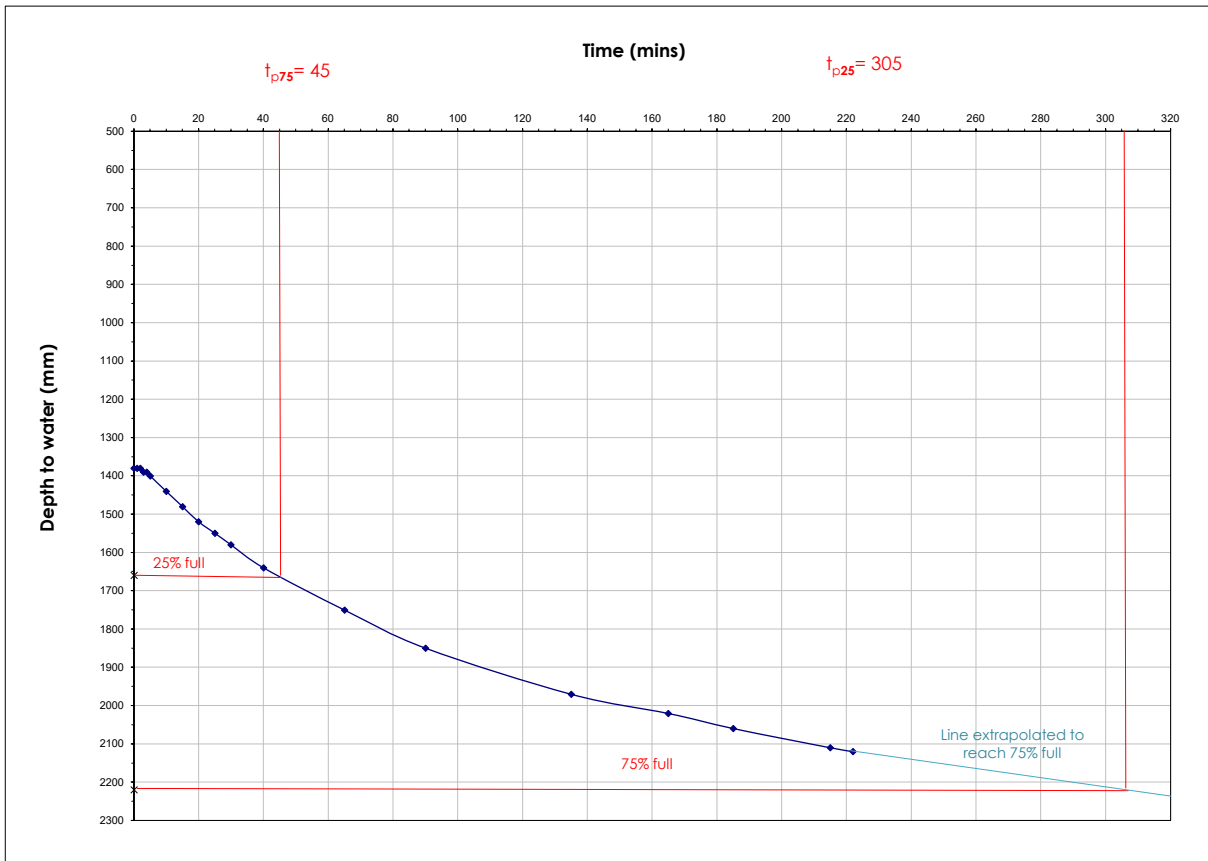
Read from the graph:			
t_{p75} (min)	=	45	
t_{p25} (min)	=	305

Soil infiltration rate, f , (m/s) = 1.31E-05
