THE FORMER HOPE INN, CUNDY CROSS, BARNSELEY – PLANNING, DESIGN AND ACCESS STATEMENT

Appendix 3 – Tree Survey

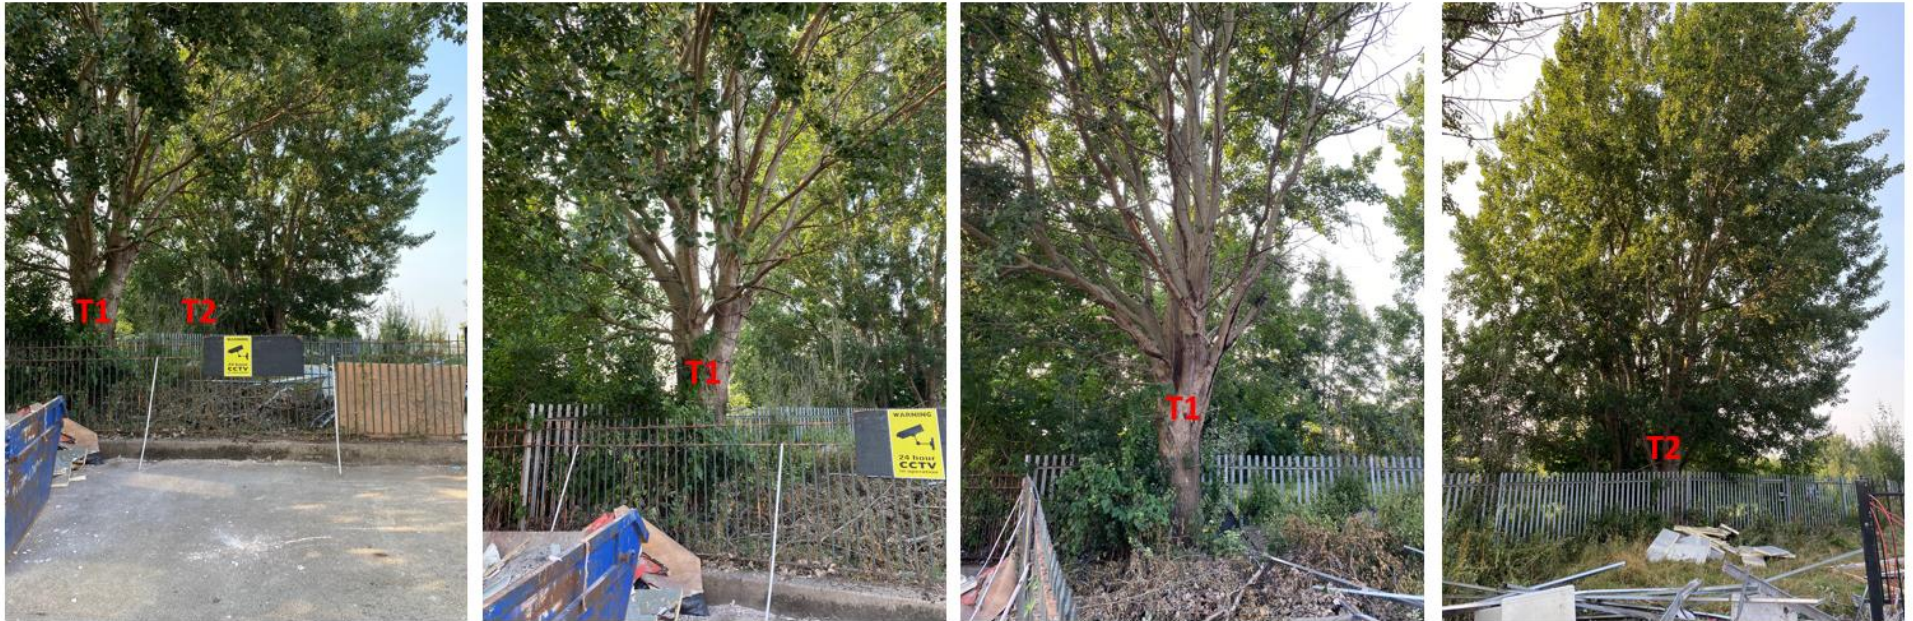
Photographs taken on 12 August 2020

Tree Ref No	TPO	Tree Species	Height	Single/ Multi-stemmed (S or M)	Stem diameter (mm)	Structural condition	Age class	Estimated useful life	BS Cat Sub-cat
T1	No	Beech, common(<i>Fagus sylvatica</i>)	20	S	970mm	Good	Mature	> 40 years	B
T2	No	Beech, common(<i>Fagus sylvatica</i>)	22	S	990mm	Good	Mature	> 40 years	B

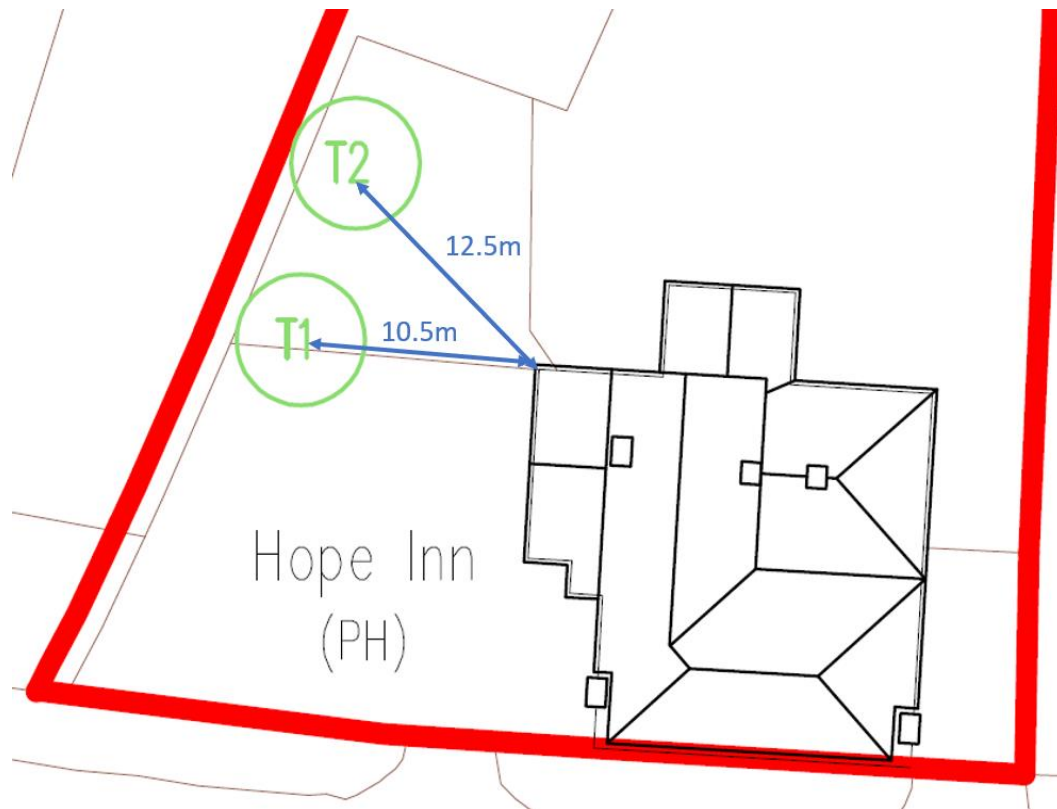
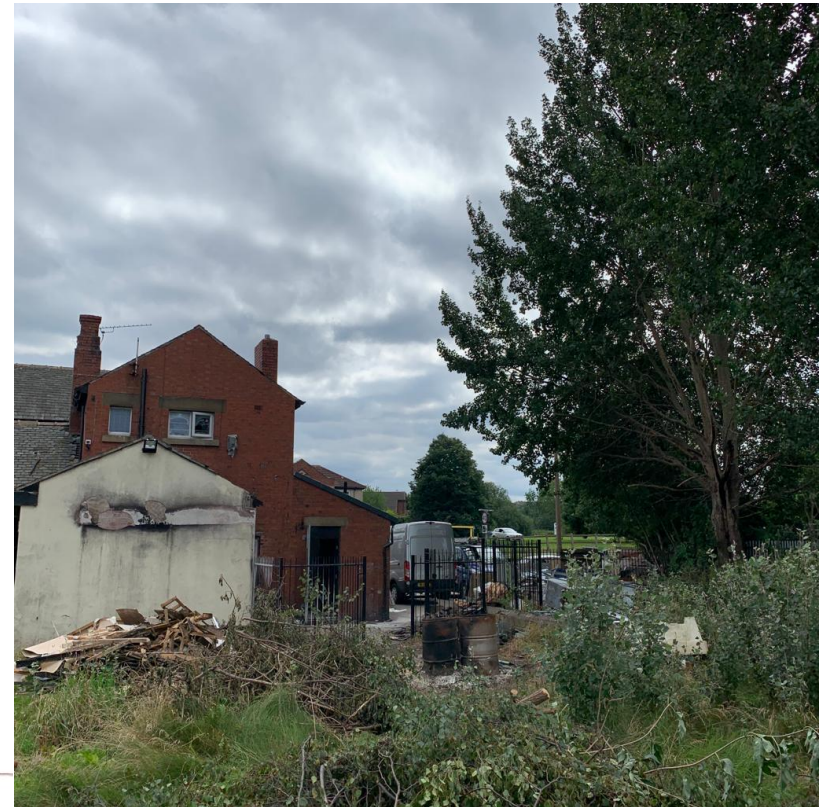
Proximity of Trees to Existing Building

The drawing below shows the proximity of the identified trees to the existing building: -

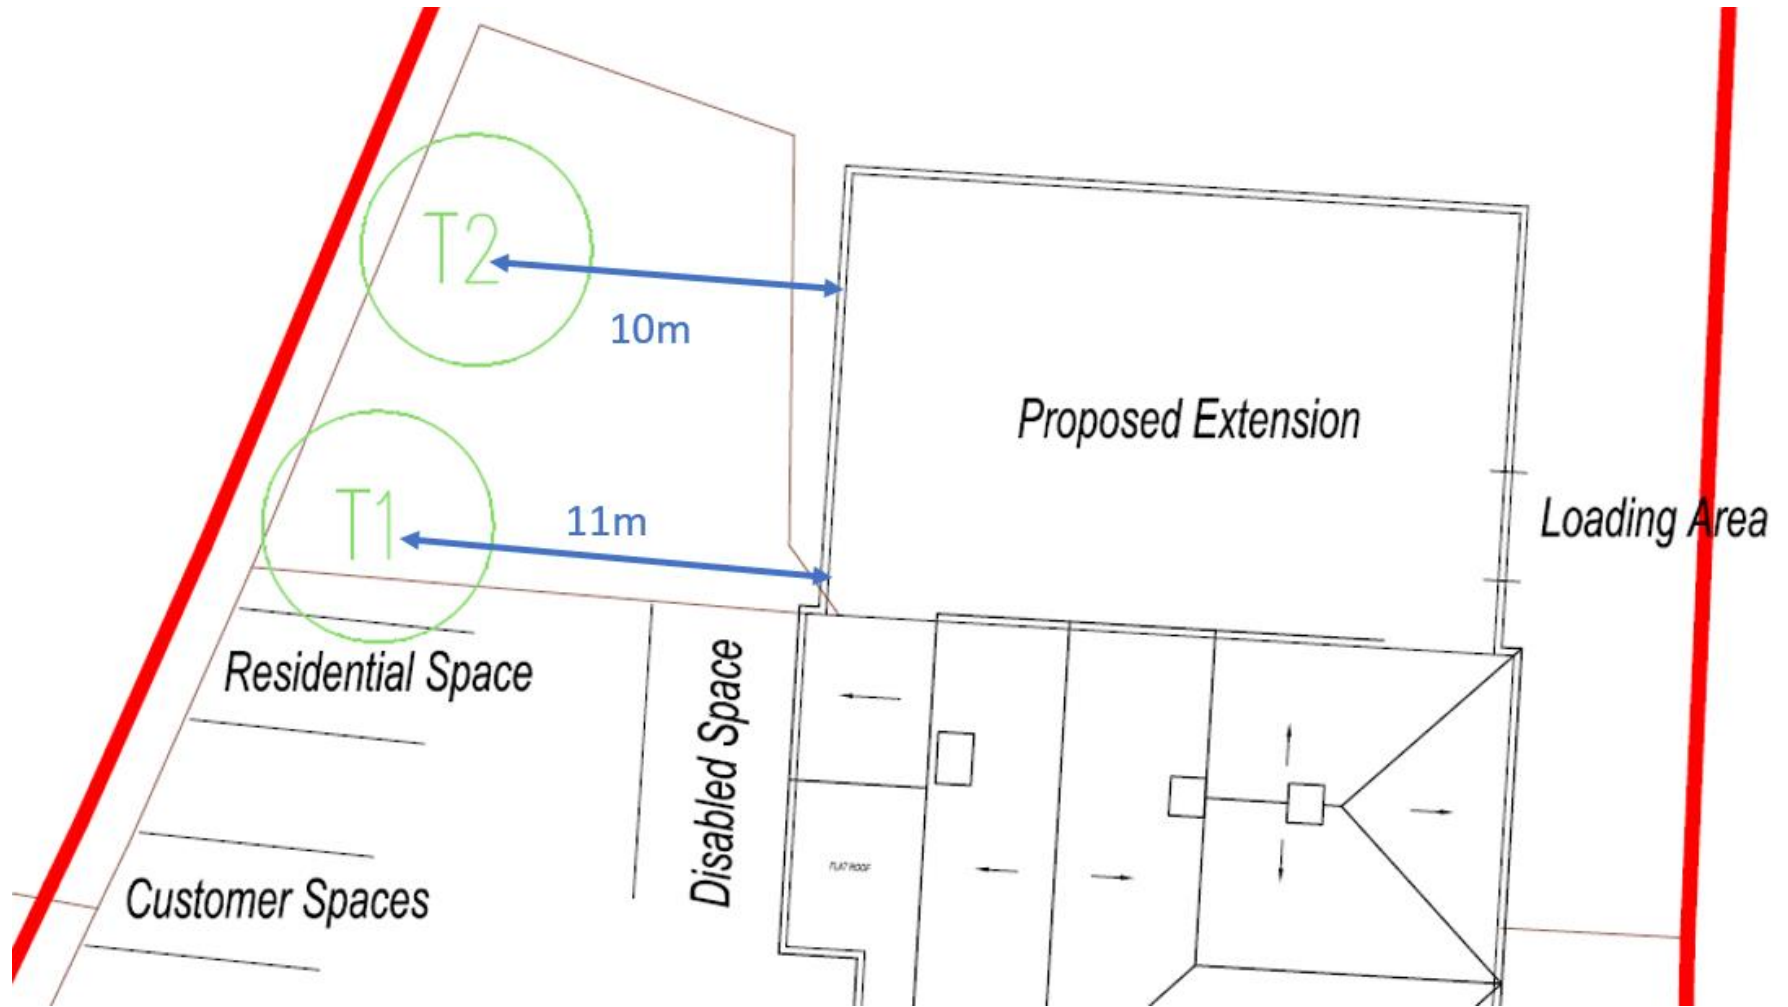
Proximity of Trees to Development Proposals

The drawing below shows the proximity of the identified trees to the development proposals: -

Given the distance between the proposed rear workshop extension and the existing trees it is concluded that both trees can be retained as desired by the Applicant.

During construction, the Applicant will take reasonable care to protect the trees and should roots be encountered during excavations, they be adequately protected to prevent damage.

Construction and material movements will be kept as far from the tree locations as possible.
