26 – 28 Racecommon Road, Barnsley

Bat Survey Report

24th March 2026

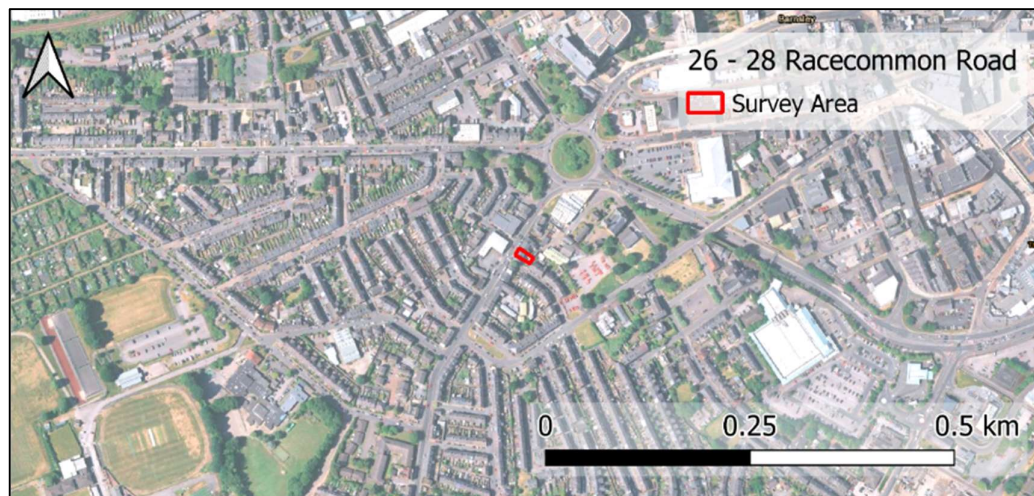
Figure 1. The survey area

- 3.1.1 The site was located to the southwest of the centre of Barnsley. The site comprised two terraced buildings with a hardstanding yard at the rear of the building. The site had been subject to recent repair, including roof replacement, and ongoing renovation works were evident at the time of survey.
- 3.1.2 The surrounding area comprised houses, and commercial units. Some street trees and amenity grassland were also present in the local area. More extensive areas of green space particularly sports pitches, were present c. 300 m to the southwest (Figure 1, Plate 1).

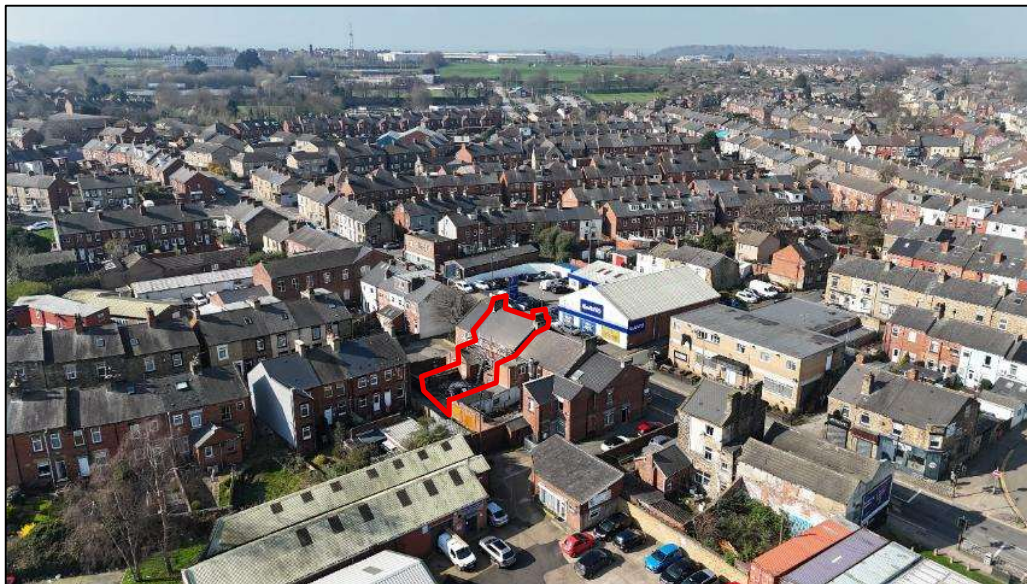
Plate 1. The site (approximate outline in red) and the surrounding area viewed from the east

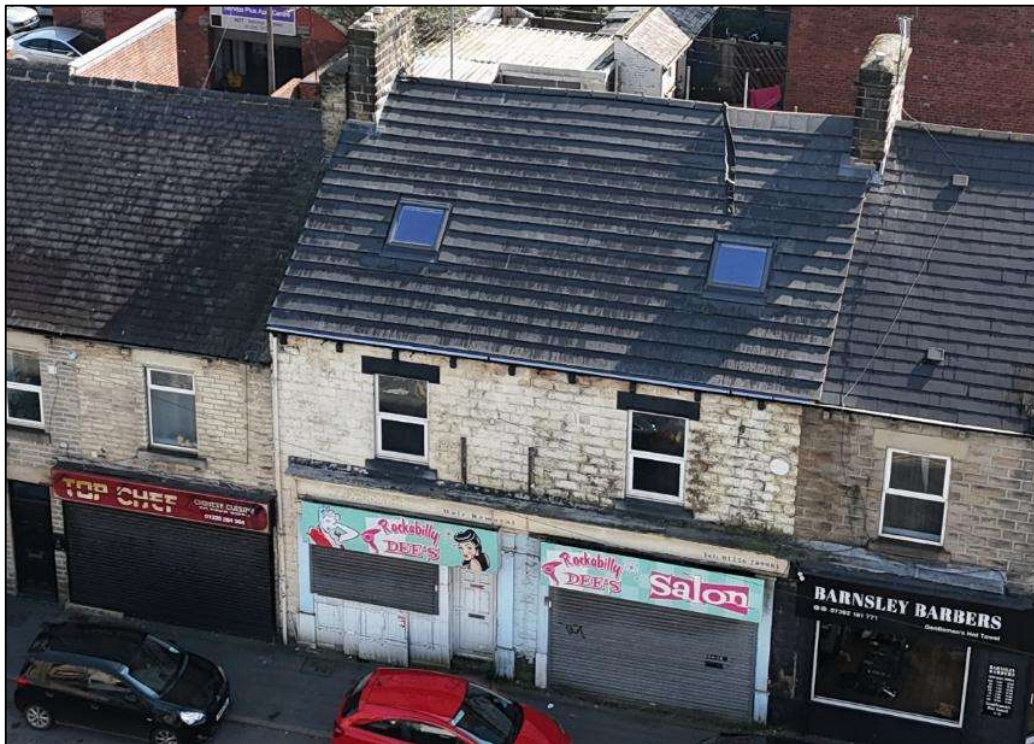
- 5.1.1 The building comprised two adjoining mid-terrace buildings with a two-pitched roof (Plate 2 and 3). The façade was faced with stone which had been painted white, and the internal and rear walls were constructed from brick. The pitched roof had been recently replaced and was covered with interlocking tiles and incorporated two roof lights. The ridge comprised angle cap tiles and was in the process of being installed.

Plate 2. The dwelling façade viewed from the southeast

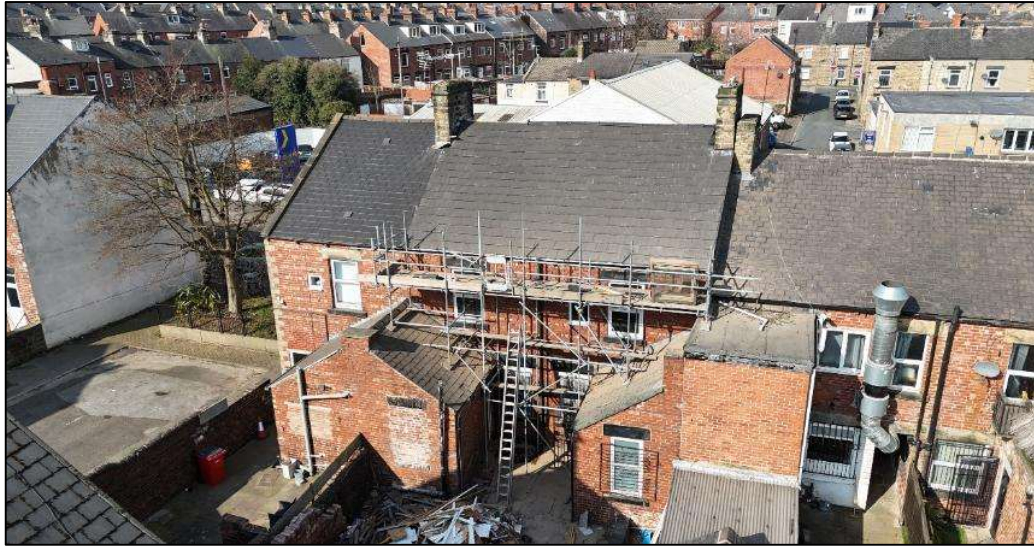
Plate 3. The rear of the building (viewed from the southeast)

- 5.1.5 Given that the roof and guttering had been replaced on the two-storey section, and the mortar had been ground out between the masonry on the rear of the building ready for repointing, and there were no obviously suitable features present on the buildings frontage, it was determined that the overall suitability of the building for bats was negligible.

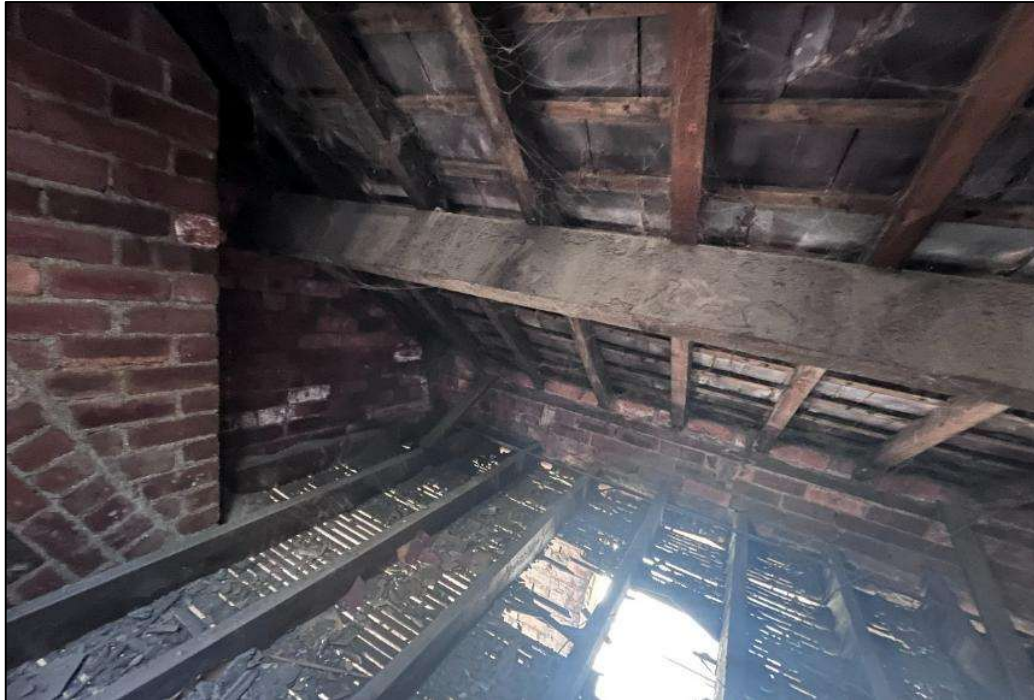
- 5.1.3 Photos of the roof void prior to the replacement were available from the client and it can be seen that the roof appeared to comprise slates sitting on battens without underfelt or a membrane with some cobwebbing present between the rafters (Plate 5). An insect mesh was present at the eaves allowing ventilation but providing a barrier to access by insects or other animals.

Plate 5. The roof void prior to reroofing

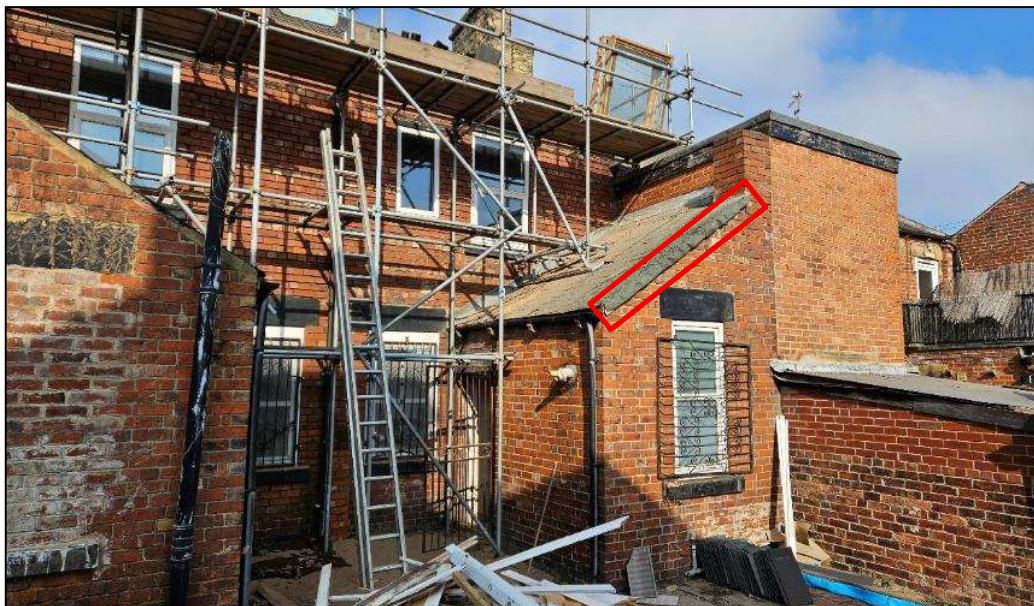
- 5.1.4 A single low-quality feature was identified. This comprised overlapping roofing felt on the verge of the single-storey lean-to (Plate 6). However, due to its low height, minimal crevice dimensions, and the surrounding hardstanding habitat, suitability was considered negligible. However, it was checked during the survey and no bats or signs of bats were present.

Plate 6. The roofing felt on the verge of the single storey section of the building which comprised the only potential roost feature present
