**ARBORICULTURAL IMPACT ASSESSMENT  
to BS 5837:2012  
at  
Wombwell Hall  
57 Park Street  
Wombwell  
South Yorkshire  
S73 0HJ**

**JCA Ref:**  
17391-A/AJB

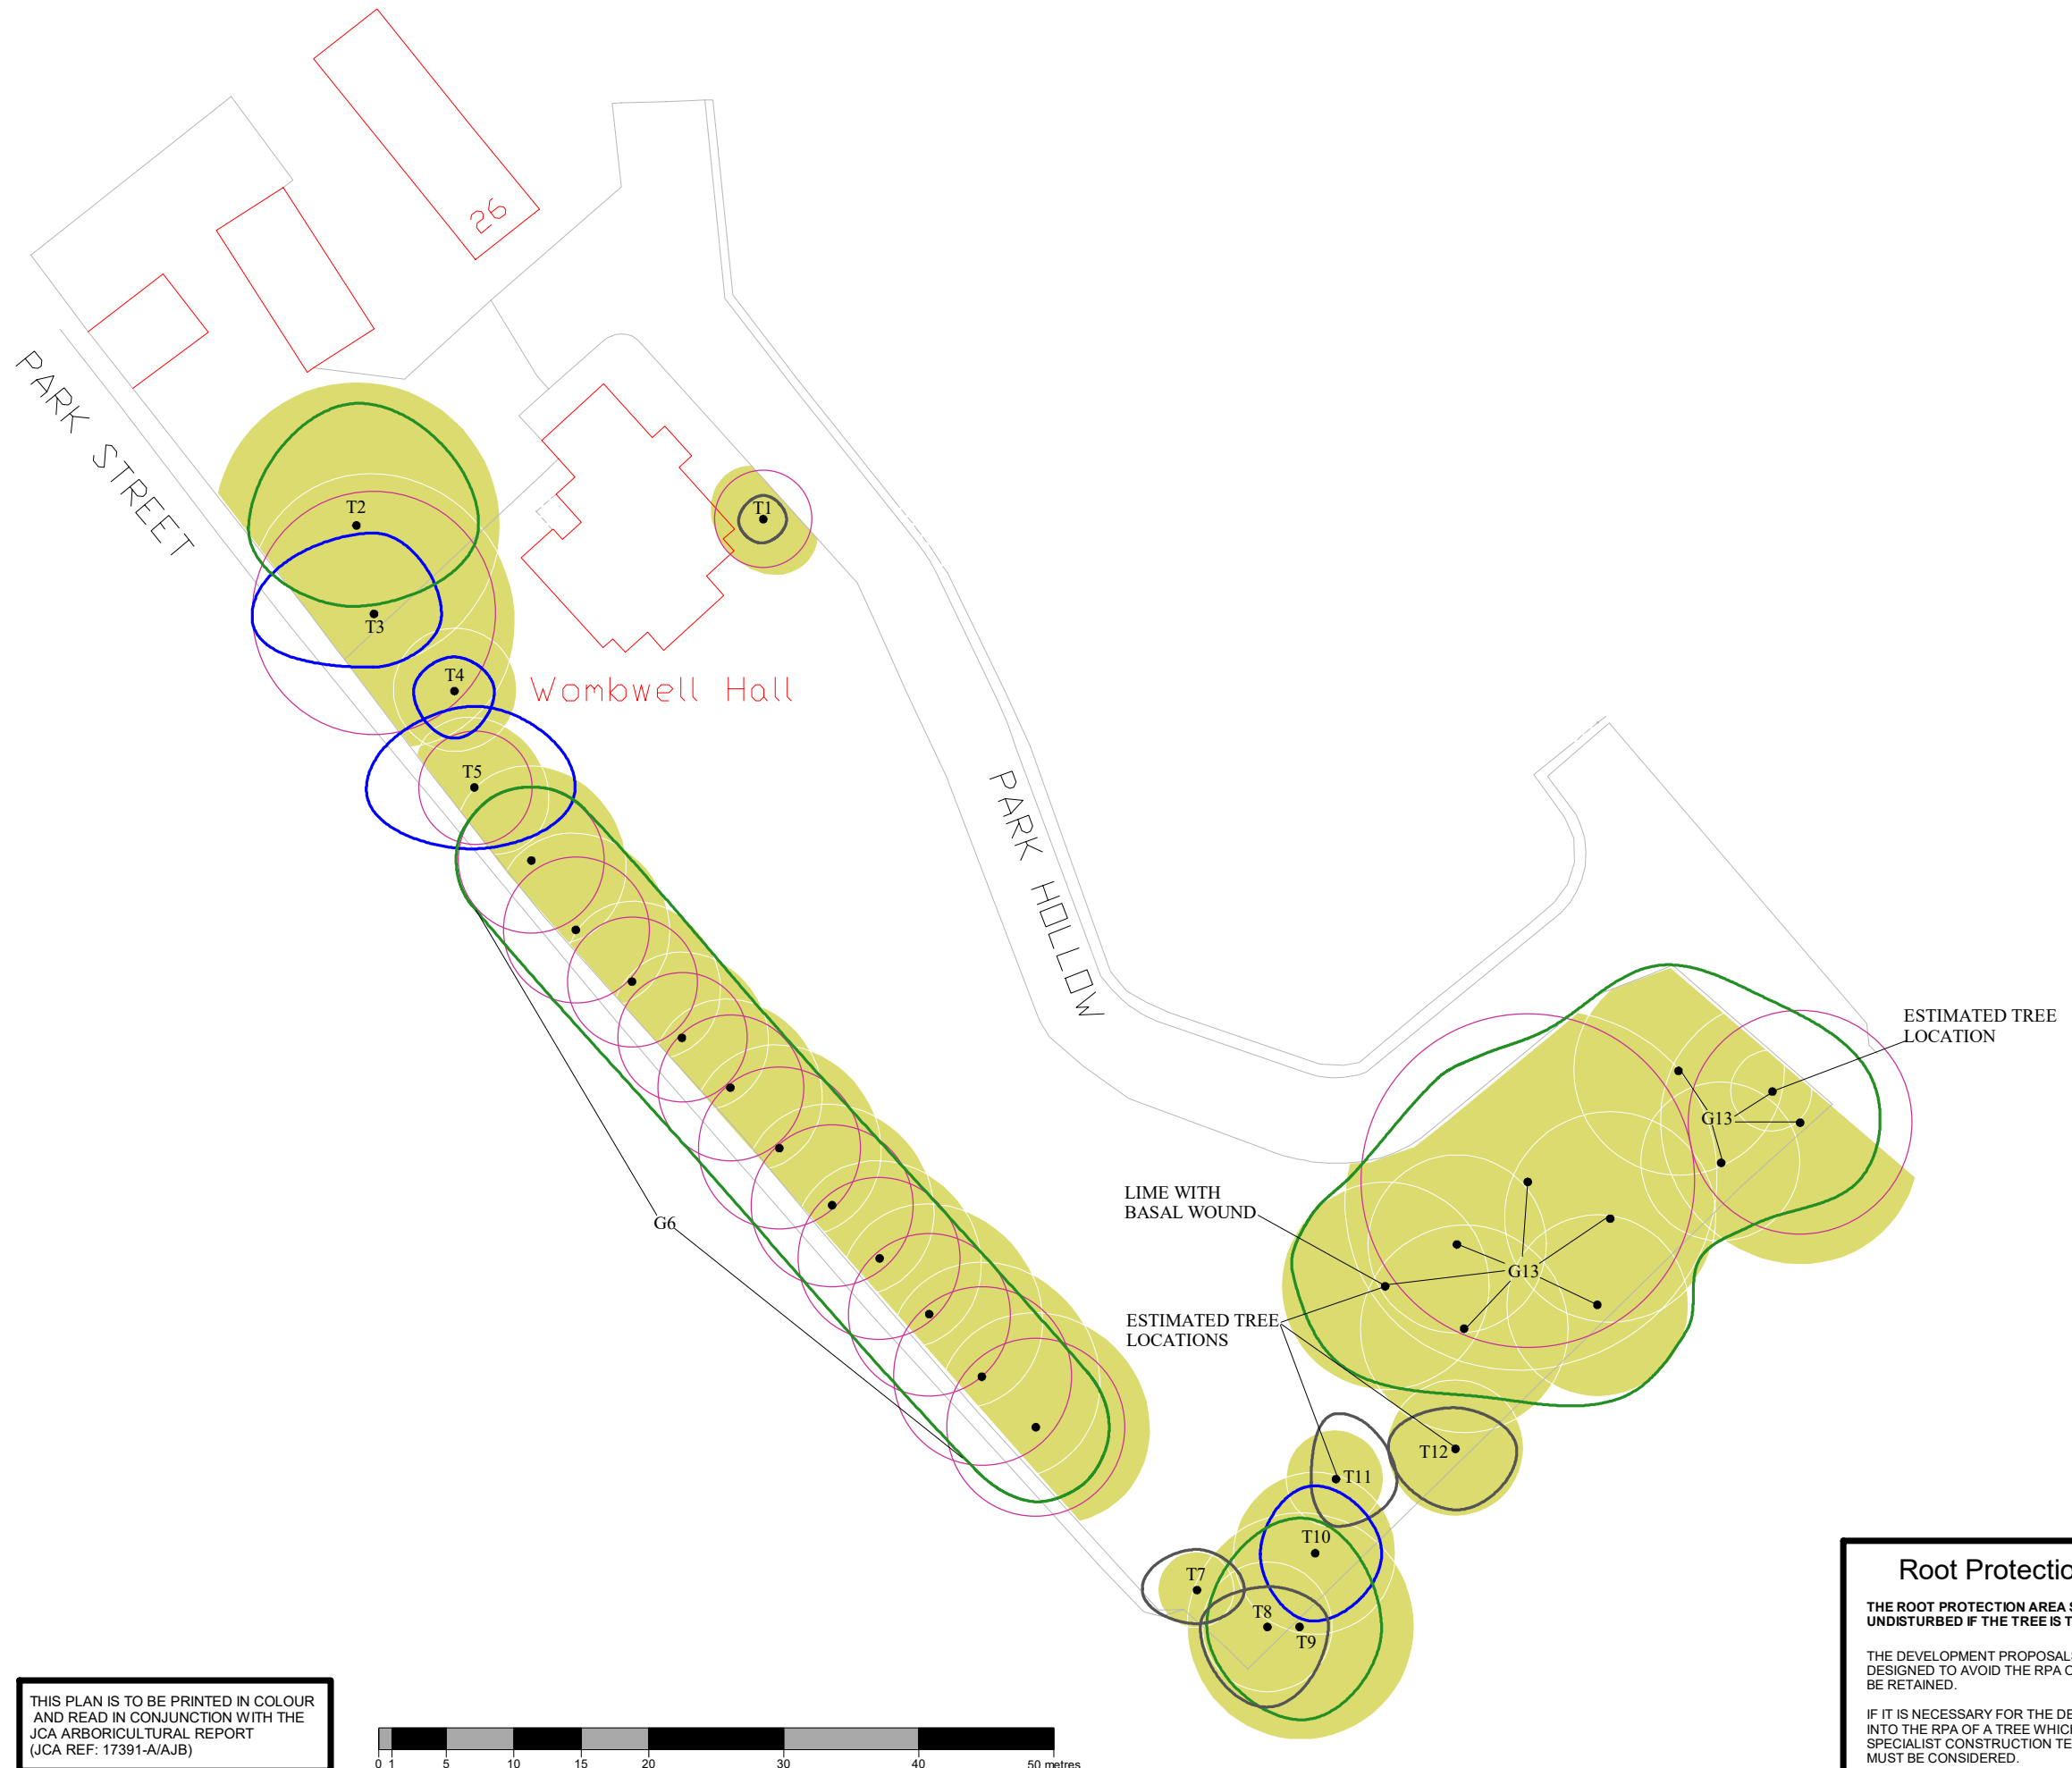
**Appendix 6:  
Tree Constraints Plan**

- 4.7 The protection of retained trees can be achieved by the creation of a Construction Exclusion Zone based on the Root Protection Area of a tree. The Root Protection Area of each tree or group is marked on the Tree Constraints Plan at **Appendix 6**.

- 2.1 Full details of all individual trees surveyed are recorded in the tables at **Appendix 1**. A full explanation of the tables can be found at **Appendix 2**. Please refer also to the Tree Constraints Plan at **Appendix 6** for tree locations.
