**TRUNCE FARM, GREEN MOOR.**

**PRELIMINARY ECOLOGICAL APPRAISAL.**

**Ref No: 200630.**

**Date: 23<sup>rd</sup> June 2020.**

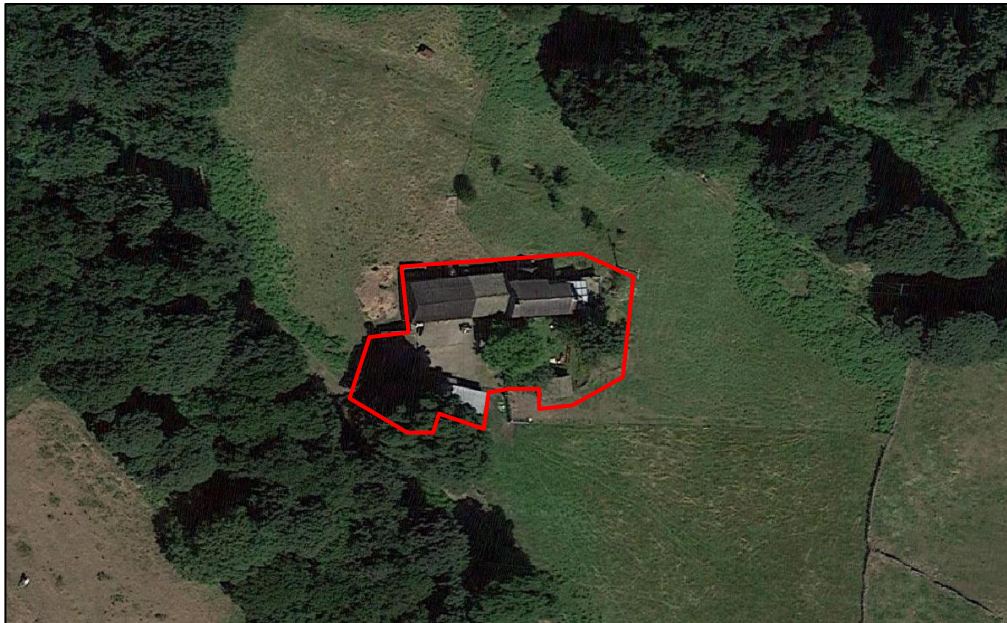
3.2.2. The aerial photograph below shows the survey area.

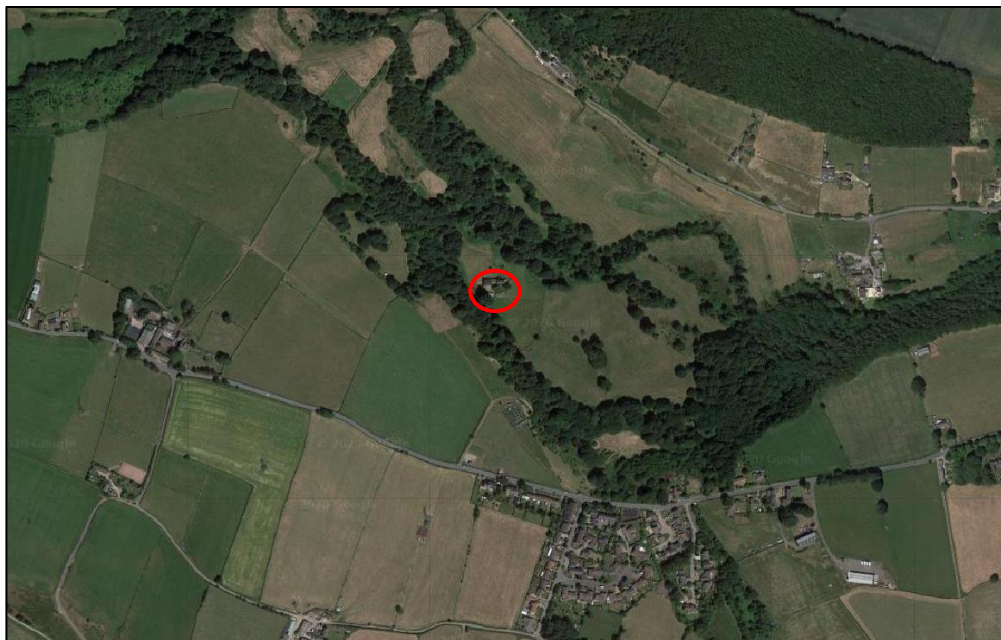
3.2.3. The aerial photograph below shows the survey area and wider surrounding area.

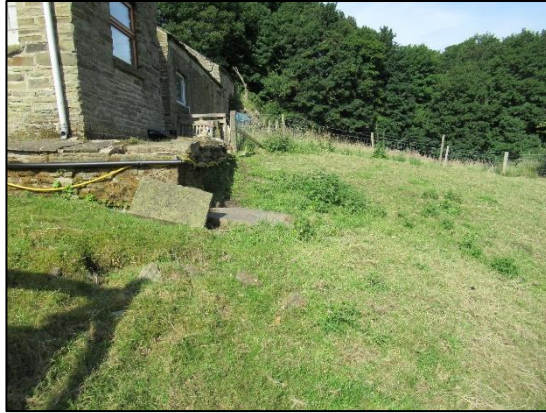
3.3.2.2. At the southern side of the survey area is a large grazing field grazed by sheep. This is grazed short and the main species present are Yorkshire fog (*Holcus lanatus*), perennial rye grass (*Lolium perenne*), annual meadowgrass (*Poa annua*), cocks' foot (*Dactylis glomerata*), thistle (*Cirsium sp(p)*), nettle (*Urtica dioica*), creeping buttercup (*Ranunculus Repens*), speedwell (*Veronica persica*), and herb Robert (*Geranium robertianum*). This field extends up to the walls of the southern side of Building 1.

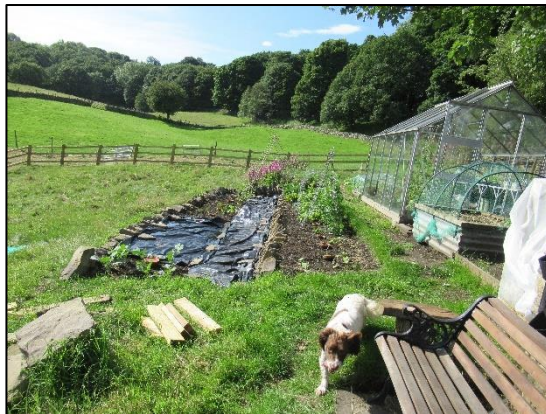
3.3.2.3. At the western end of the survey area there is an area of grassland, which has been fenced to keep out the sheep and this is being used as a garden and for growing vegetables. This appears to have been part of the large grazed field of sheep but has been recently fenced and now has a longer sward. The species present are the same as above but there is also rhubarb (*Rheum sp.*), dandelion (*Taraxacum officinale*), vetch (*Vicia sativa*) and foxglove (*Digitalis purpurea*) growing.

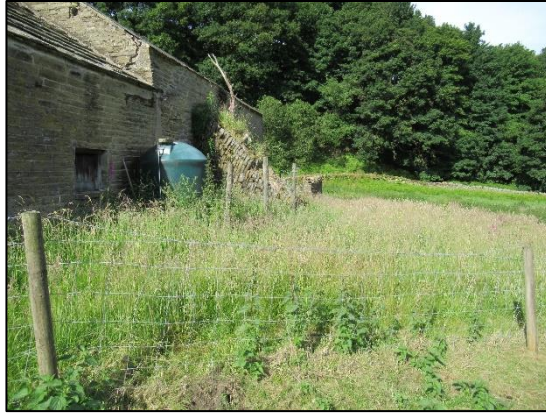
3.3.2.4. To the east of the grazed field is a large field, which appears to be a grazing field but at this time was not grazed and had a longer sward. The species in this field are the same as above but include some foxglove (*Digitalis purpurea*) and rosebay willowherb (*Chamerion angustifolium*).

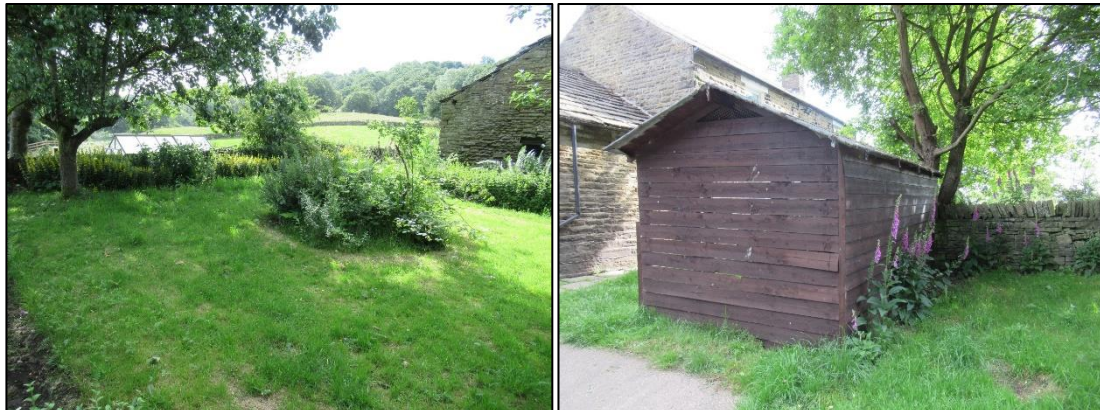
There are a few areas of grassland that are lawn but have not been mown for some time. The main species present in these areas are perennial rye grass (*Lolium perenne*), annual meadowgrass (*Poa annua*), dandelion (*Taraxacum officinale*), creeping buttercup (*Ranunculus Repens*), ragwort (*Senecio jacobaea*), white clover (*Trifolium repens*) and some foxglove (*Digitalis purpurea*).

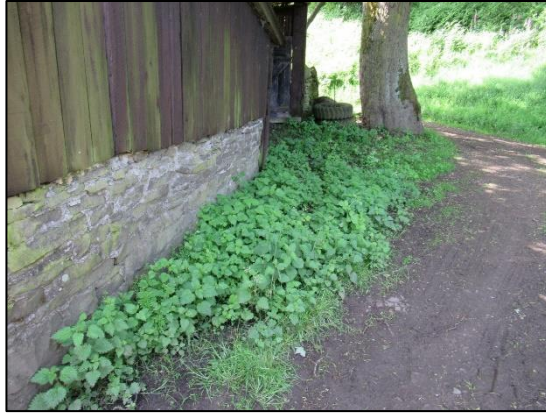
At either side of the entrance to the farm there is a narrow strip of tall ruderal species growing. The main species present are nettle (*Urtica dioica*), garlic mustard (*Alliaria petiolata*), wood avens (*Geum urbanum*), cleavers (*Galium aparine*), ragwort (*Senecio jacobaea*) with some cocks' foot (*Dactylis glomerata*).

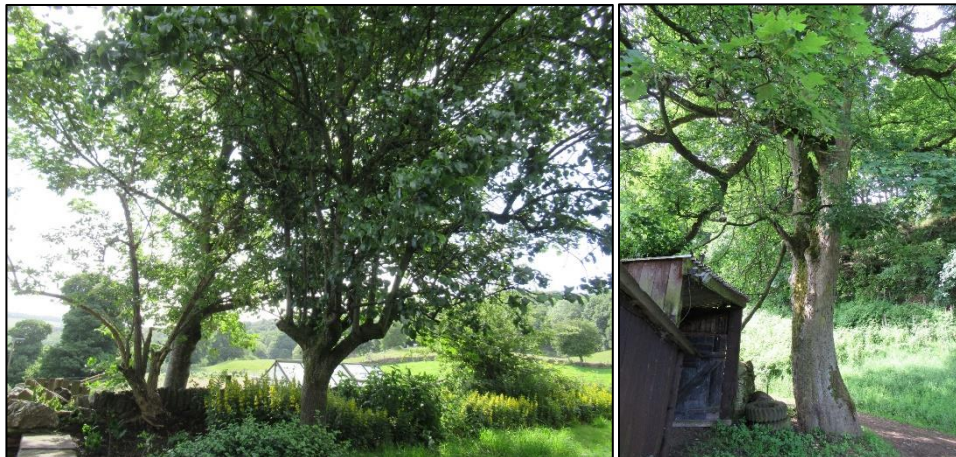
There are a few trees growing within the survey area. There is a large mature sycamore (*Acer pseudoplatanus*) growing at the entrance to the farm, adjacent to Building 8. Within the garden area there are three apple (*Malus domestica*) trees, one semi-mature sycamore (*Acer pseudoplatanus*) and a small elder (*Sambucus nigra*).

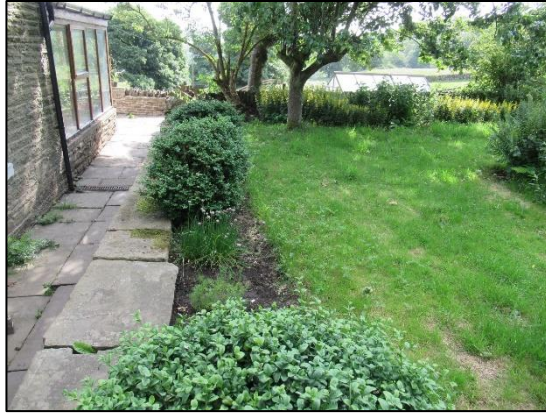
3.3.6.1. Around the area of amenity grassland at the front of the house, Building 1, there is a narrow border of plants forming a garden, although this is becoming overgrown. The main species present are box (*Buxus*), loosestrife (*Lysimachia punctata*), ferns (*Pteridophyte sp.*), foxglove (*Digitalis purpurea*), gooseberry (*Ribes uva-crispa*), rose (*Rosa sp.*), aquilegia (*Aquilegia canadensis*), flowering currant (*Ribes sanguineum*), chives (*Allium schoenoprasum*), bramble (*Rubus fruticosus*), cleavers (*Galium aparine*), ragwort (*Senecio jacobaea*) and nettle (*Urtica dioica*).

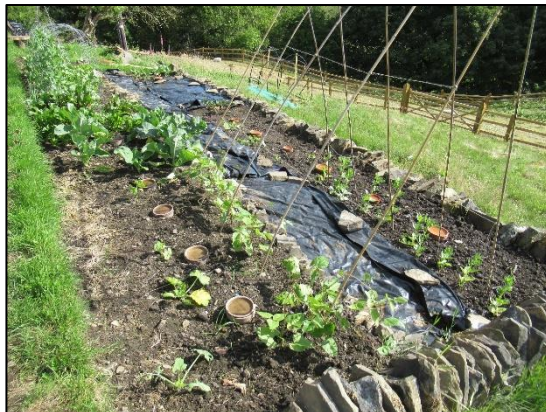
3.3.6.2. At the western end of the survey area there is a well-tended vegetable garden with a variety of young vegetatable plants growing, including runner bean, beetroot, broadbean and courgette plants.

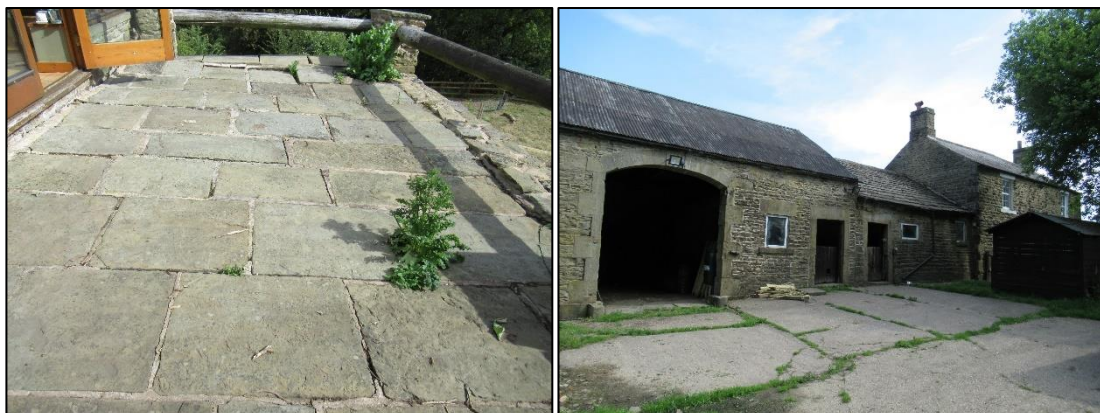
### 3.3.7. Bare Ground

There is a large slab patio at the western end of the house, slab paths surrounding the house and a large concrete yard. The access track to the farm is bare hardstanding.

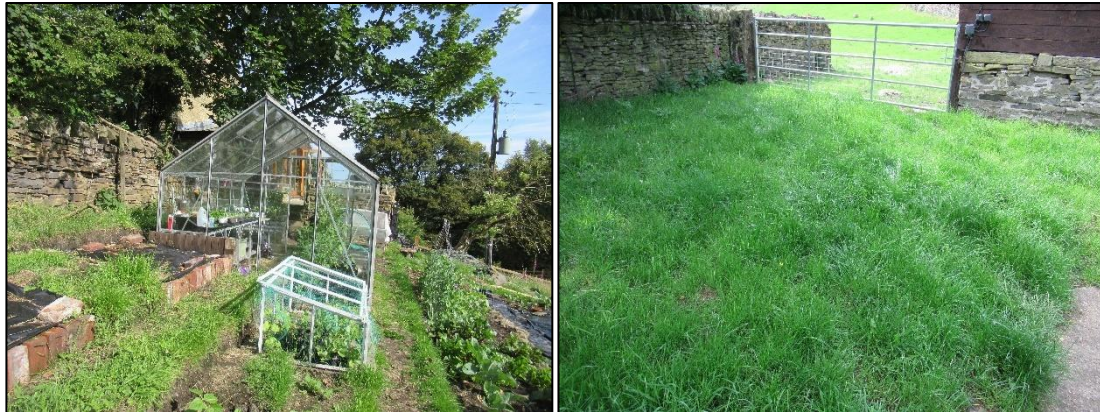
### 3.3.8. Wall

There are a number of walls within the survey area, most are dry stone walls. There is also a stone retaining wall below the patio at the western end of the house.

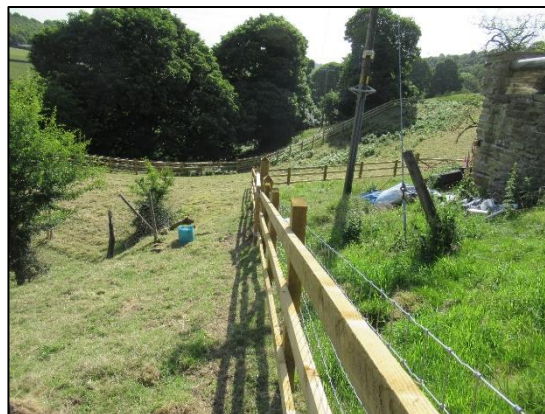
### 3.3.9. Fence

Around the garden area at the western end of the survey area there is a wooden post and rail fence with stock fencing attached. There are also areas of post and mesh stock fence.

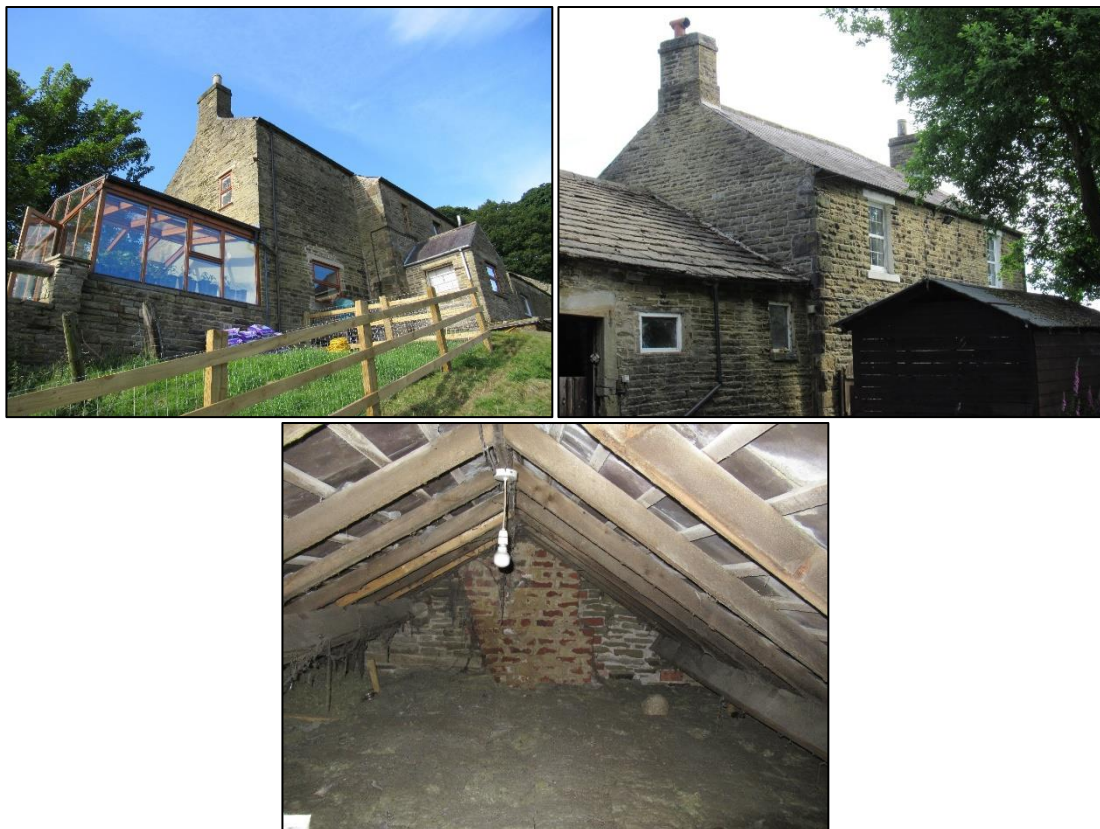
#### 3.3.10.1. Building 1. (T1)

3.3.10.1.1. This is the main house, which is a two-storey building constructed with stone walls and a pitched slate roof. There is a large conservatory on the western end of the building and the eastern end of the building is joined to Building 2. There is a

3.3.10.1.2. The walls of the building are generally in good condition although there are a few small gaps in the walls.

3.3.10.1.3. The roof has numerous slipped slates and internally there is no lining below the slates. Daylight can be seen in the loft space showing the gaps in the roof.

3.3.10.1.4. There are fascia boards on the front and rear and there are gaps under these, mainly due to the uneven nature of the stone walls.

3.3.10.1.5. Internally there is one loft space with a low stone wall across the centre. The floor of the loft is well insulated. Daylight can be seen through gaps in the unlined slate roof.

5.1. As a bat roost has been found in Building 3 and bat roost potential in Buildings 1, 2, 3 and 4, further bat activity surveys must be carried out of these buildings before any works can be carried out. These surveys must be carried out during the bat activity season, between May and August.

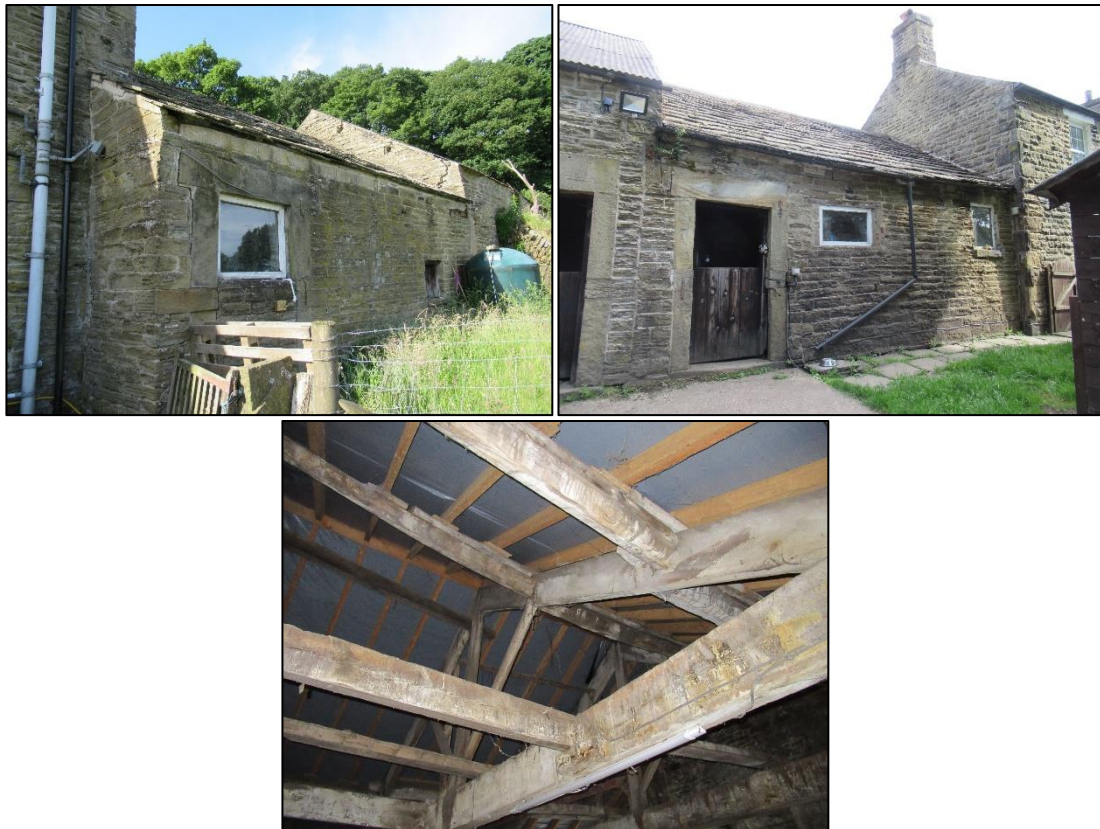
### 3.3.10.2. Building 2. (T2)

3.3.10.2.1. This is a single storey building constructed with stone walls and a pitched stone slate roof. The building is joined to Building 1 on the east and Building 3 on the west.

3.3.10.2.1. The building has cracks and gaps in the stone walls and gaps under roof slates due to the uneven nature of the slates and slipped slates.

3.3.10.2.2. Internally the building is one room open to the underside of the roof, which has a breathable membrane below the slates.

**3.4.4.2. Building 2** is a single storey barn and has numerous features suitable for roosting bats with cracks and gaps in the walls and slipped and broken stone roof slates, although the roof lining is not ideal for roosting bats.

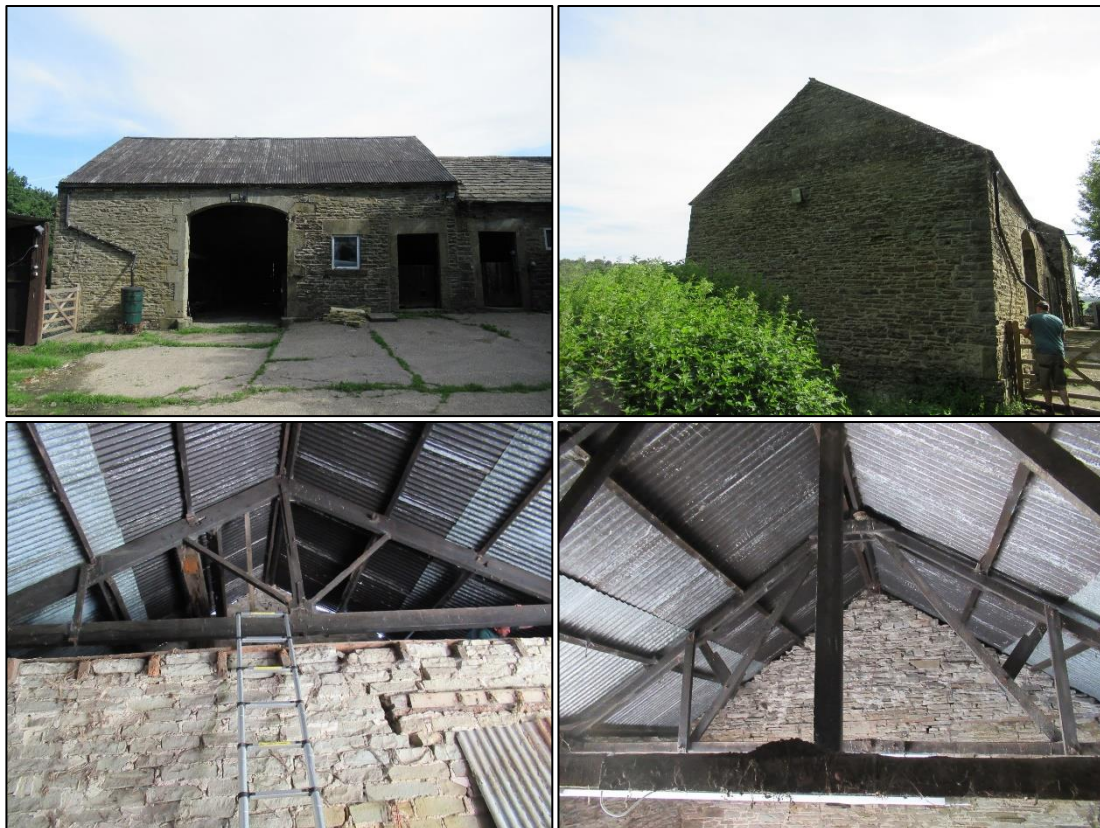
### 3.3.10.3. Building 3. (T3)

3.3.10.3.1. This is a two storey barn joined to Building 2 on the east side. The building is constructed from stone with a pitched corrugated sheet roof. There is a large open doorway on the southern side of the building.

3.3.10.3.2. Internally the building has a room at the eastern side forming a first floor above. The rest of the barn is one room open to the underside of the corrugated roof sheets, which have no lining.

3.3.10.3.3. The roof is in good condition with all roof sheets in place. The walls have numerous gaps and cracks internally and externally.

**3.4.4.3. Building 3** is a two storey barn and has numerous features suitable for roosting bats with cracks and gaps in the interior and exterior walls and gaps between roof beams internally.

5.1.2. As bats have been found roosting in Building 3 a mitigation strategy must be prepared and submitted with the planning application once all surveys are complete. Once planning permission is granted a Natural England EPS licence is required before works can begin on any building with a bat roost present.

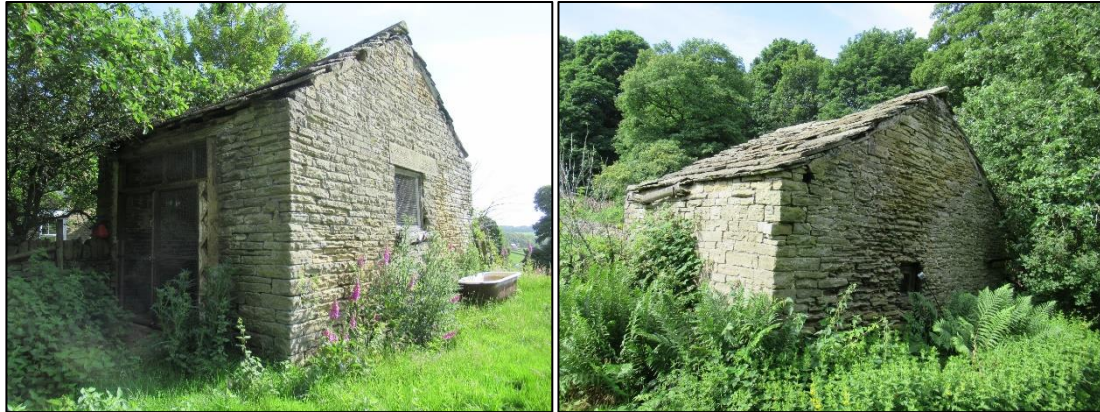
### 3.3.10.4. Building 4. (T4)

3.3.10.4.1. This is a single storey building constructed with stone walls and a pitched stone slate roof. Internally the building is one room open to the underside of the roof slates, which have no lining.

3.3.10.4.2. There are mesh windows and doors on the building and the building is not used. There are gaps under the stone roof slates due to the uneven nature of the slates and due to slipped and broken slates.

**3.4.4.4. Building 4** is a single storey barn and has numerous features suitable for roosting bats with cracks and gaps in the walls and slipped and broken stone roof slates.

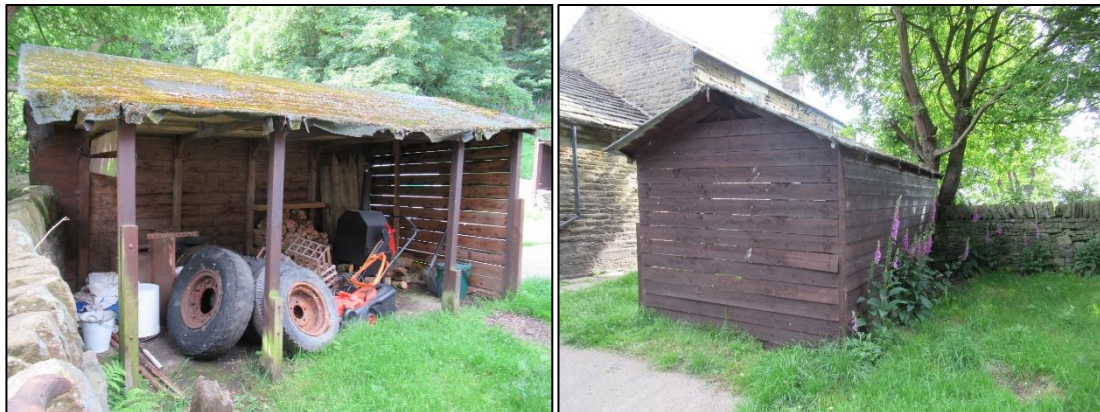
#### 3.3.10.5. Building 5. (T5)

This is a single storey shelter with timber clad walls on three sides, an open front and a pitched felt covered roof.

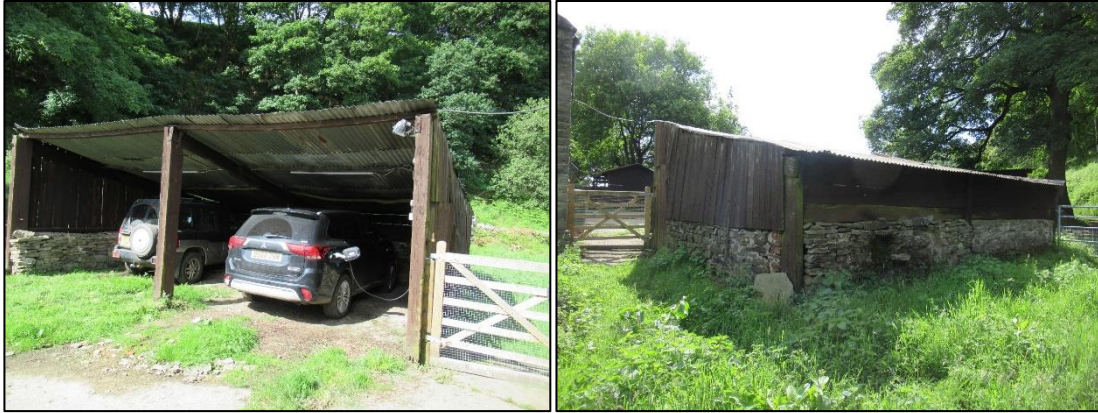
#### 3.3.10.6. Building 6. (T6)

This is a single storey building used to park cars and is open on the eastern side. The walls are a low stone wall with timber cladding above and a sloping corrugated tin roof.

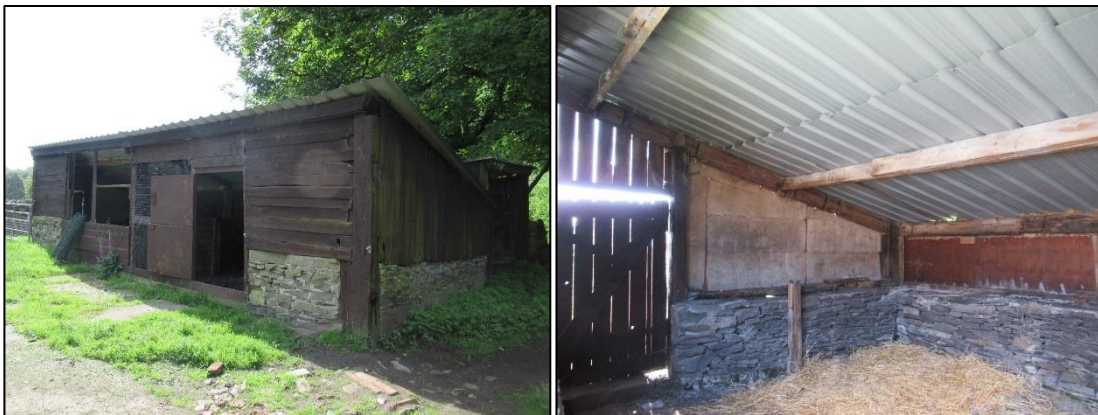
### 3.3.10.7. Building 7. (T7)

This is a single storey building, which is open on the northern side. The walls are a low stone wall with timber cladding above and a sloping corrugated tin roof.

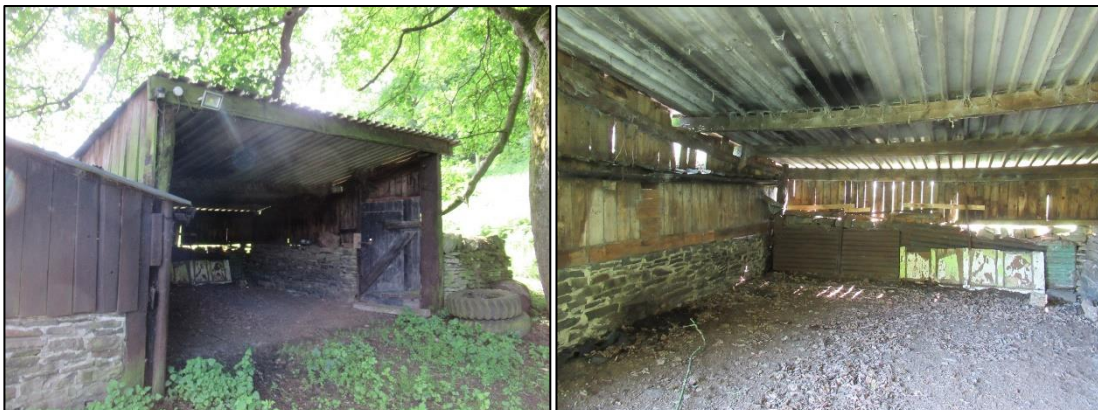
### 3.3.10.8. Building 8. (T8)

This is a single storey building, which is open on the western side. The walls are a low stone wall with timber cladding above and a sloping corrugated tin roof.

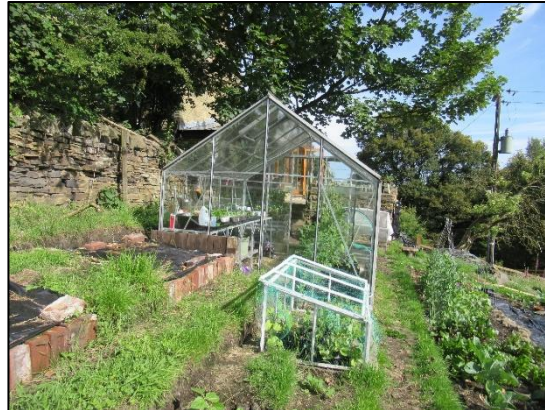
#### 3.3.10.9. Building 9. (T9)

This is a small greenhouse used for growing plants.

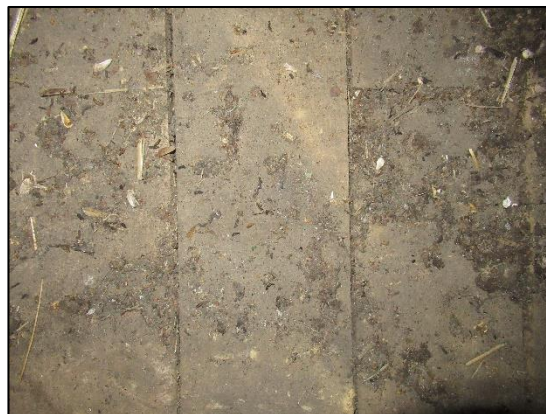
3.4.4.3.1. During the survey two concentrations of bat droppings were found on the first floor of the building. One concentration was under the ridge and contained approximately fifty fresh and old droppings with numerous butterfly wings suggesting a feeding roost.

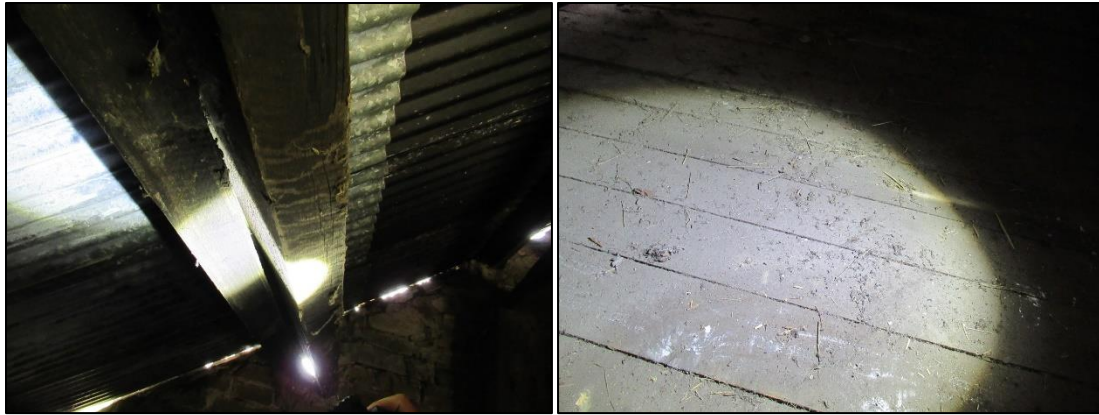
3.4.4.3.2. The second concentration was under a pair of double roof beams with a gap between. There were approximately eighty fresh and old droppings, suggesting a roost. No bats were seen in the gap between the beams during this survey.

3.4.4.3.3. As bat roosts were identified and due to the features present the building is assessed as providing **high** potential for roosting bats.

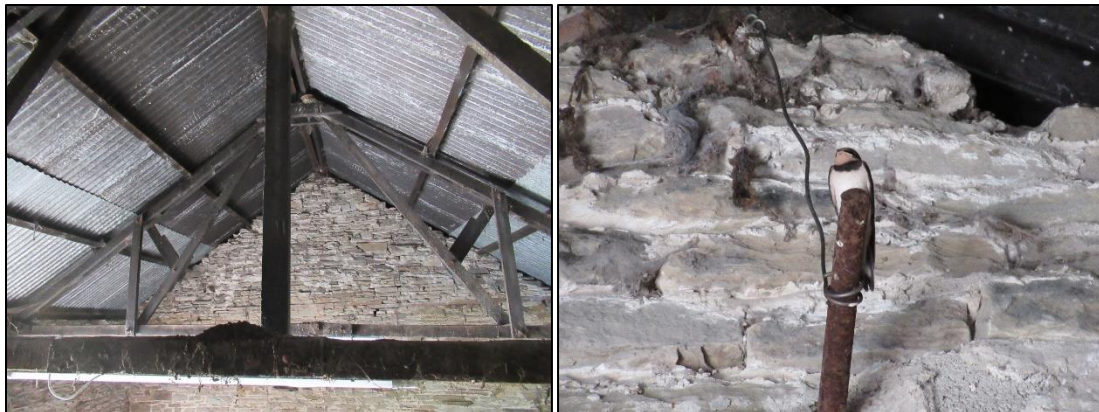
3.4.6.1. The photograph below shows the swallow nest and a newly fledged swallow in Building 3.

5.3. If any vegetation clearance or works to the buildings is to be carried out during the nesting bird season a thorough nesting bird survey must be carried out by a suitably experienced person immediately prior to works commencing. If any active nests are found during this survey, they must be left undisturbed until the young have fledged. This could put a considerable delay on proposed works.

5.6. In order to provide biodiversity enhancements in line with the NPPF, it is recommended that nesting opportunities remain on the site for swallows to nest. Mitigation will be required for roosting bats but this mitigation will be determined once the activity surveys have been carried out and the species, number and type of roosts have been identified.

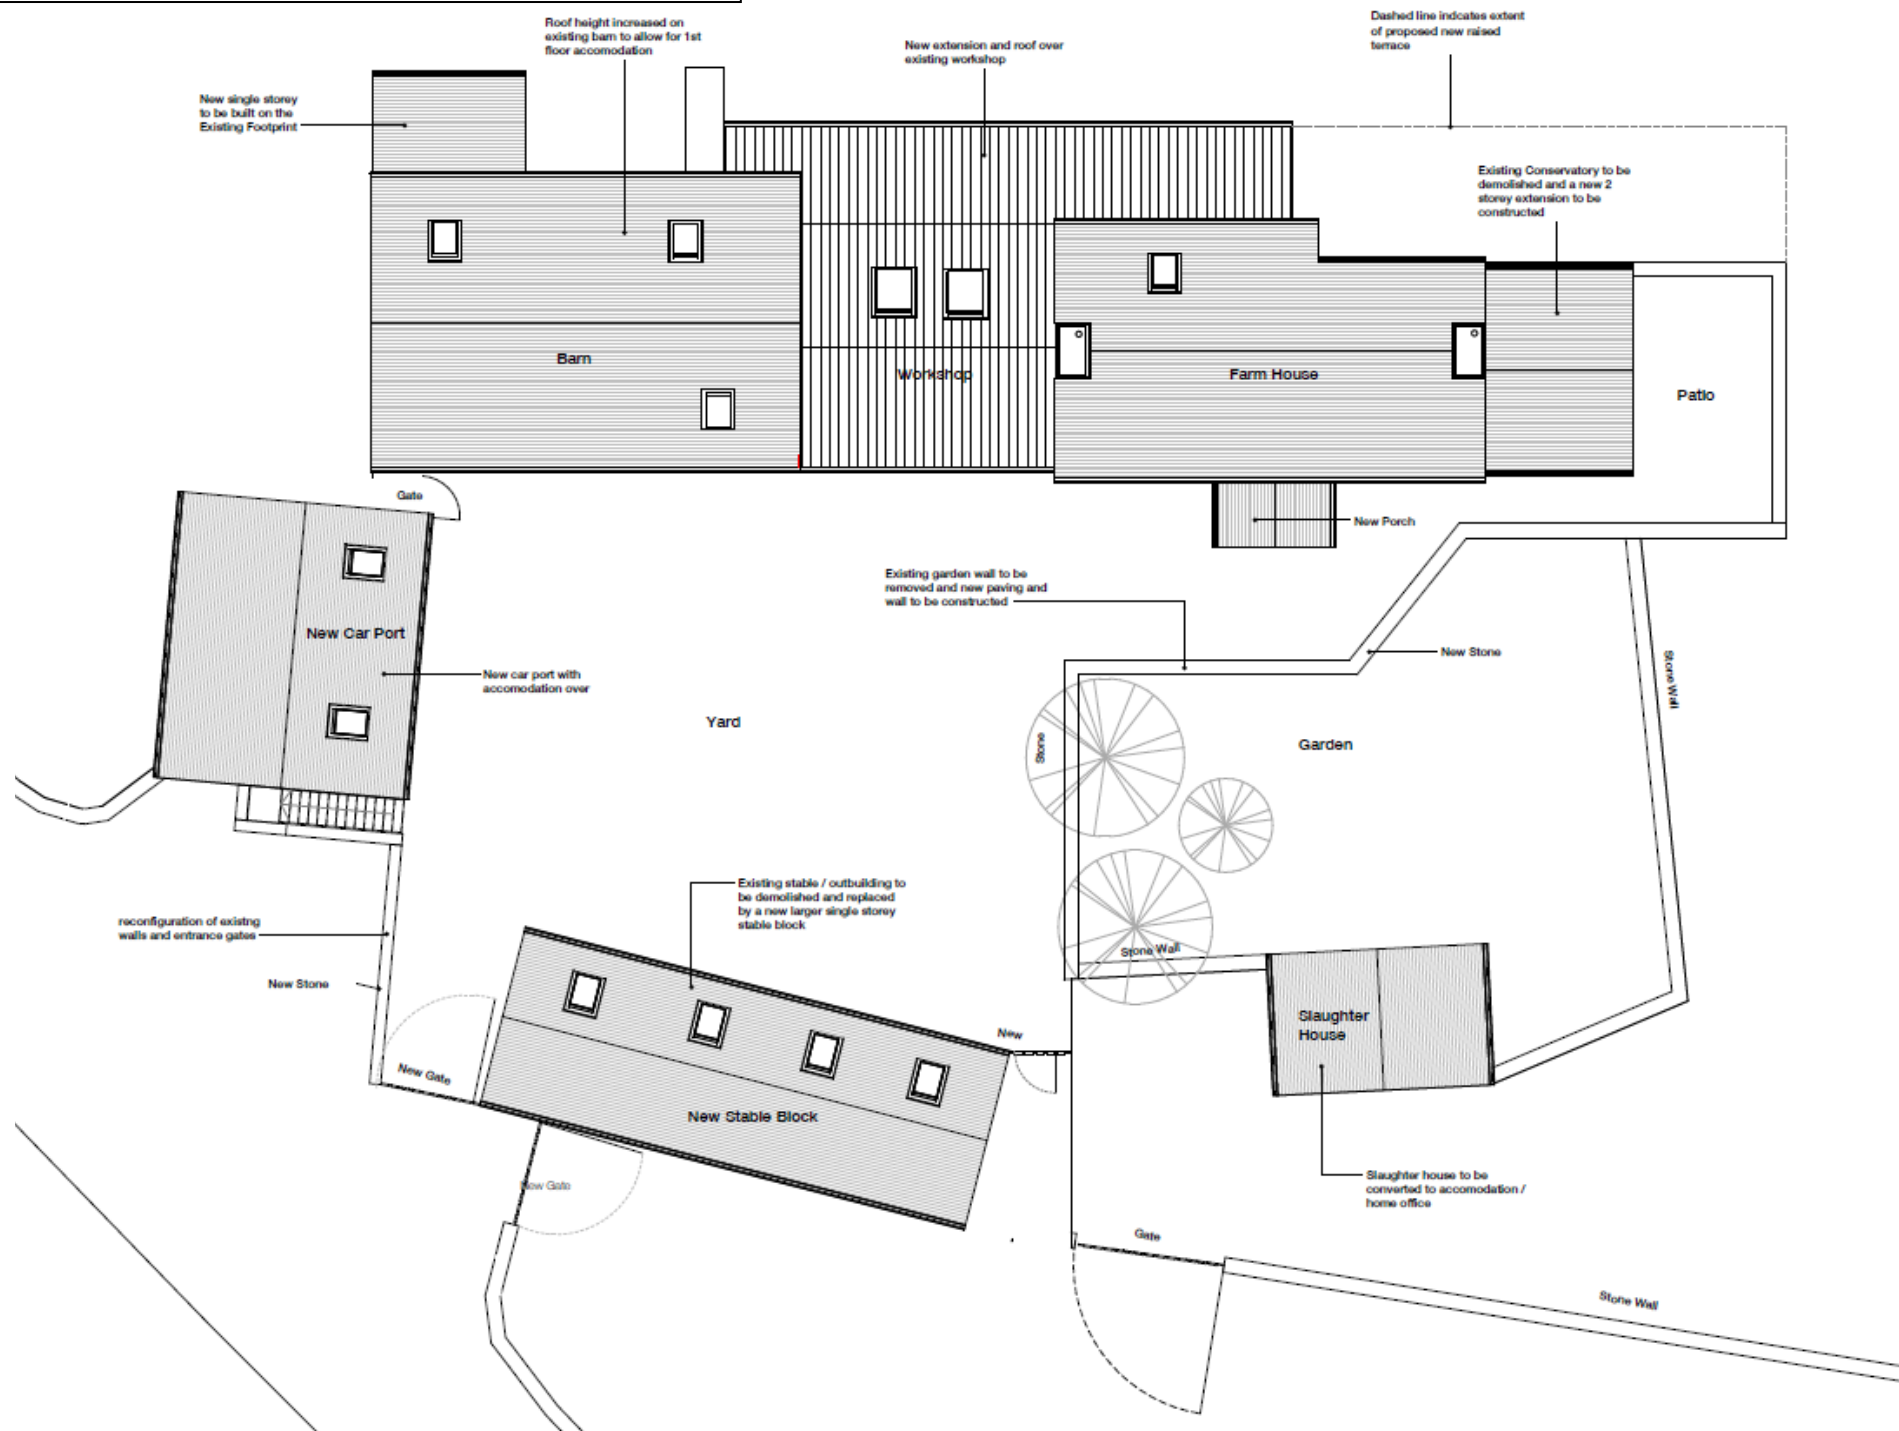
# Appendix VIII. DEVELOPMENT PLAN.

1.1. There are plans to carry out works at Trunce Farm in Green Moor. Works will be carried out to all buildings on the site and will either be extensions and re-roofing works to create accommodation or will be demolition and replacement of existing buildings. A proposed development plan can be found in Appendix VIII of this report.
