**LOW CUDWORTH GREEN FARM,
CUDWORTH.**

BAT SURVEY.

Ref No:- 150745/Rev 1.

Date: 20th July 2015.

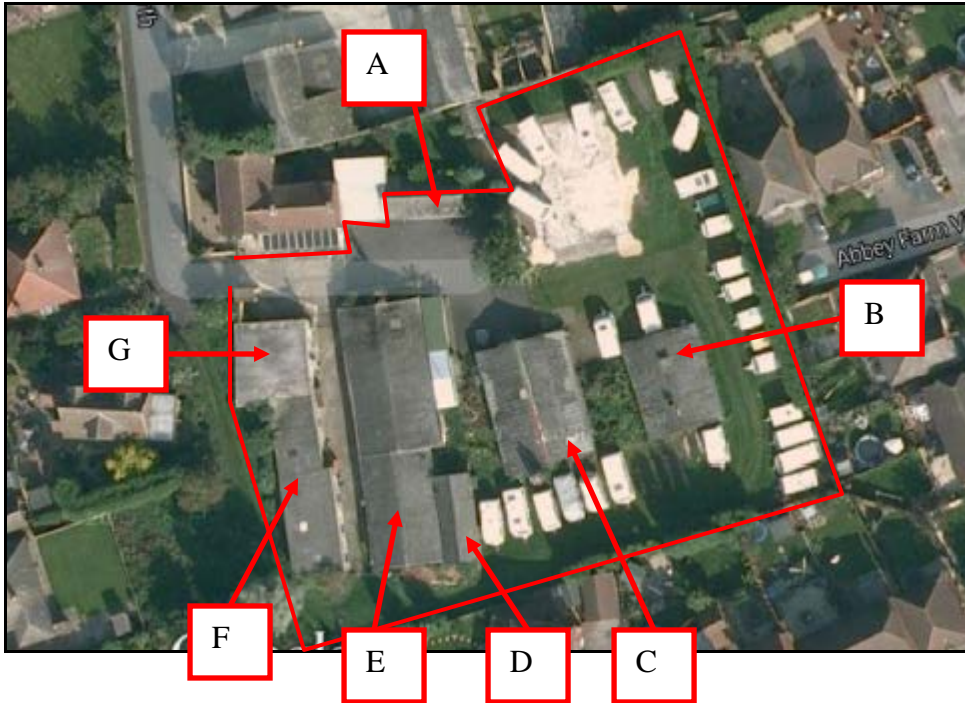
The aerial photograph below shows the site outlined approximately in red. Each building has been given a reference letter used within this report.

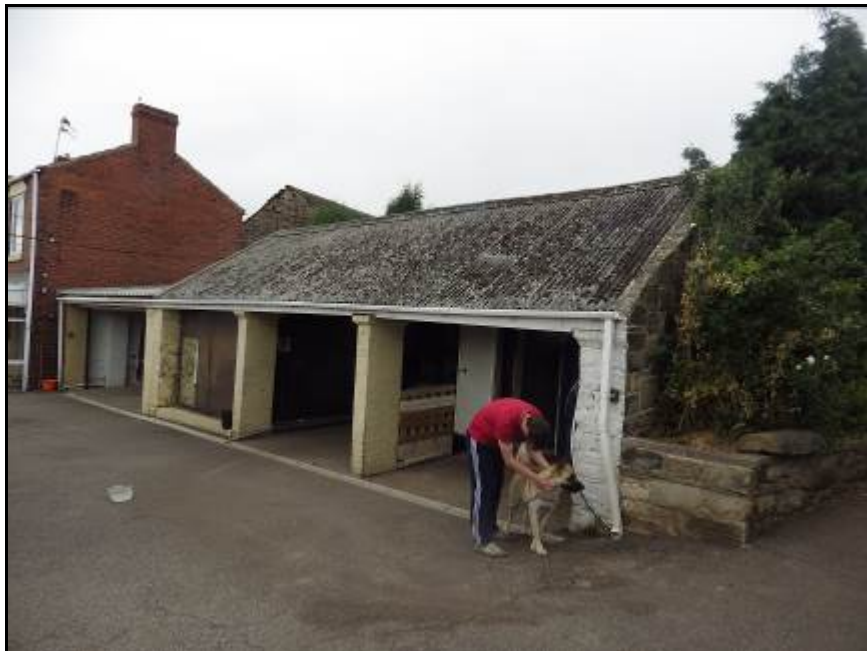
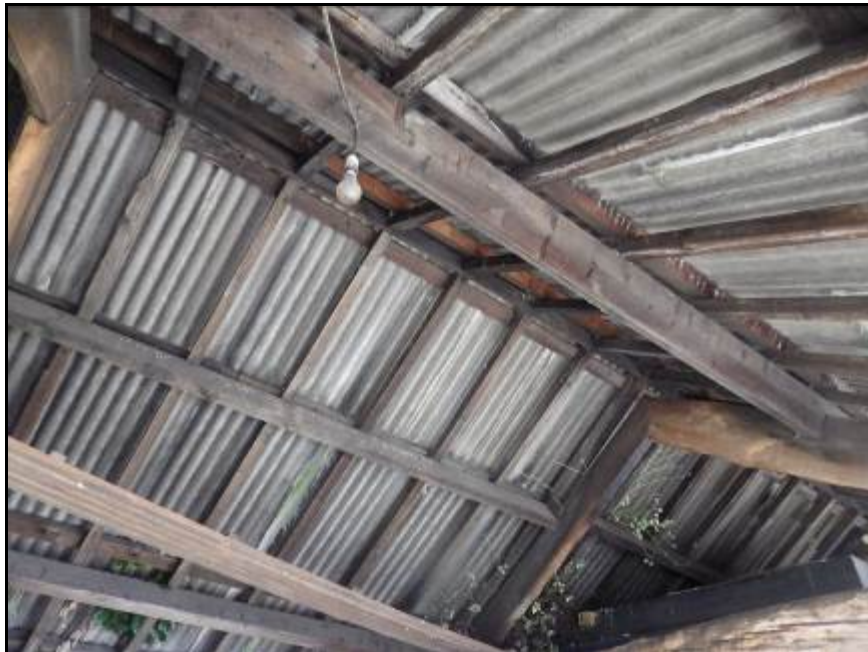
3.3.1. Building A.

3.3.1.1. Building A is an open fronted cart shed with stone walls and a pitched corrugated cement sheet roof. This is part used for vehicle parking and in one end there is a freezer unit.

3.3.1.2. The walls of the building are well pointed on the outside and on the inside most of them are painted white.

3.3.1.3. Internally the building is open to the underside of the corrugated sheets.

3.3.1.4. No bat field signs were identified in this building and it was assessed to have no potential for roosting bats.

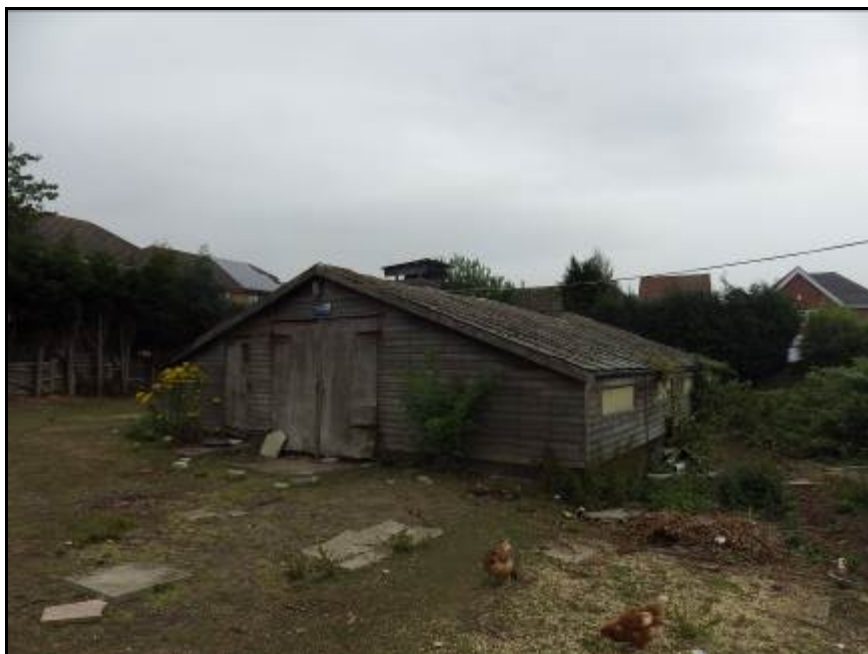
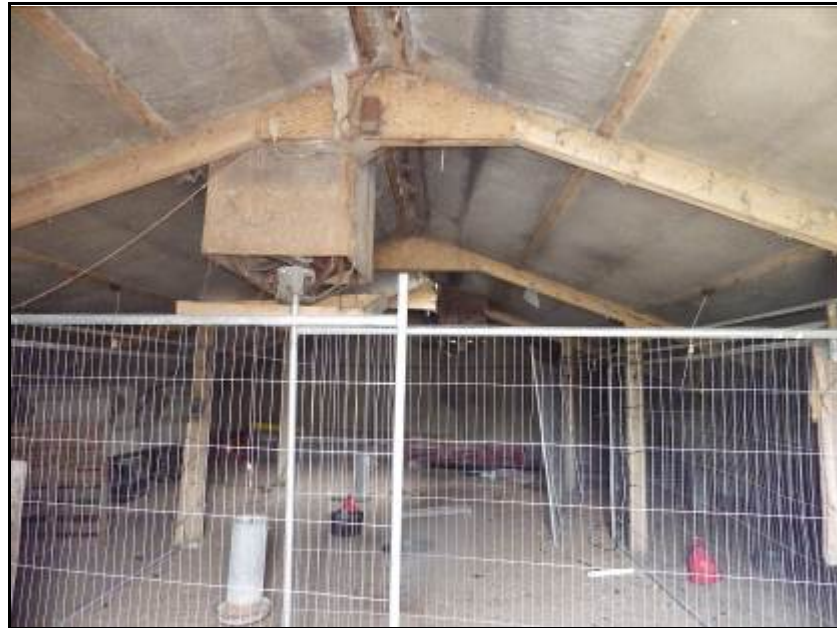
3.3.2. Building B.

3.3.2.1. Building 2 is a timber chicken shed with a pitched corrugated sheet roof as shown above.

3.3.2.2. Inside the roof and walls are lined with fibre board. The shed is used for chickens and the entire place was dusty with cobwebs along the ridge of the building.

3.3.2.3. This design of building is totally unsuitable for roosting bats and no field signs were identified inside or outside.

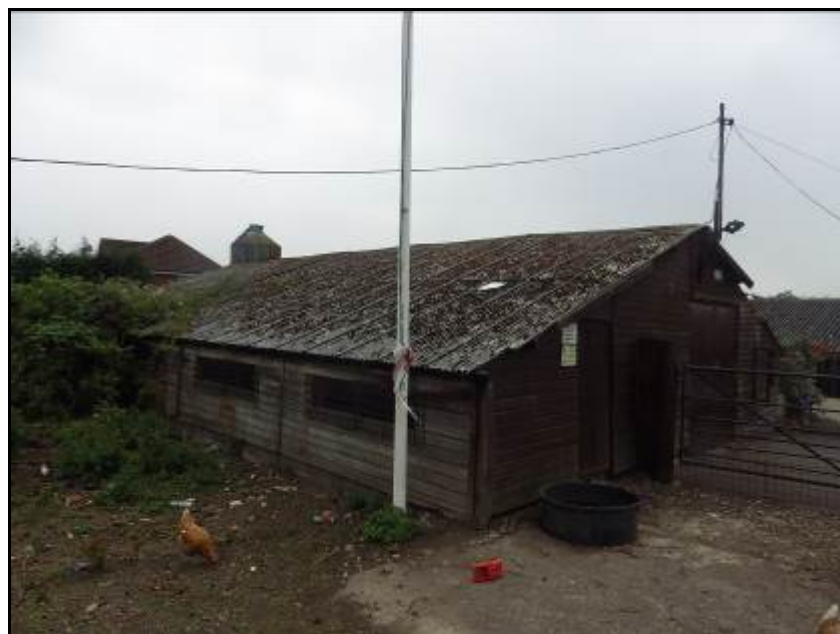
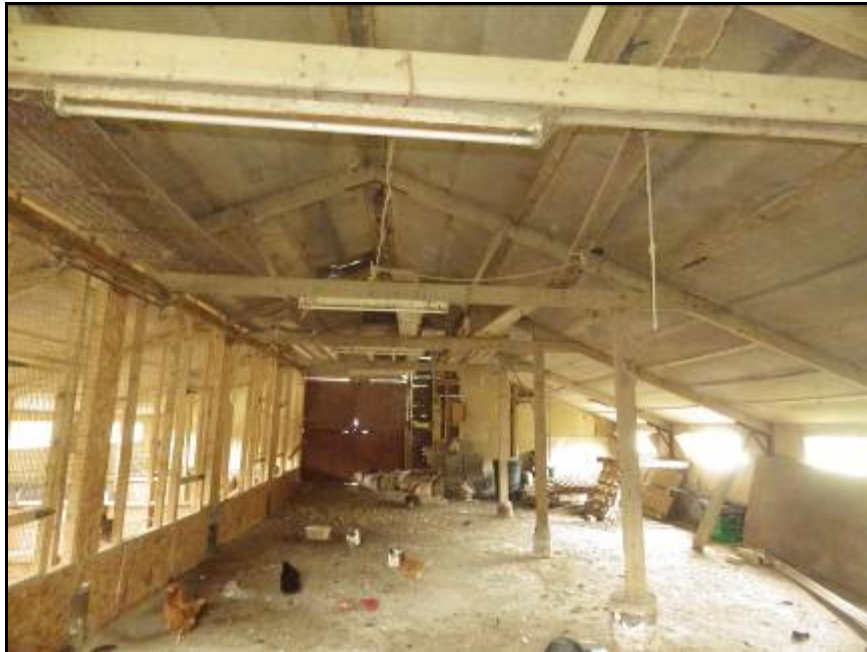
3.3.3. Building C.

3.3.3.1. Building C is another timber walled chicken shed with a corrugated cement sheet roof, as shown above. The rear and one side wall is constructed from well pointed blockwork.

3.3.3.2. Internally the roof is lined with a fibre board lining and the room is partitioned off into a number of different chicken pens.

3.3.3.3. The inside was very dusty with abundant cobwebs. No bat field signs were identified inside or outside this building and the design is such that there is no potential for roosting bats.

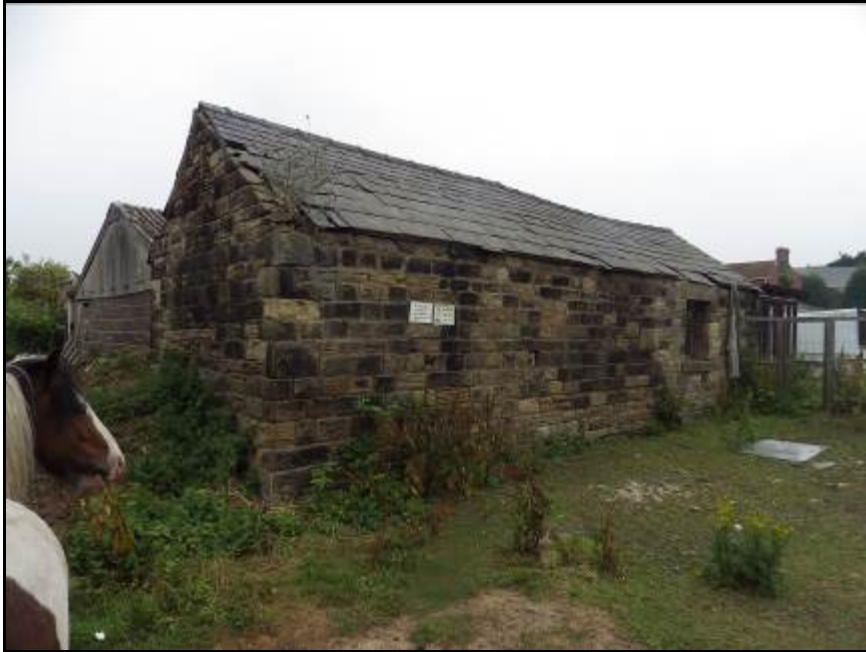
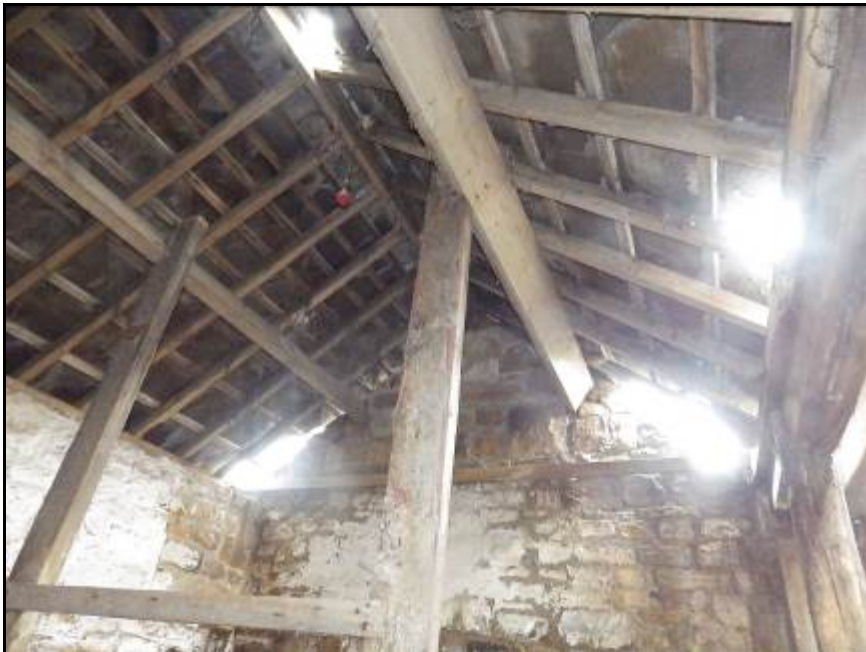
3.3.4. Building D.

3.3.4.1. Building D is a stone building with coursed stone walls. These are generally well pointed and sound and where a hole was present it was low enough to be inspected with a bright torch.

3.3.4.2. The roof is pitched and covered with Welsh slate with no lining. The roof is in a poor state of repair with abundant slipped and missing slates making the building airy and damp.

3.3.4.3. Internally the walls were painted although this was wearing off. The floor was a soil floor and the building is unused.

3.3.4.4. Whilst the materials used for this building can be ideal for roosting bats this building is in a poor state of repair and is therefore draughty and damp and assessed to be unsuitable for roosting bats.

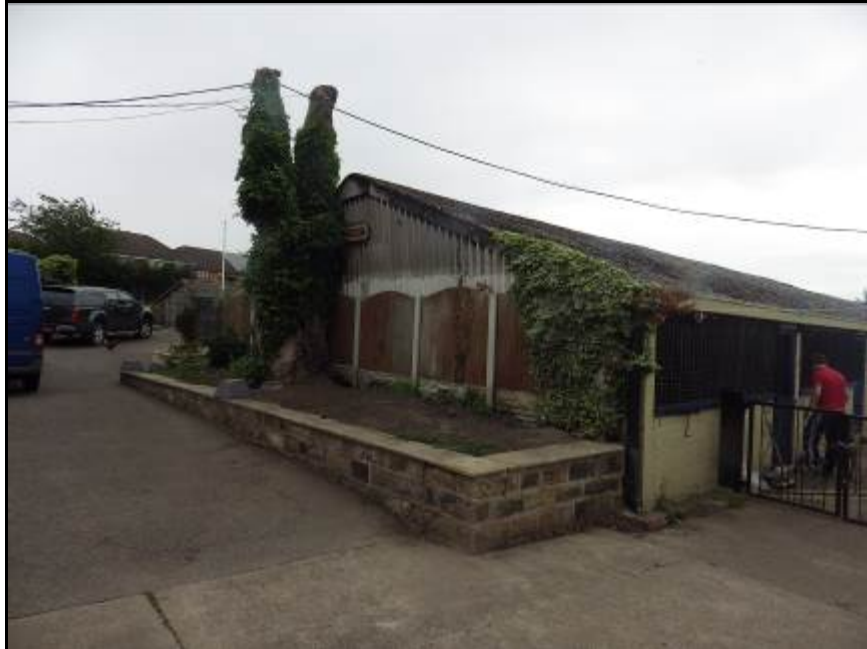
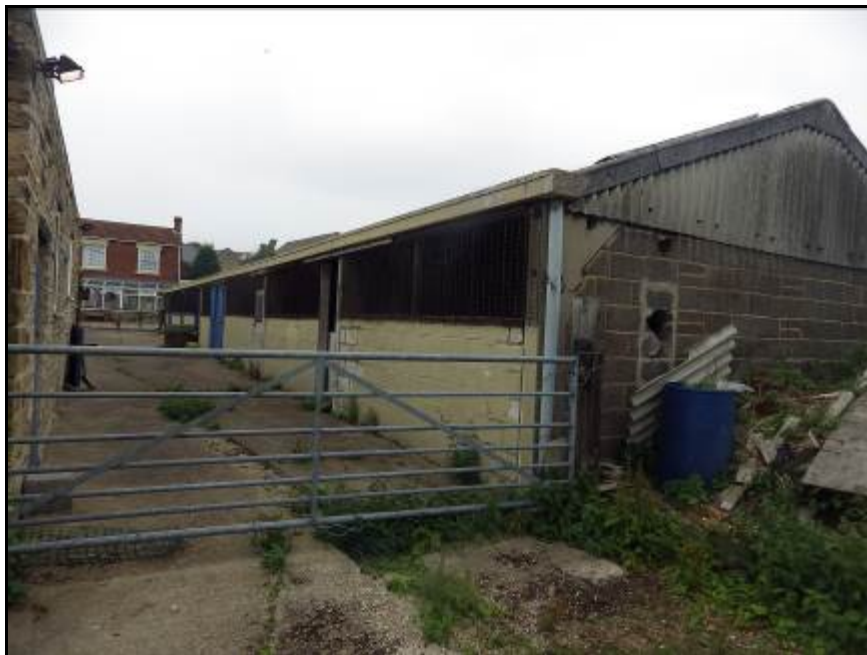
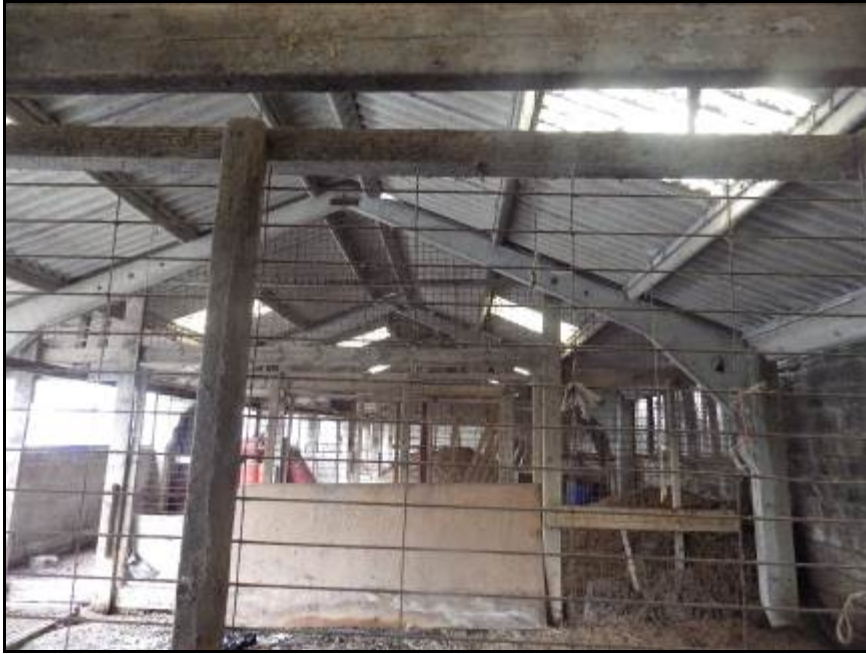
3.3.5. Building E.

3.3.5.1. Building E is the central building on the site. It is a concrete “Dutch Barn” type of structure with blockwork lower walls and with open meshed panels above.

3.3.5.2. This type of building is unsuitable for roosting bats and no bats or bat field signs were identified inside or outside the building.

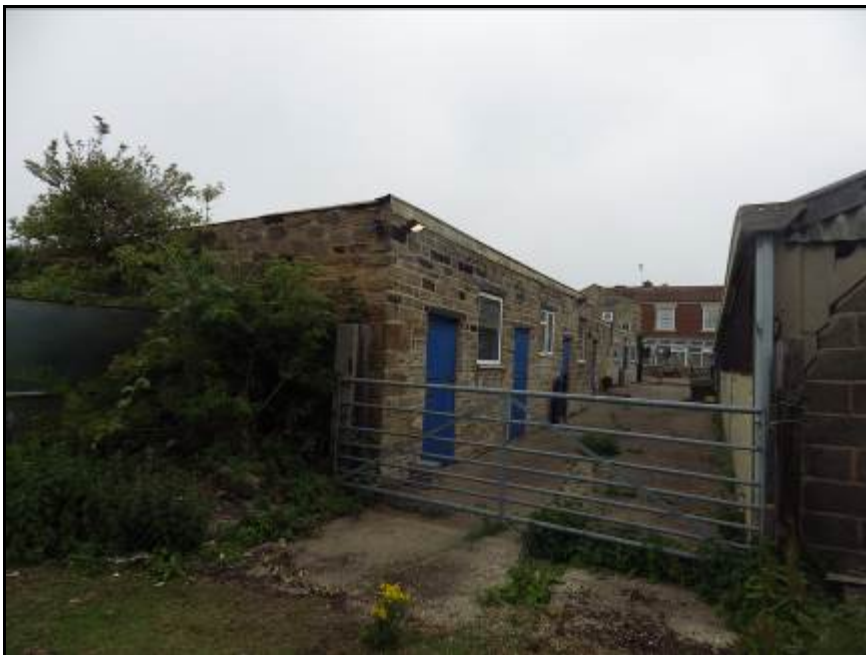
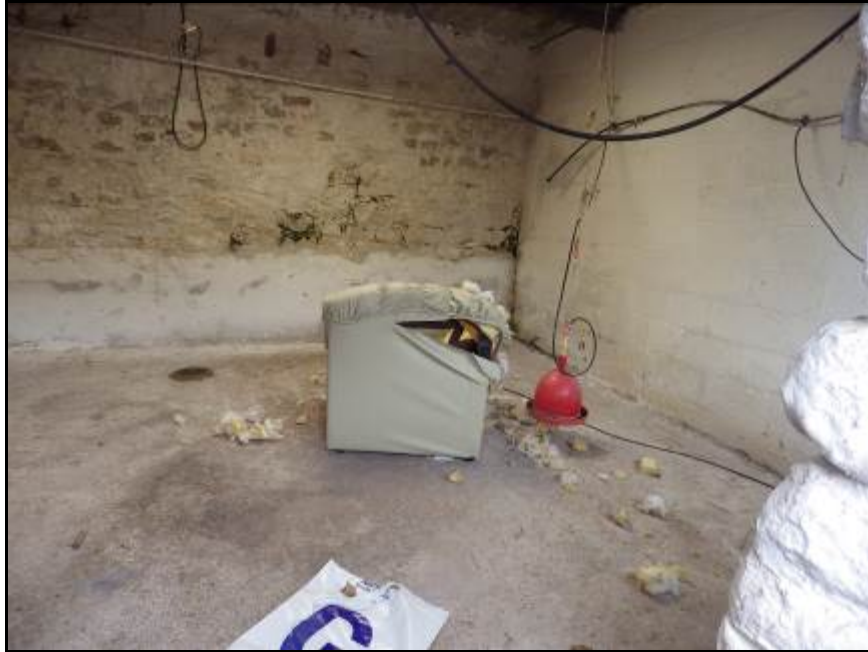
3.3.6. Building F.

3.3.6.1. Building F is a series of stone walled buildings with sloping corrugated sheet roofs that extend down the western side of the site.

3.3.6.2. Externally the stonework is well pointed and internally the walls are painted white. These buildings are used for kennels and for storage.

3.3.6.3. No bats or bat field signs were identified inside or outside these buildings and they were assessed as having no potential for roosting bats.

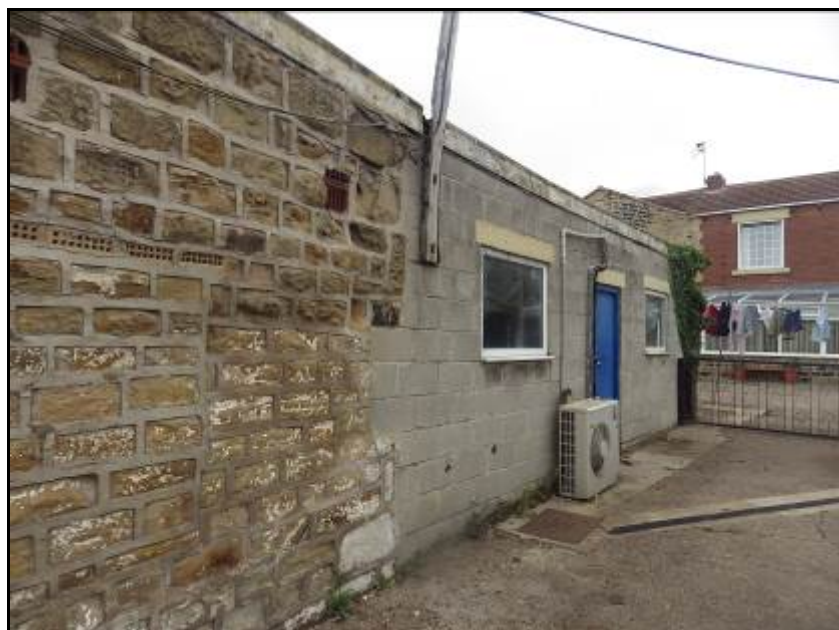
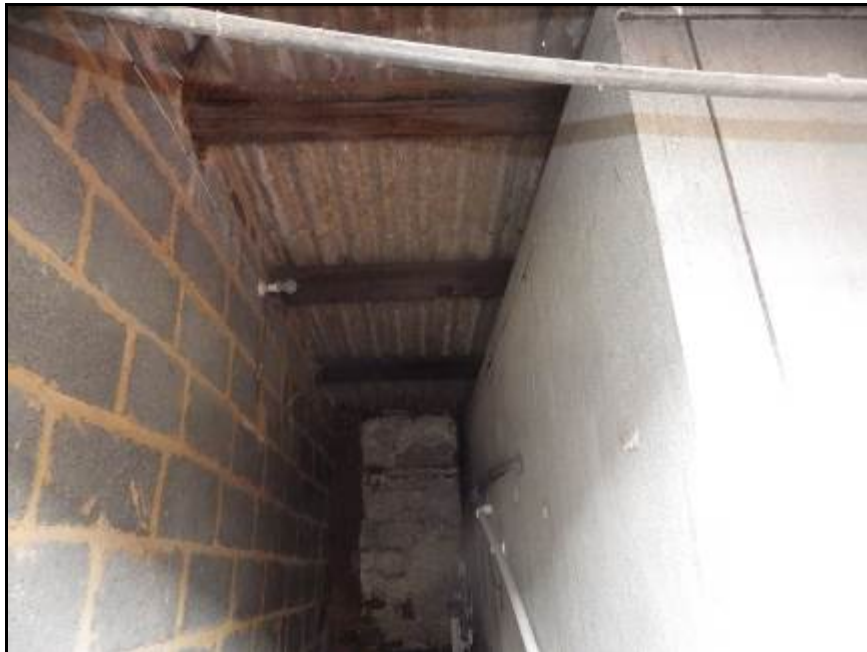
3.3.7. Building G.

3.3.7.1. Building G is constructed with a mixture of stone and blockwork walls and is an extension to the kennels in building F.

3.3.7.2. The walls are in good condition and well pointed. The roof is a sloping corrugated sheet roof.

3.3.7.3. Inside this building is a large freezer unit that occupies all but a small section at the back, as shown below.

3.3.7.4. This building is in good condition and provides no opportunities for roosting bats.

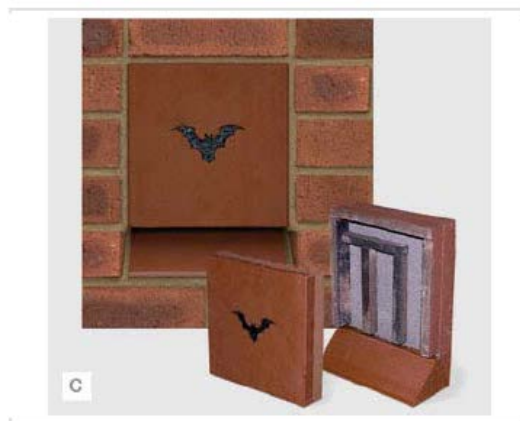
Enclosed Bat Box C with engraved motif

Designed specifically for the pipistrelle bat

5.5. To enhance the biodiversity of the site, it is recommended that a bat brick be installed in one of the gable ends of the new houses. The preferred location would be in the gable end of the house on Plot 9, overlooking the bridleway. The bat brick should be as shown below or equivalent.
