Project:
BARNSELY

Description:
EXTERNAL ATM REPLACEMENT

Location:
NATWEST BARNSELY,
26 MARKET HILL,
BARNSELY,
S70 2QE

5560-WKS-00006-030

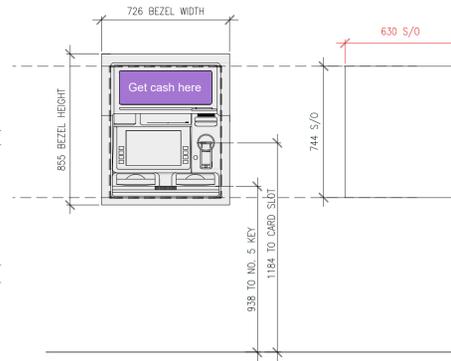
Existing Elevation
1:20

Existing Structural opening
1:20

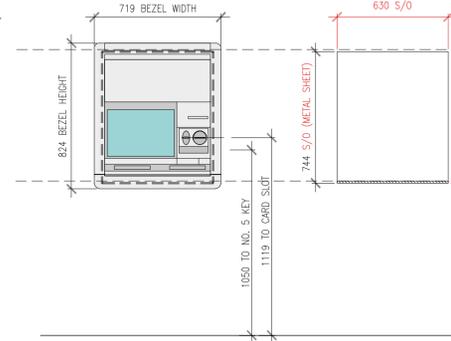
Proposed Elevation
1:20

Proposed Structural opening
1:20

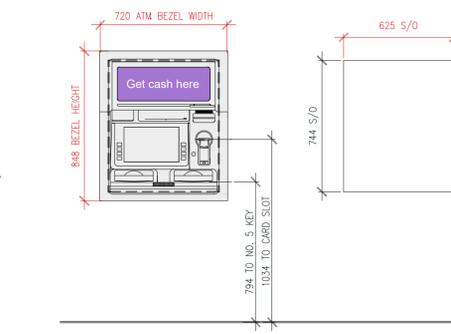
Existing Elevation
1:20

Existing Structural opening
1:20

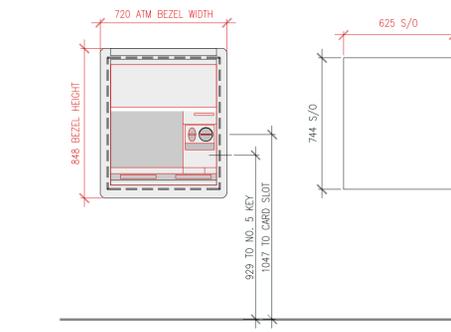
Proposed Elevation
1:20

Proposed Structural opening
1:20

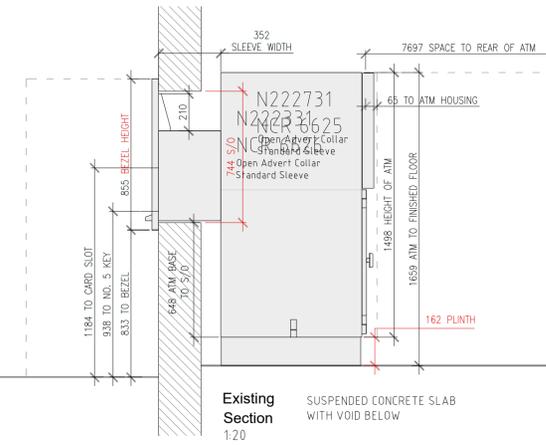
Existing Section
1:20

SUSPENDED CONCRETE SLAB WITH VOID BELOW

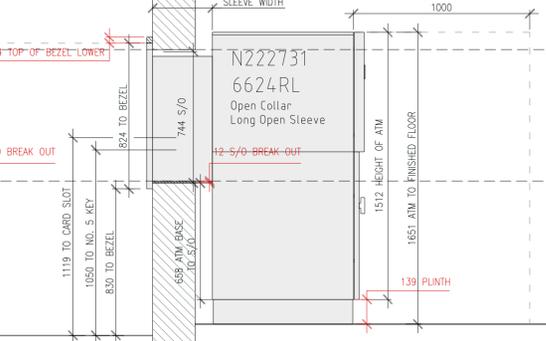
Proposed Section
1:20

SUSPENDED CONCRETE SLAB WITH VOID BELOW

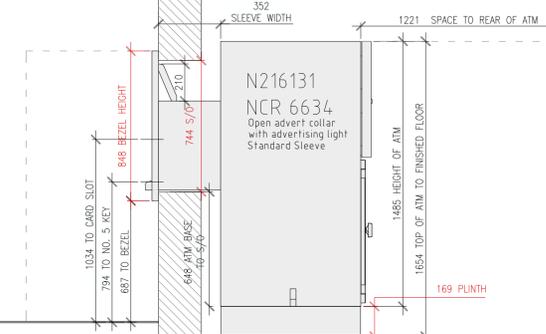
Existing Section
1:20

SUSPENDED CONCRETE SLAB WITH VOID BELOW

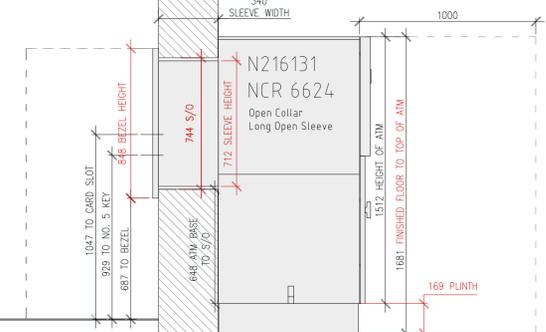
Proposed Section
1:20

SUSPENDED CONCRETE SLAB WITH VOID BELOW
