Bat Scoping Survey to
Kexborough Farm
Churchfield Lane
Kexborough
S75 5DU

1st October 2019

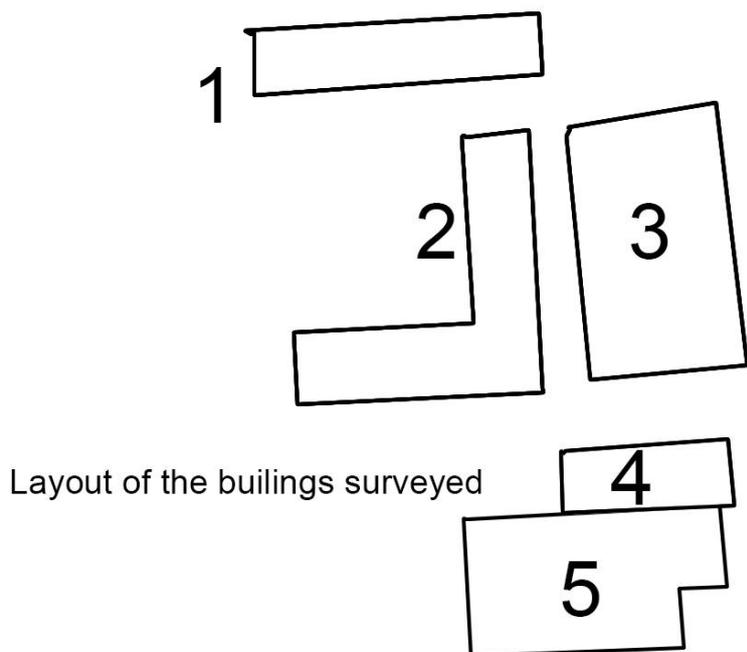
Figure 3. layout of buildings for reference

The site consists of three stone barns arranged around an open farmyard with two of the barns joined to form an L-shape (building 2). Along the outer edge of the site are a series of large, modern agricultural units and a small, open fronted building (building 4).

Buildings numbered 3 and 5 above are large agricultural units constructed around a steel frame with breeze block to the lower wall sections and corrugated tin or cement fibre to the sides and roof. These buildings are not considered to be of any interest to bats in terms of providing roost sites, though they will be used by bats as foraging areas, especially by any bats emerging locally. Both common pipistrelle and whiskered bats seem to favour hunting in this kind of units just after emerging, but the buildings do not have the cavity walls or roof voids that bats require for roosting. These units are classed as being of negligible interest to bats.

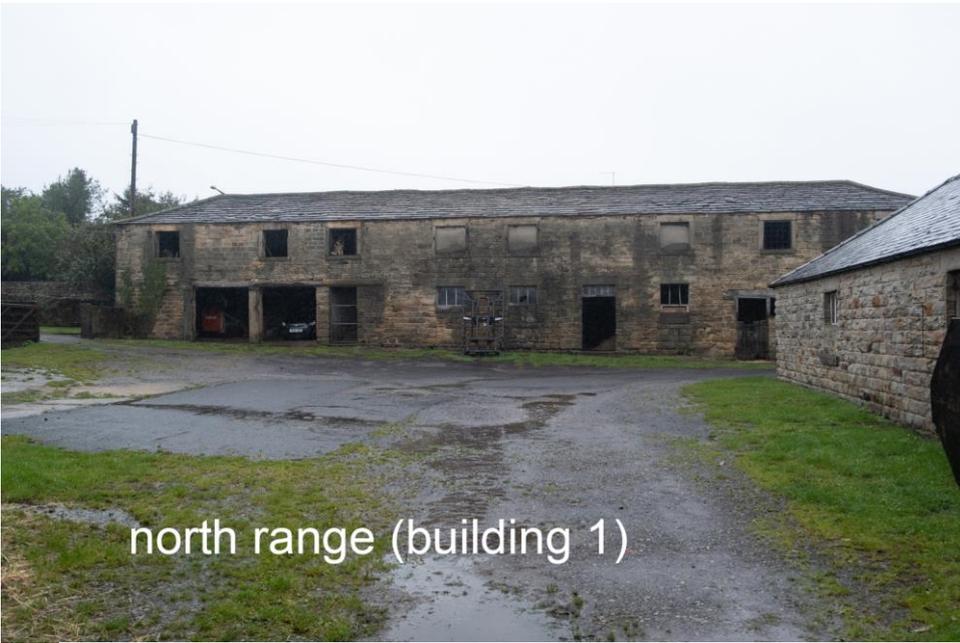
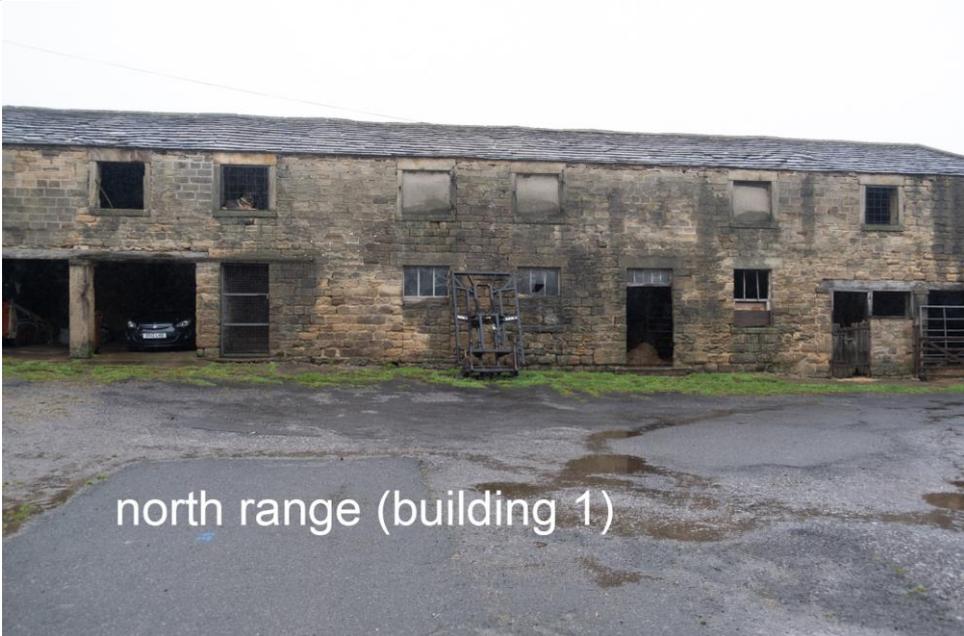
The buildings with the most potential interest to bats are the stone buildings arranged around the farmyard. Building 1 is a long, two-storey building with stone roof tiles. The roof is unlined and for the most part has a heavy build-up of dirt and cobwebs on the ridge beams. The ridge tiles are all present and have had some remedial works carried out and appear to be well

bedded and could be of interest to ridge dwelling species. The gable walls have also had some repointing works undertaken and have limited access points. The gable walls have a stone cap and do not have any kind of fascia or other features that bats could roost beneath. The walls have some structural gaps and other minor cavities that may be used by small numbers or individual bats. Although there was no evidence to suggest use by bats, the building has some potential and is classified as being of low importance to bats.

- 9.3 The large range of the stone barn on the north boundary has the most roost potential, although the stone roof is unlined and does appear to have a heavy build-up of cobwebs and dust along the ridges. There are gaps in between stone lintels and wall joints that might offer roost potential and the building is likely to be used by nesting swallows.

north range (building 1)

10.2 The stone barns should not be demolished or altered without an activity survey being carried out and checks for nesting birds should also be made.

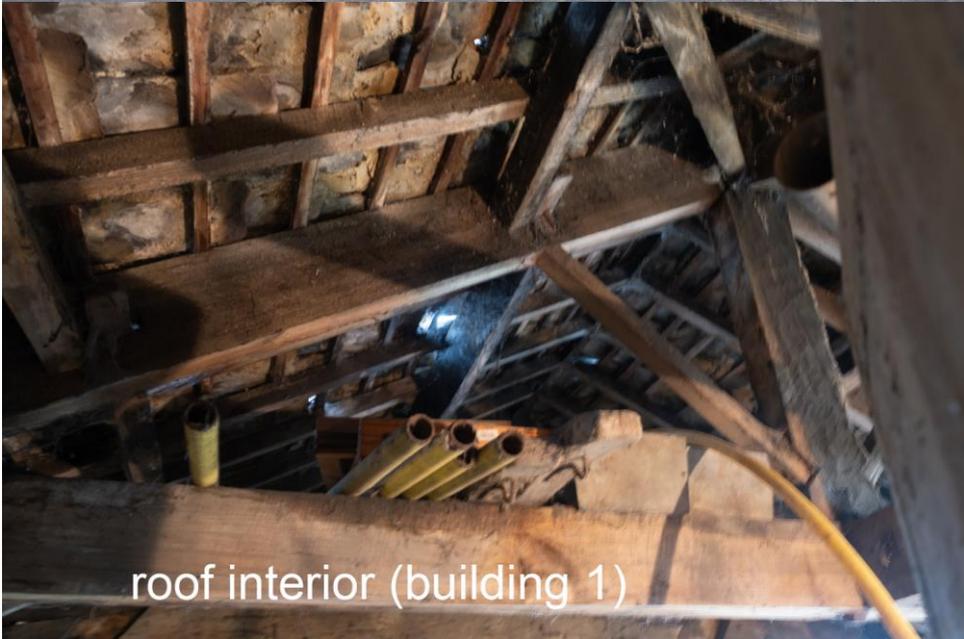
roof interior (building 1)

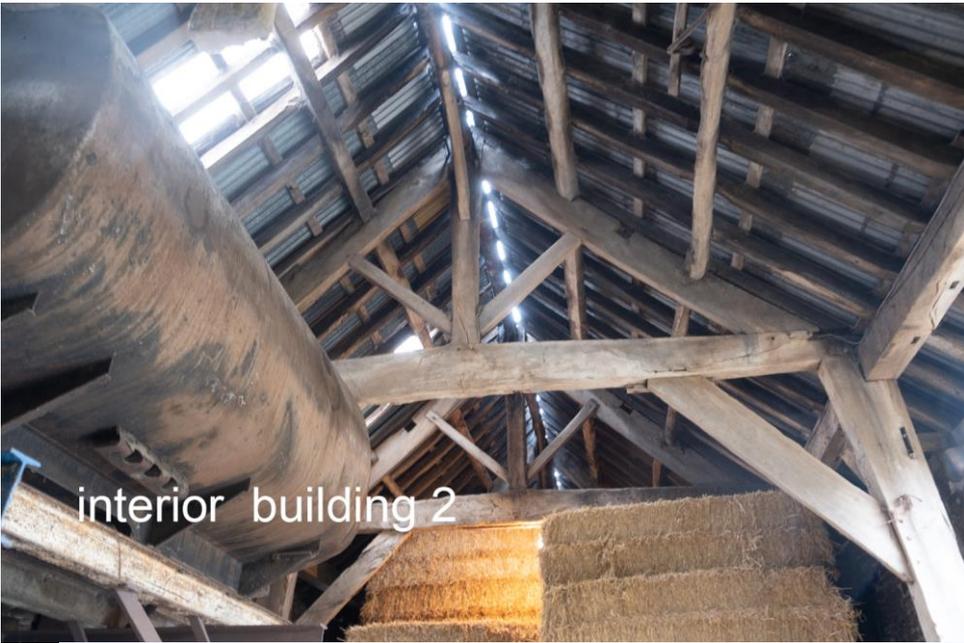
Building 2 is an L-shaped barn consisting of a single storey unit with slate roof connected to the larger, Grade 2 listed barn which has a corrugated tin roof. The single storey section appears to be modern and has a sound slate roof which is lined with felt. It is hipped on the exposed gable and all hip and ridge tiles are present and well bedded and without gaps. The stone walls are well pointed and do not have gaps. The larger section of this barn is two storey and is a stone shell built around the original (medieval) timbers but without being connected to them. The stone roof has long been taken away and replaced with a corrugated tin roof which has gaps the whole length of the ridge. The roof is of no interest to ridge dwelling species and does not provide any kind of potential roosting site. The interior of the barn is incredibly dusty due to the presence of a milling machine that is used daily to grind fodder for the cattle. The amount of dust is likely to make this barn very unattractive to bats. It is, nevertheless, categorised as being of low interest and will require at least one activity survey.

- 9.2 The large Grade 2 listed barn has limited roost potential due to the tin roof with large ridge gaps and the huge amounts of dust in the interior section caused by the grinding machine. There is a slim chance individual bats could find roost sites in mortice joints in the huge medieval timbers but the dust is likely to penetrate any potential gaps. The walls have small cracks and cavities that may be of interest and a single activity survey would determine if bats were using this building in any way. The single storey building that adjoins this barn has some possibility of bats behind gutter boards and, to a much lesser extent, in the roof.

interior building 2

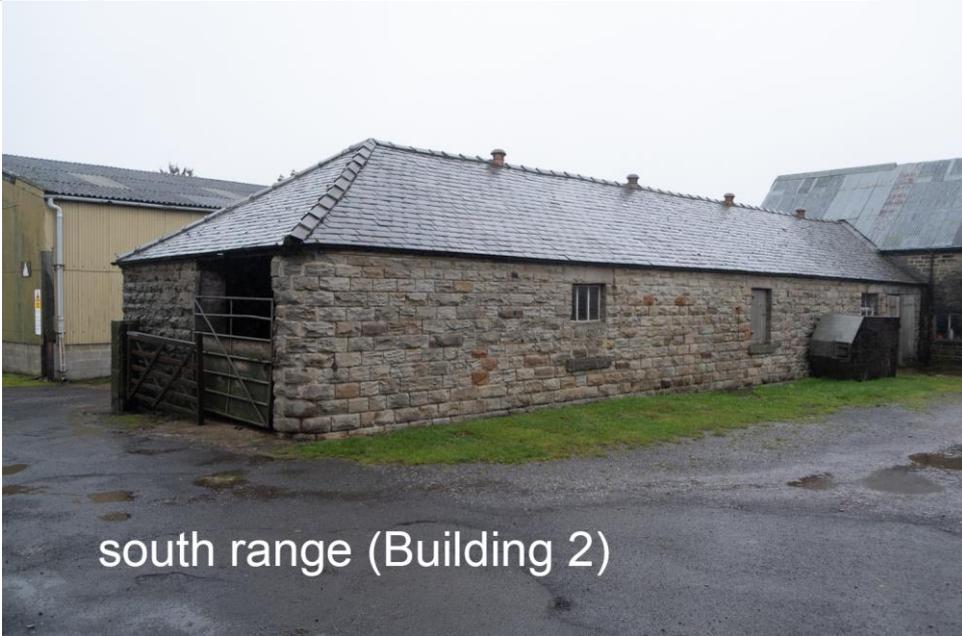
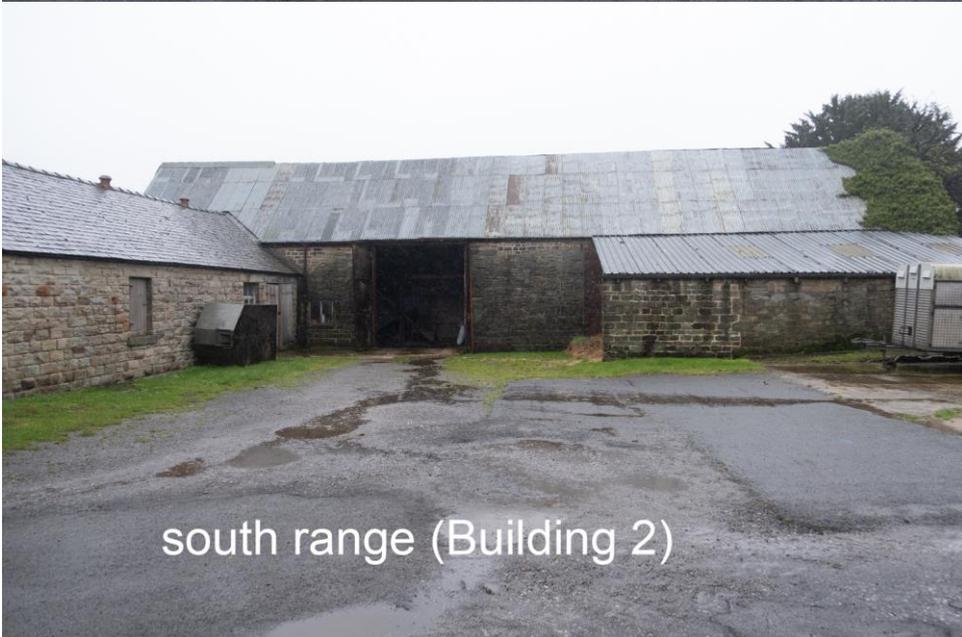
south range (Building 2)

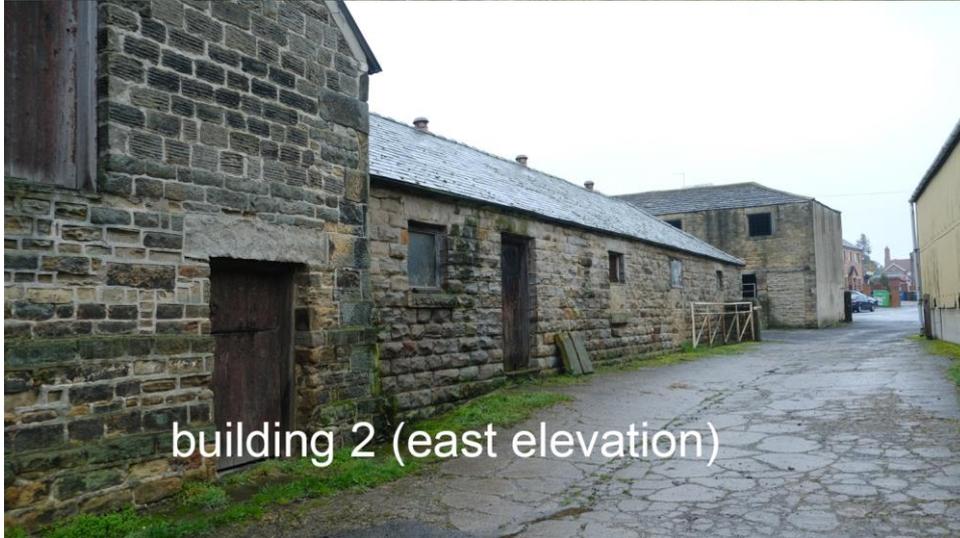
building 2 (east elevation)

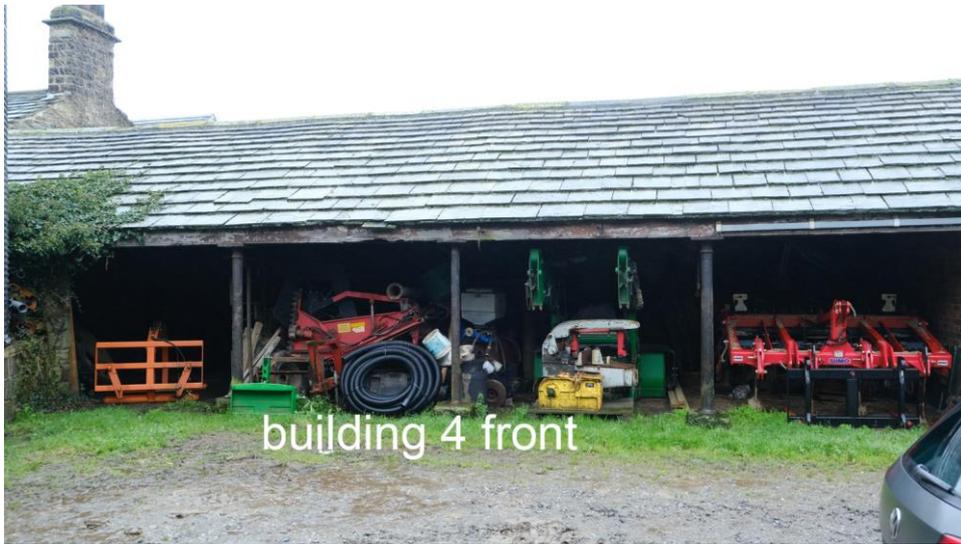
To the rear of the farmyard is a small, open-fronted, single storey building used for storing farm machinery (building 4). This has a stone roof which appears to be relatively new and is lined and may provide either roosting potential or could be used as a feeding perch by brown long-eared bats. An activity survey would establish if the building is being used by bats.

building 4 front

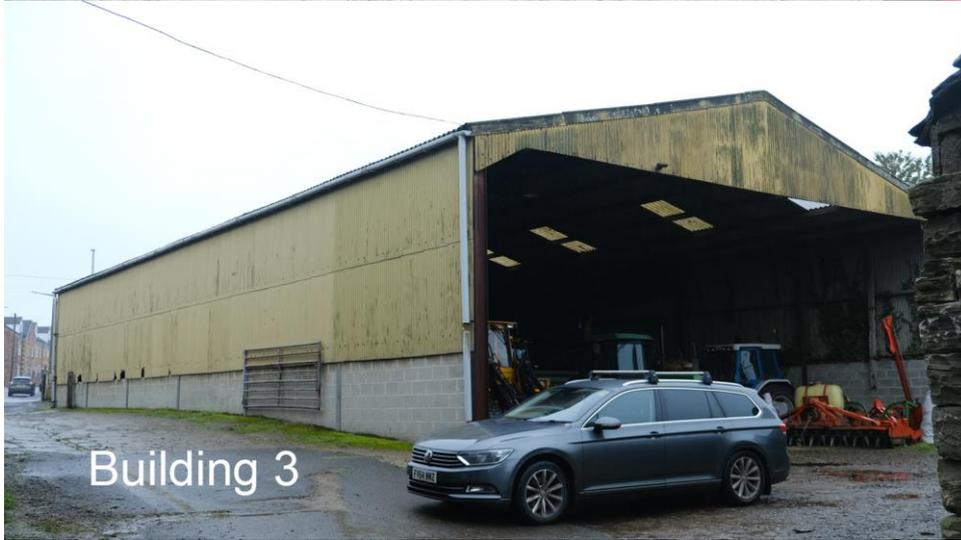
- 9.1 The modern units have no value to bats other than to possibly provide a sheltered feeding site that would probably be used just after emergence or just as bats return to roost. It is unlikely that these buildings would be used as a roost of any kind as the lower walls are solid block while the upper walls and roof are single thickness corrugated material.

Building 3

- 10.1 It is unlikely that bats are using the modern units on site (buildings 3 & 5) and these could be demolished at any time without any impact to bats or the local bat population. In addition to
