# Preliminary Geoenvironmental Investigation

## Land at Midland Road, Royston For Kier Living Northern

Report no: 2321/1

Date: July 2016

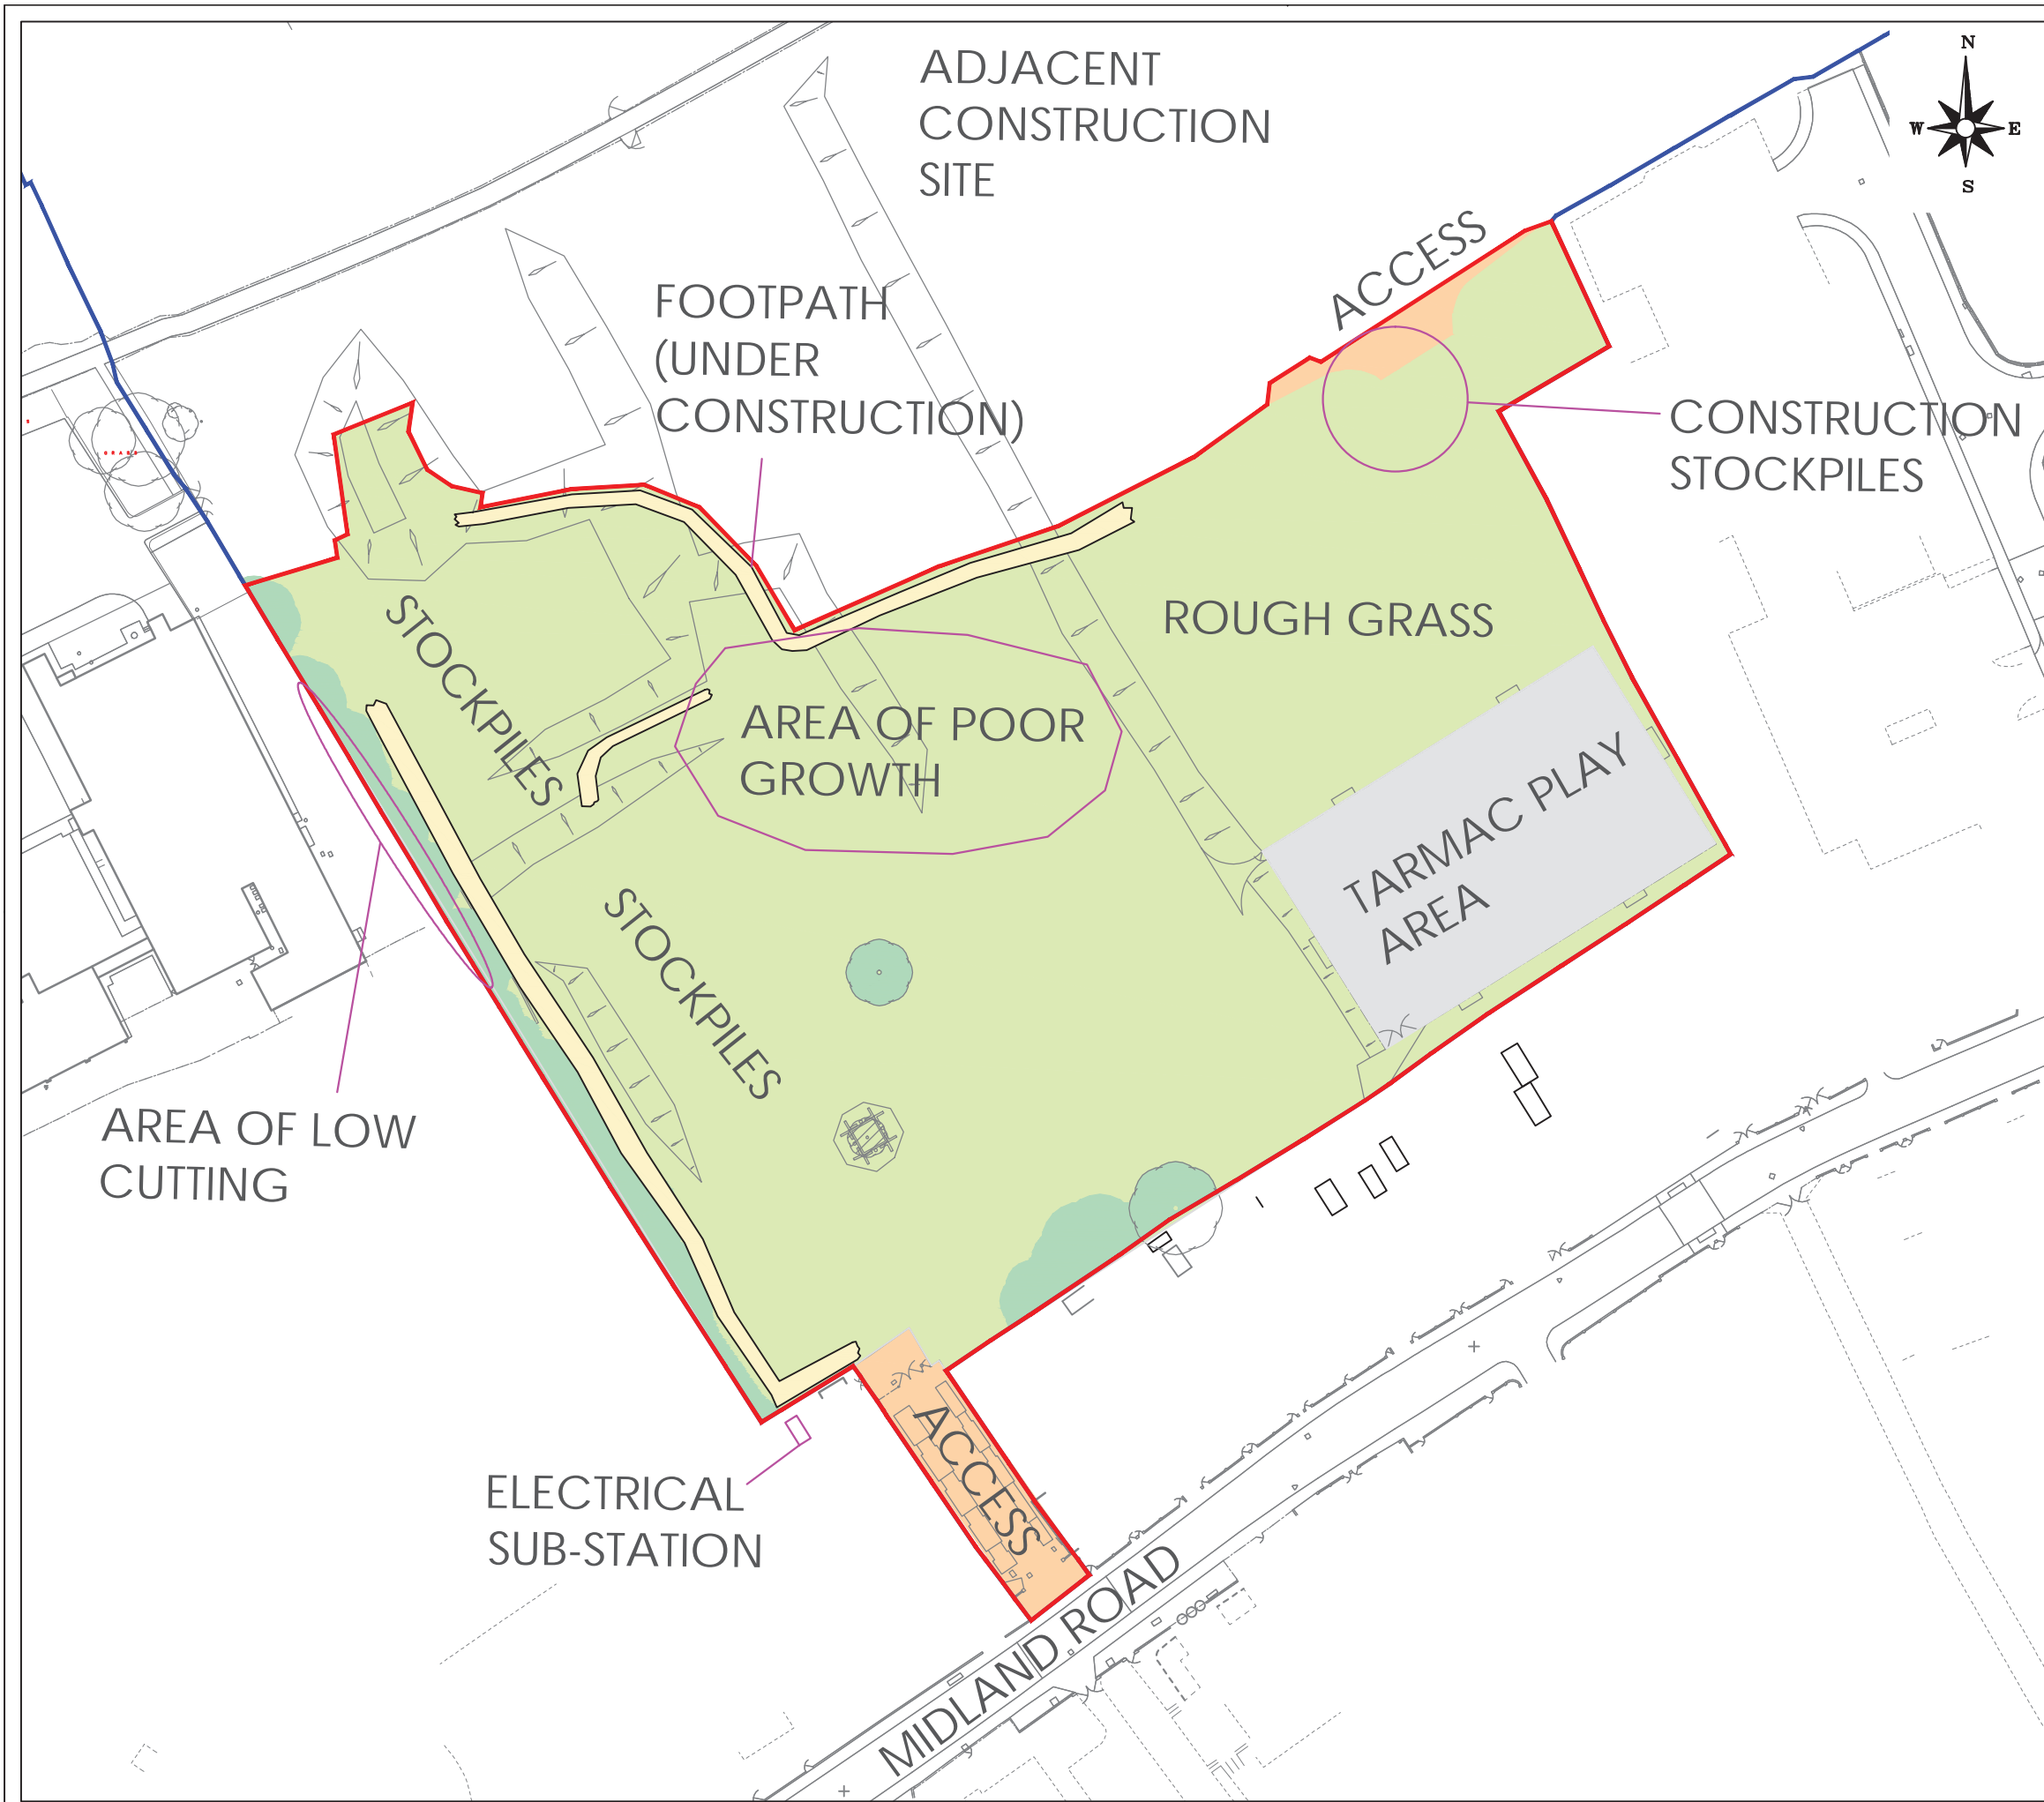
DRAWN	GLM	DATE	22/07/2016	STATUS	FOR COMMENT	<input type="checkbox"/>
CHECKED	REG	DATE	22/07/2016	FOR APPROVAL	DRAFT	<input type="checkbox"/>
				FINAL		<input checked="" type="checkbox"/>
SCALE	1:1,000	SHEET	A3	DRAWING NO.	2321/2	REVISION

PROPOSED SITE LAYOUT

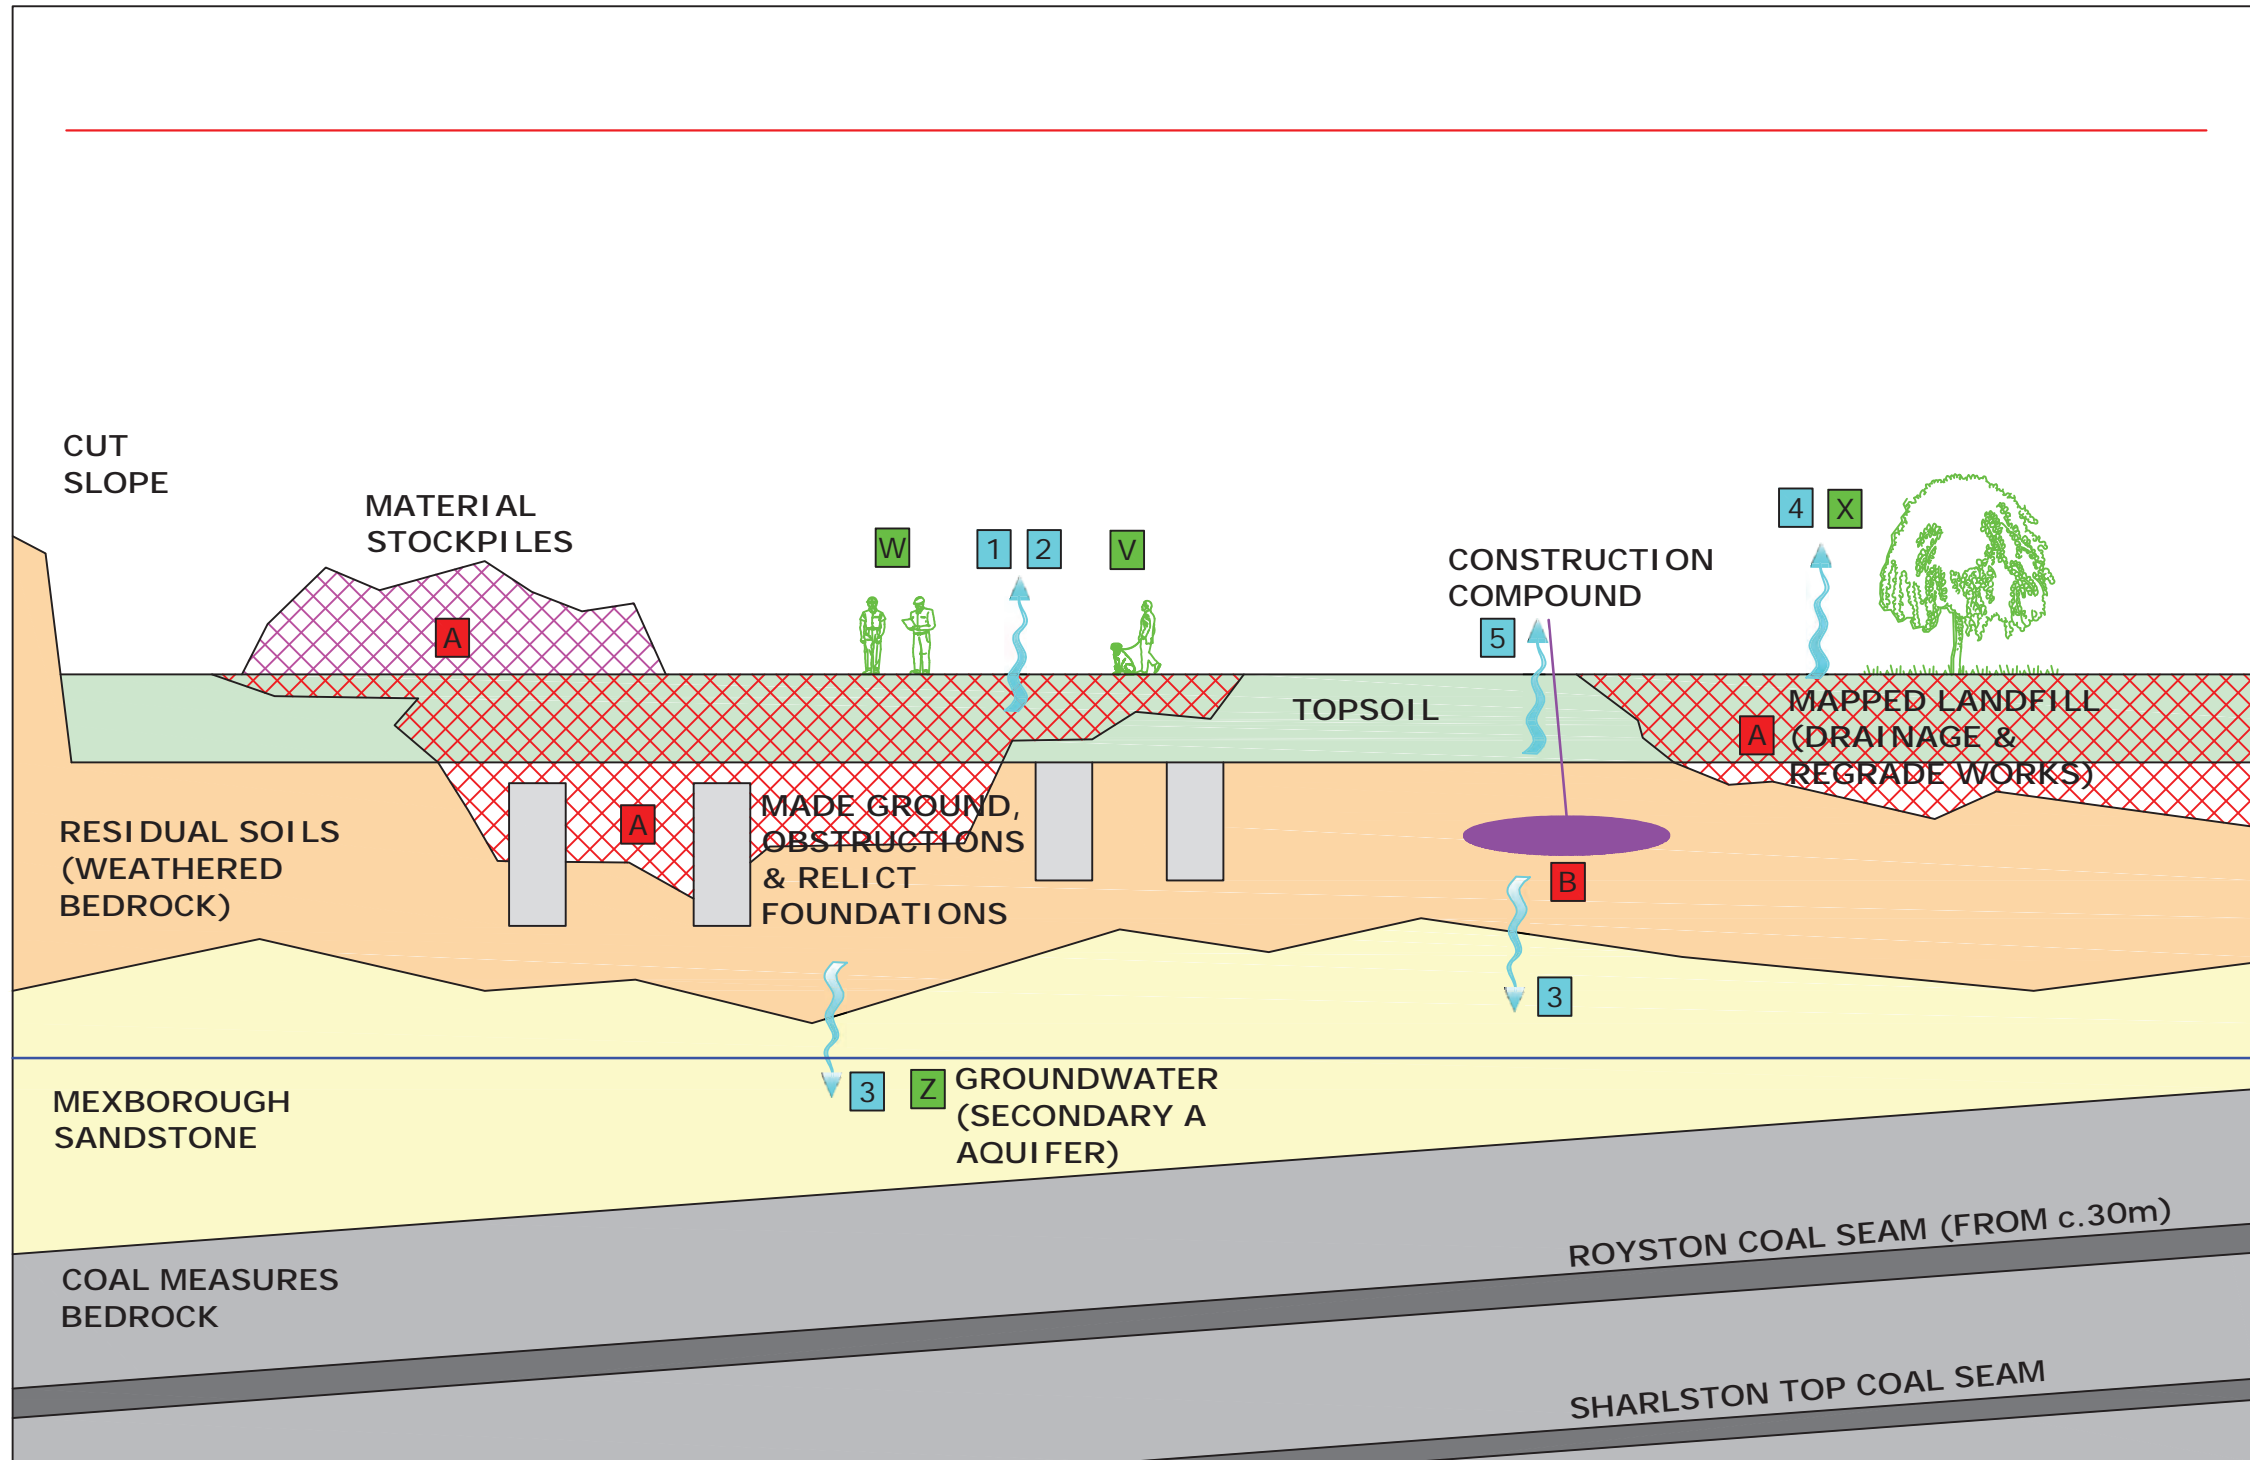
SCALE	Not to scale	SHEET	A3	DRAWING NO.	2321/5	REVISION	
-------	--------------	-------	----	-------------	--------	----------	--

SOURCES	
<b>A</b>	MADE GROUND (INORGANICS)
<b>B</b>	LEAKAGE/SPILLAGE (ORGANICS)

PATHWAYS	
<b>1</b>	DERMAL CONTACT
<b>2</b>	INGESTION/INHALATION
<b>3</b>	LEACHING OF CONTAMINANTS
<b>4</b>	UPTAKE BY PLANTS
<b>5</b>	VOLATILISATION

Potential pollutant linkages are shown on a preliminary conceptual site model, presented as a Drawing in an Appendix to this Geoenvironmental Report. The preliminary model is revised in light of data arising from the subsequent ground investigation.
