# Geoenvironmental Appraisal

## Land at Smithy Wood Lane, Dodworth For The Wentworth Trustees & Avant Homes Yorkshire

Report no : 1979/2B

Date : April 2021

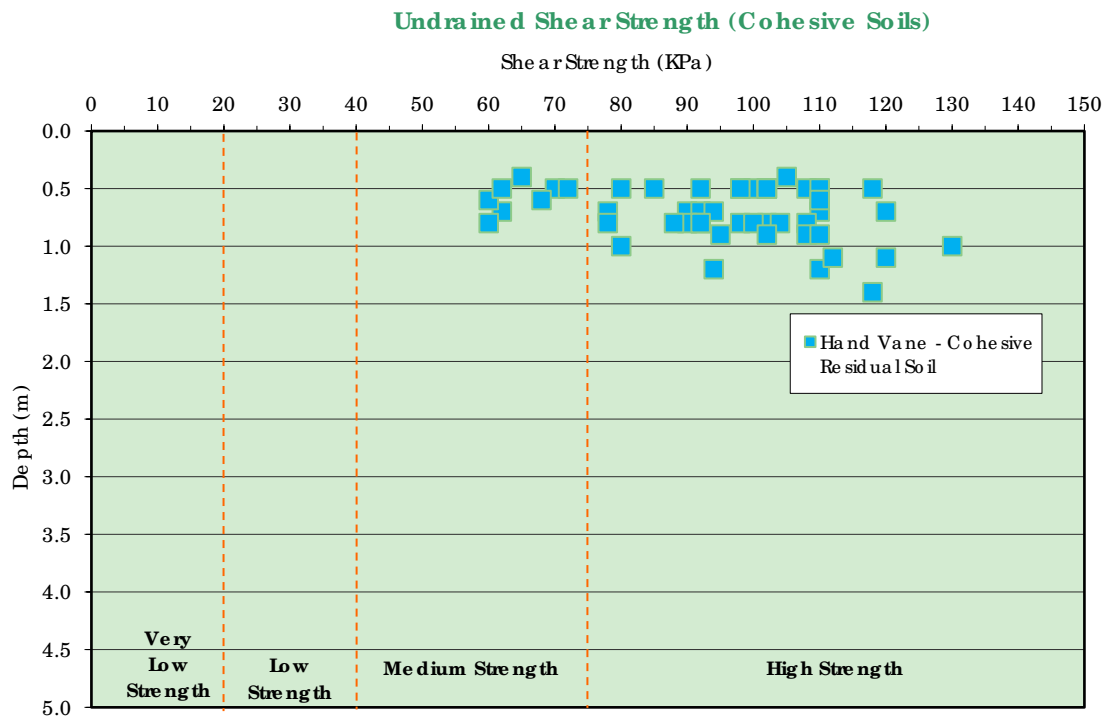
- 12.3.6 Hand shear vane testing was undertaken within trial pits in-situ to around 1.2m depth and from larger blocks of excavated clay below that depth.
- 12.3.7 The results are summarised within the plot below and illustrate a linear increase in undrained shear strength ( $S_u$ ) with depth within the Cohesive Residual Soils. Below approximately 0.5m depth  $S_u$  is typically greater than 60kPa. The majority of readings lie within the high strength (>75kPa) range.
- 12.3.8 The plot below provides a summary of undrained shear strengths.

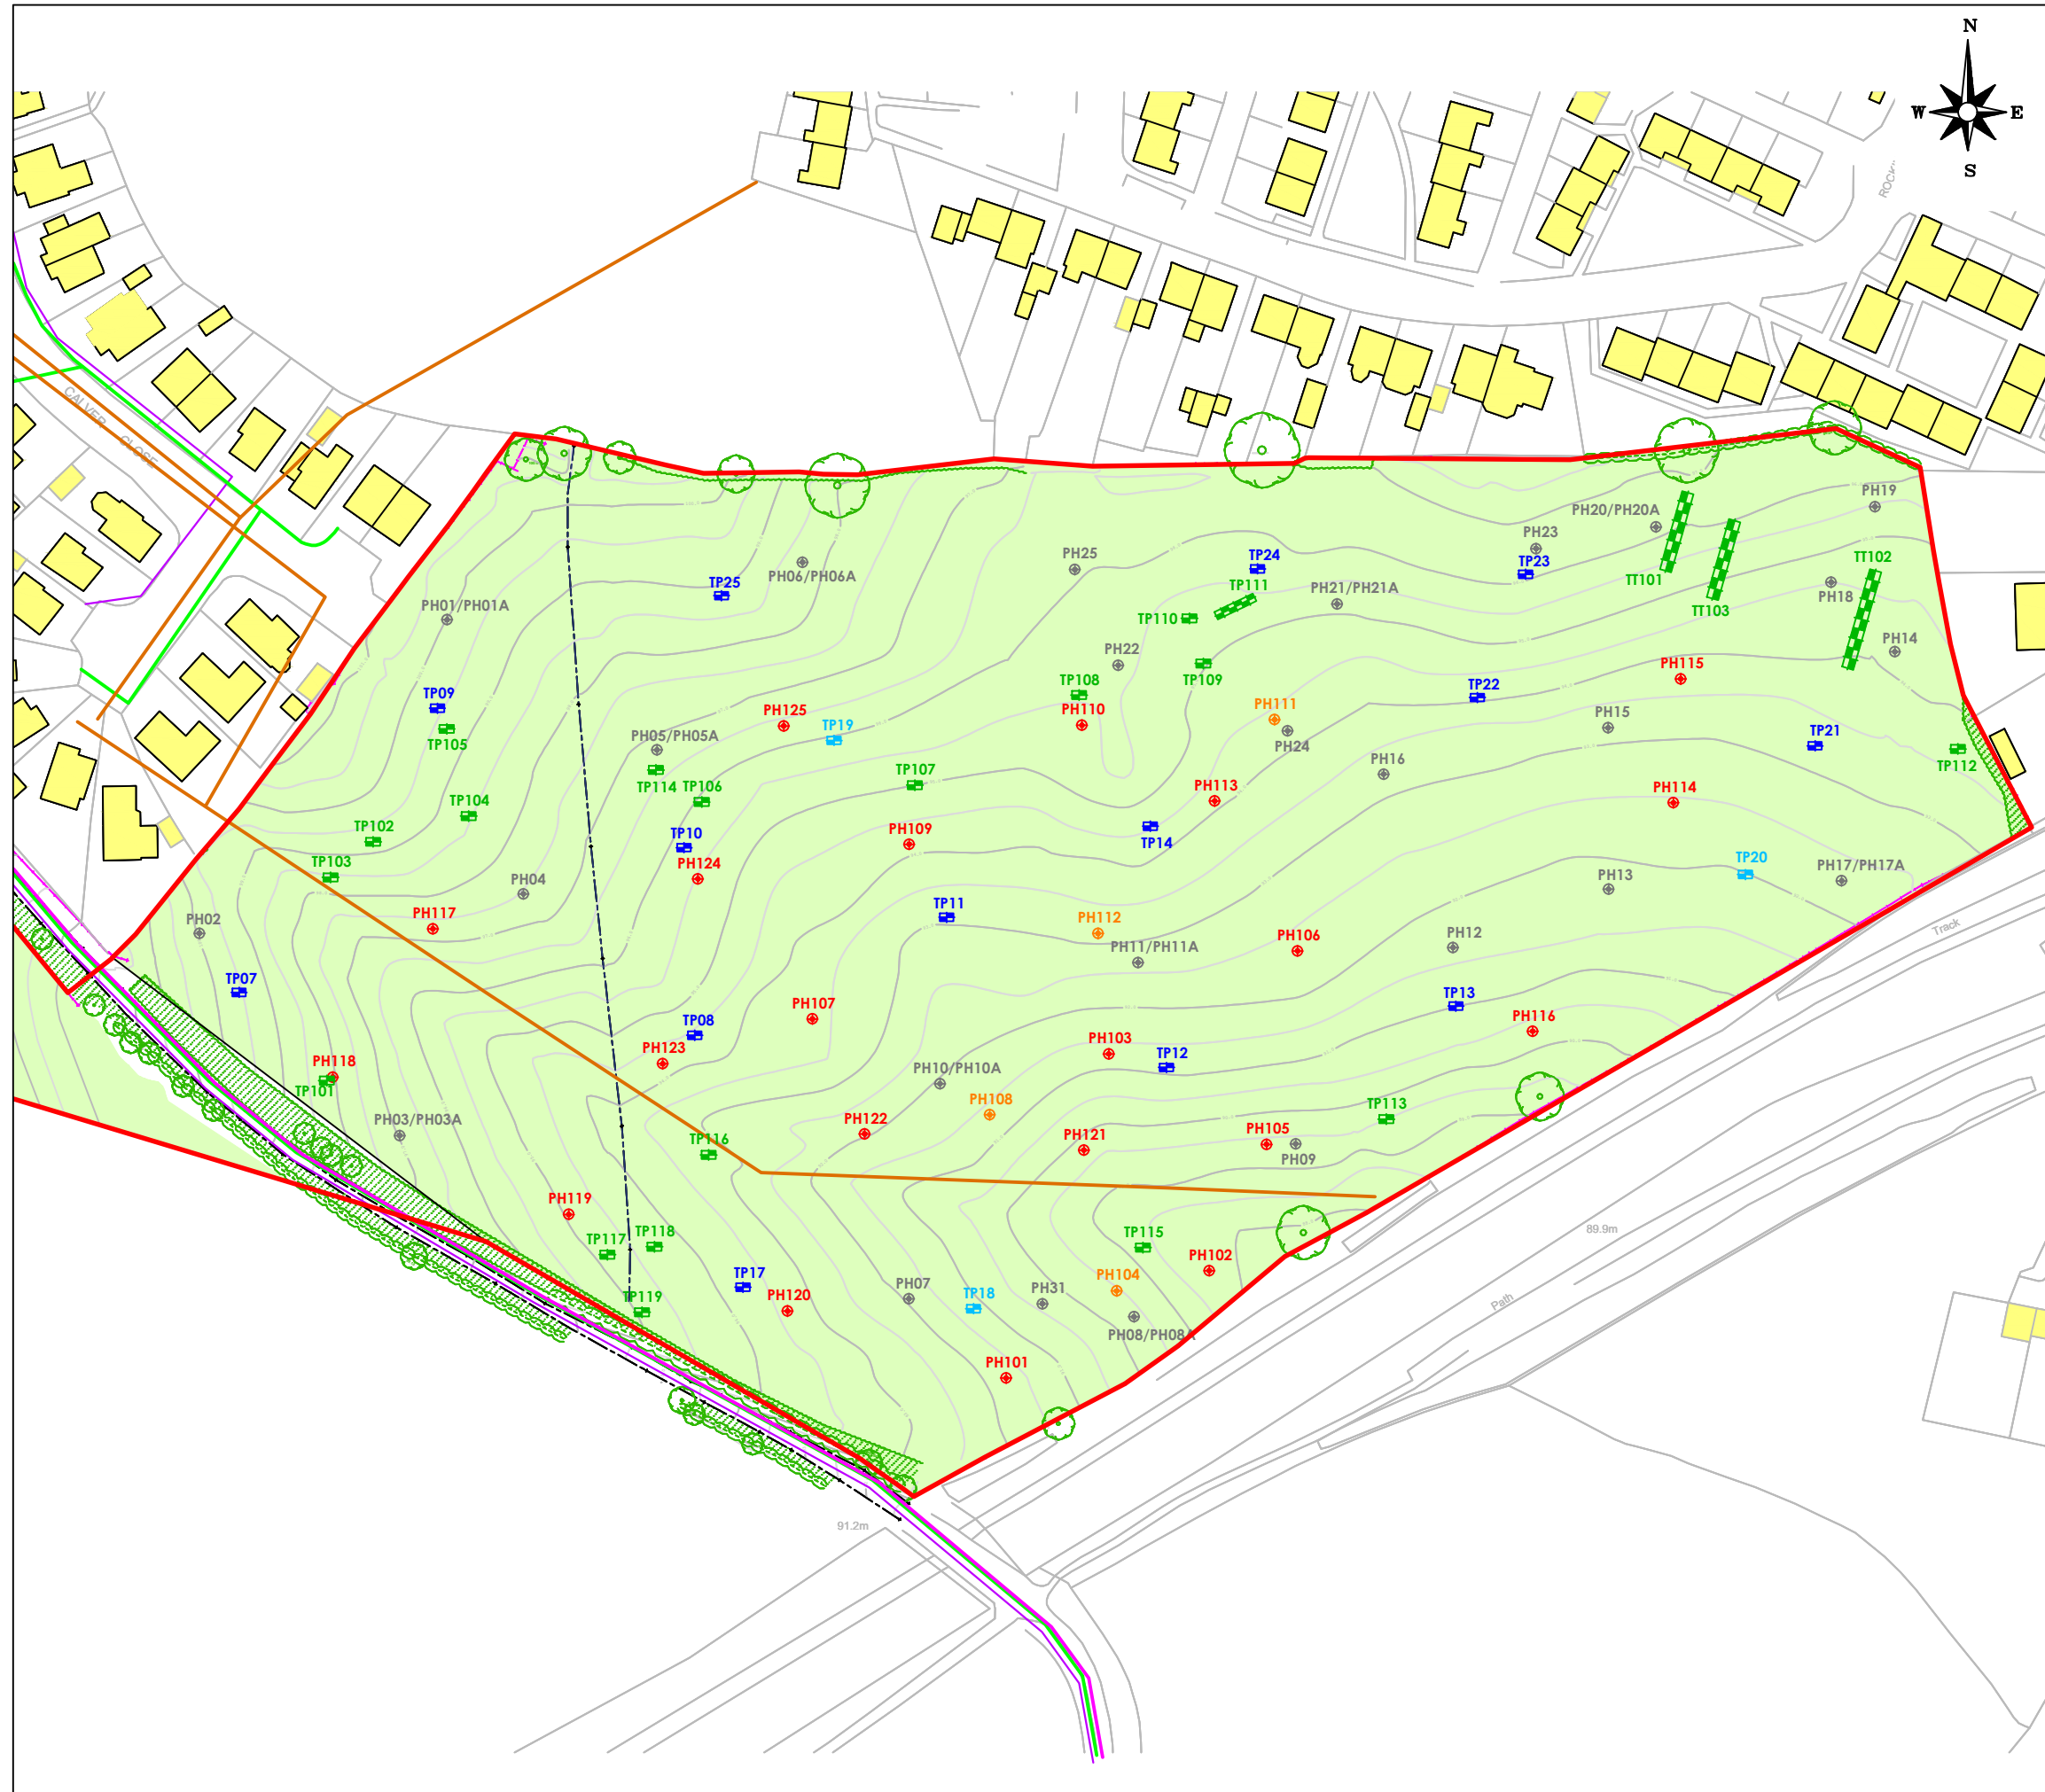
| SCALE | 1:2000 | SHEET | A3 | DRAWING NO. | 1979/I10A | REVISION |

| NOTES | | |
|---|---|---|
| | TRIAL PIT LOCATION (APR '20) | |

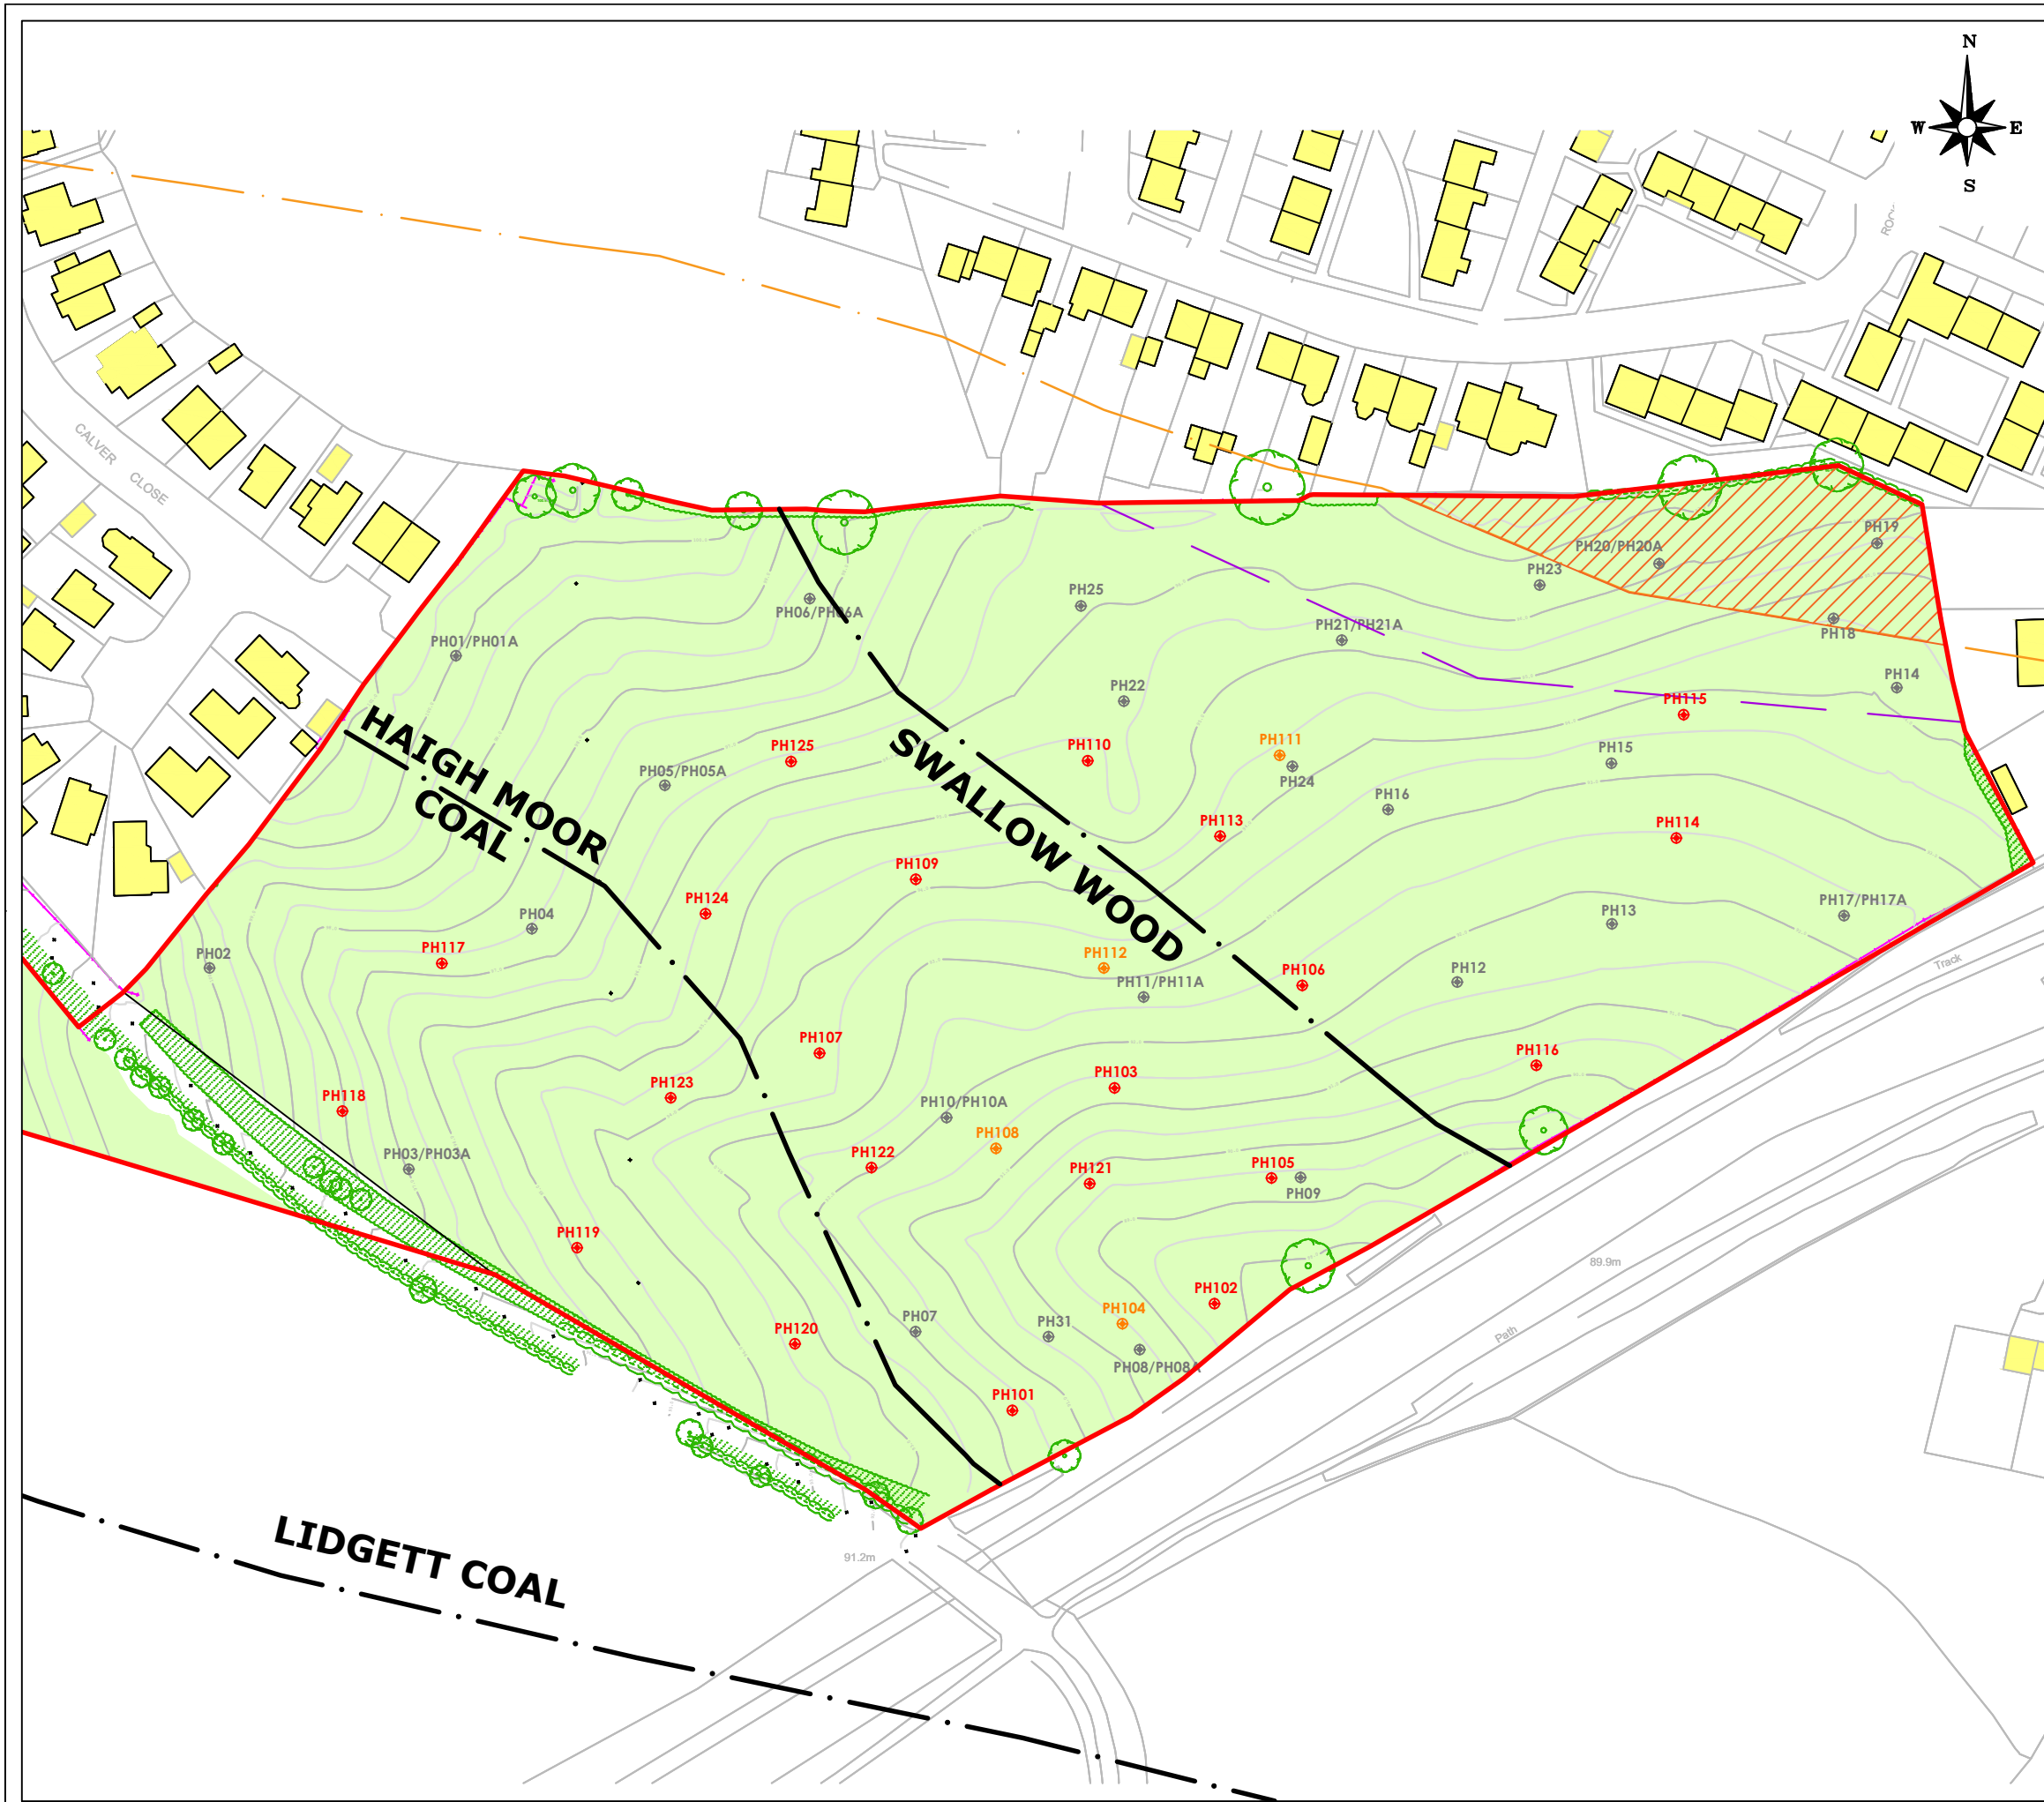
- PROBEHOLE LOCATION (JUN '20)
- PROBEHOLE LOCATION (MAR '21)
- PROBEHOLE WITH SPOT CORE LOCATION (MAR '21)
- GRASS & OVERGROWN AREAS
- BUILDING
- AREA OF SHALLOW WORKINGS IN FLOCKTON THICK SEAM (BASED ON ABANDONMENT PLAN)
- APPROXIMATE LINE OF COAL SEAM OUTCROP (BASED ON PH FINDINGS)
- APPROXIMATE LINE OF GEOLOGICAL FAULT (BASED ON ABANDONMENT PLAN)
- POSSIBLE ALTERNATIVE LINE OF GEOLOGICAL FAULT (BASED ON PH FINDINGS)
- APPROXIMATE SITE BOUNDARY

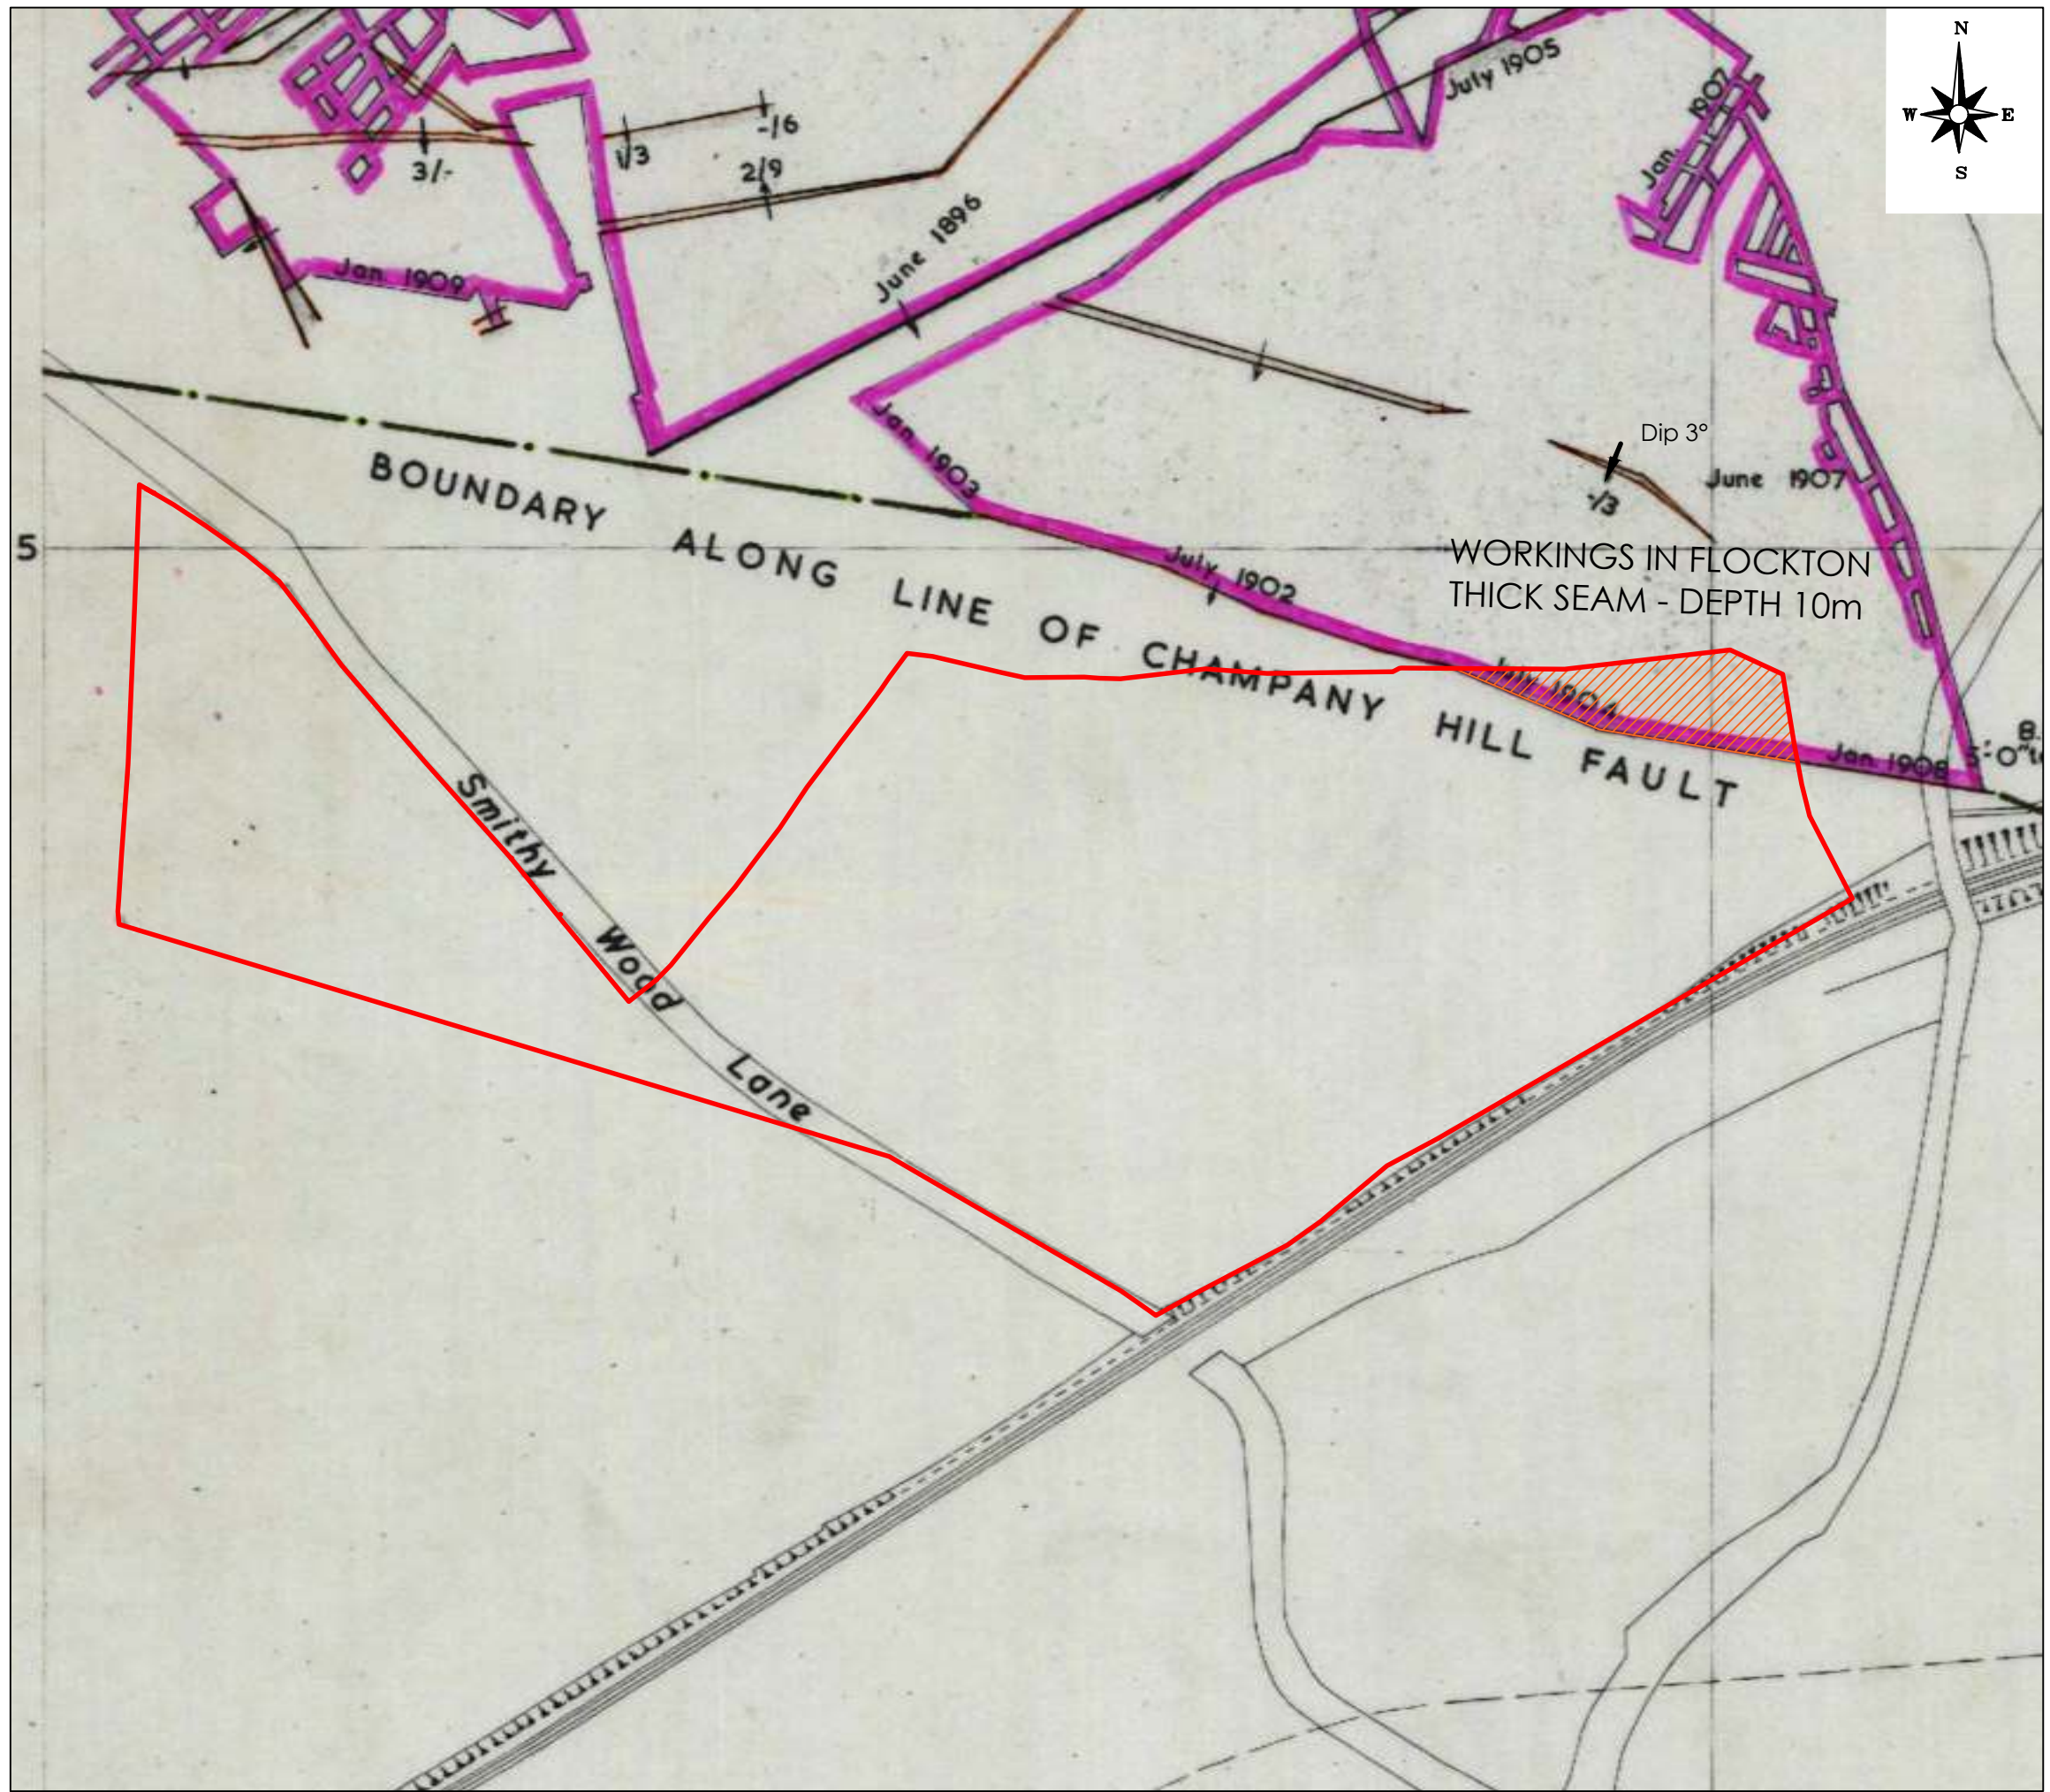
| SCALE | 1:1250 | SHEET | A3 | DRAWING NO. | 1979/108 | REVISION | A |

- APPROXIMATE SITE BOUNDARY
- AREA OF SHALLOW WORKINGS IN FLOCKTON THICK SEAM
