Arboricultural Impact Assessment to BS5837:2012

**207-208 Manchester Road,
Thurlstone,
Sheffield,
S36 9QS.**

10 February 2023

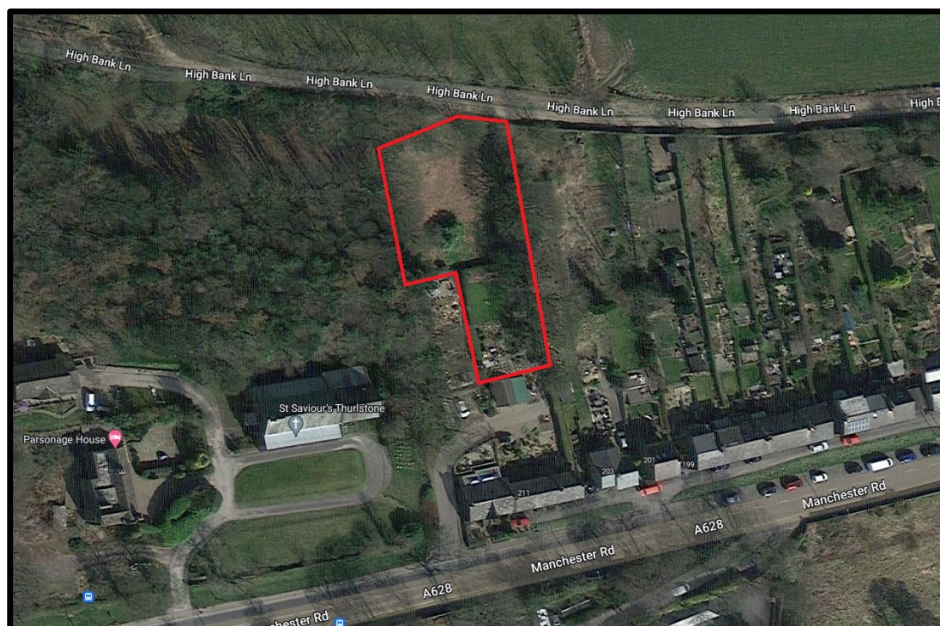
Figure 2: Aerial Image of Site (Google Earth) illustrating site boundary.

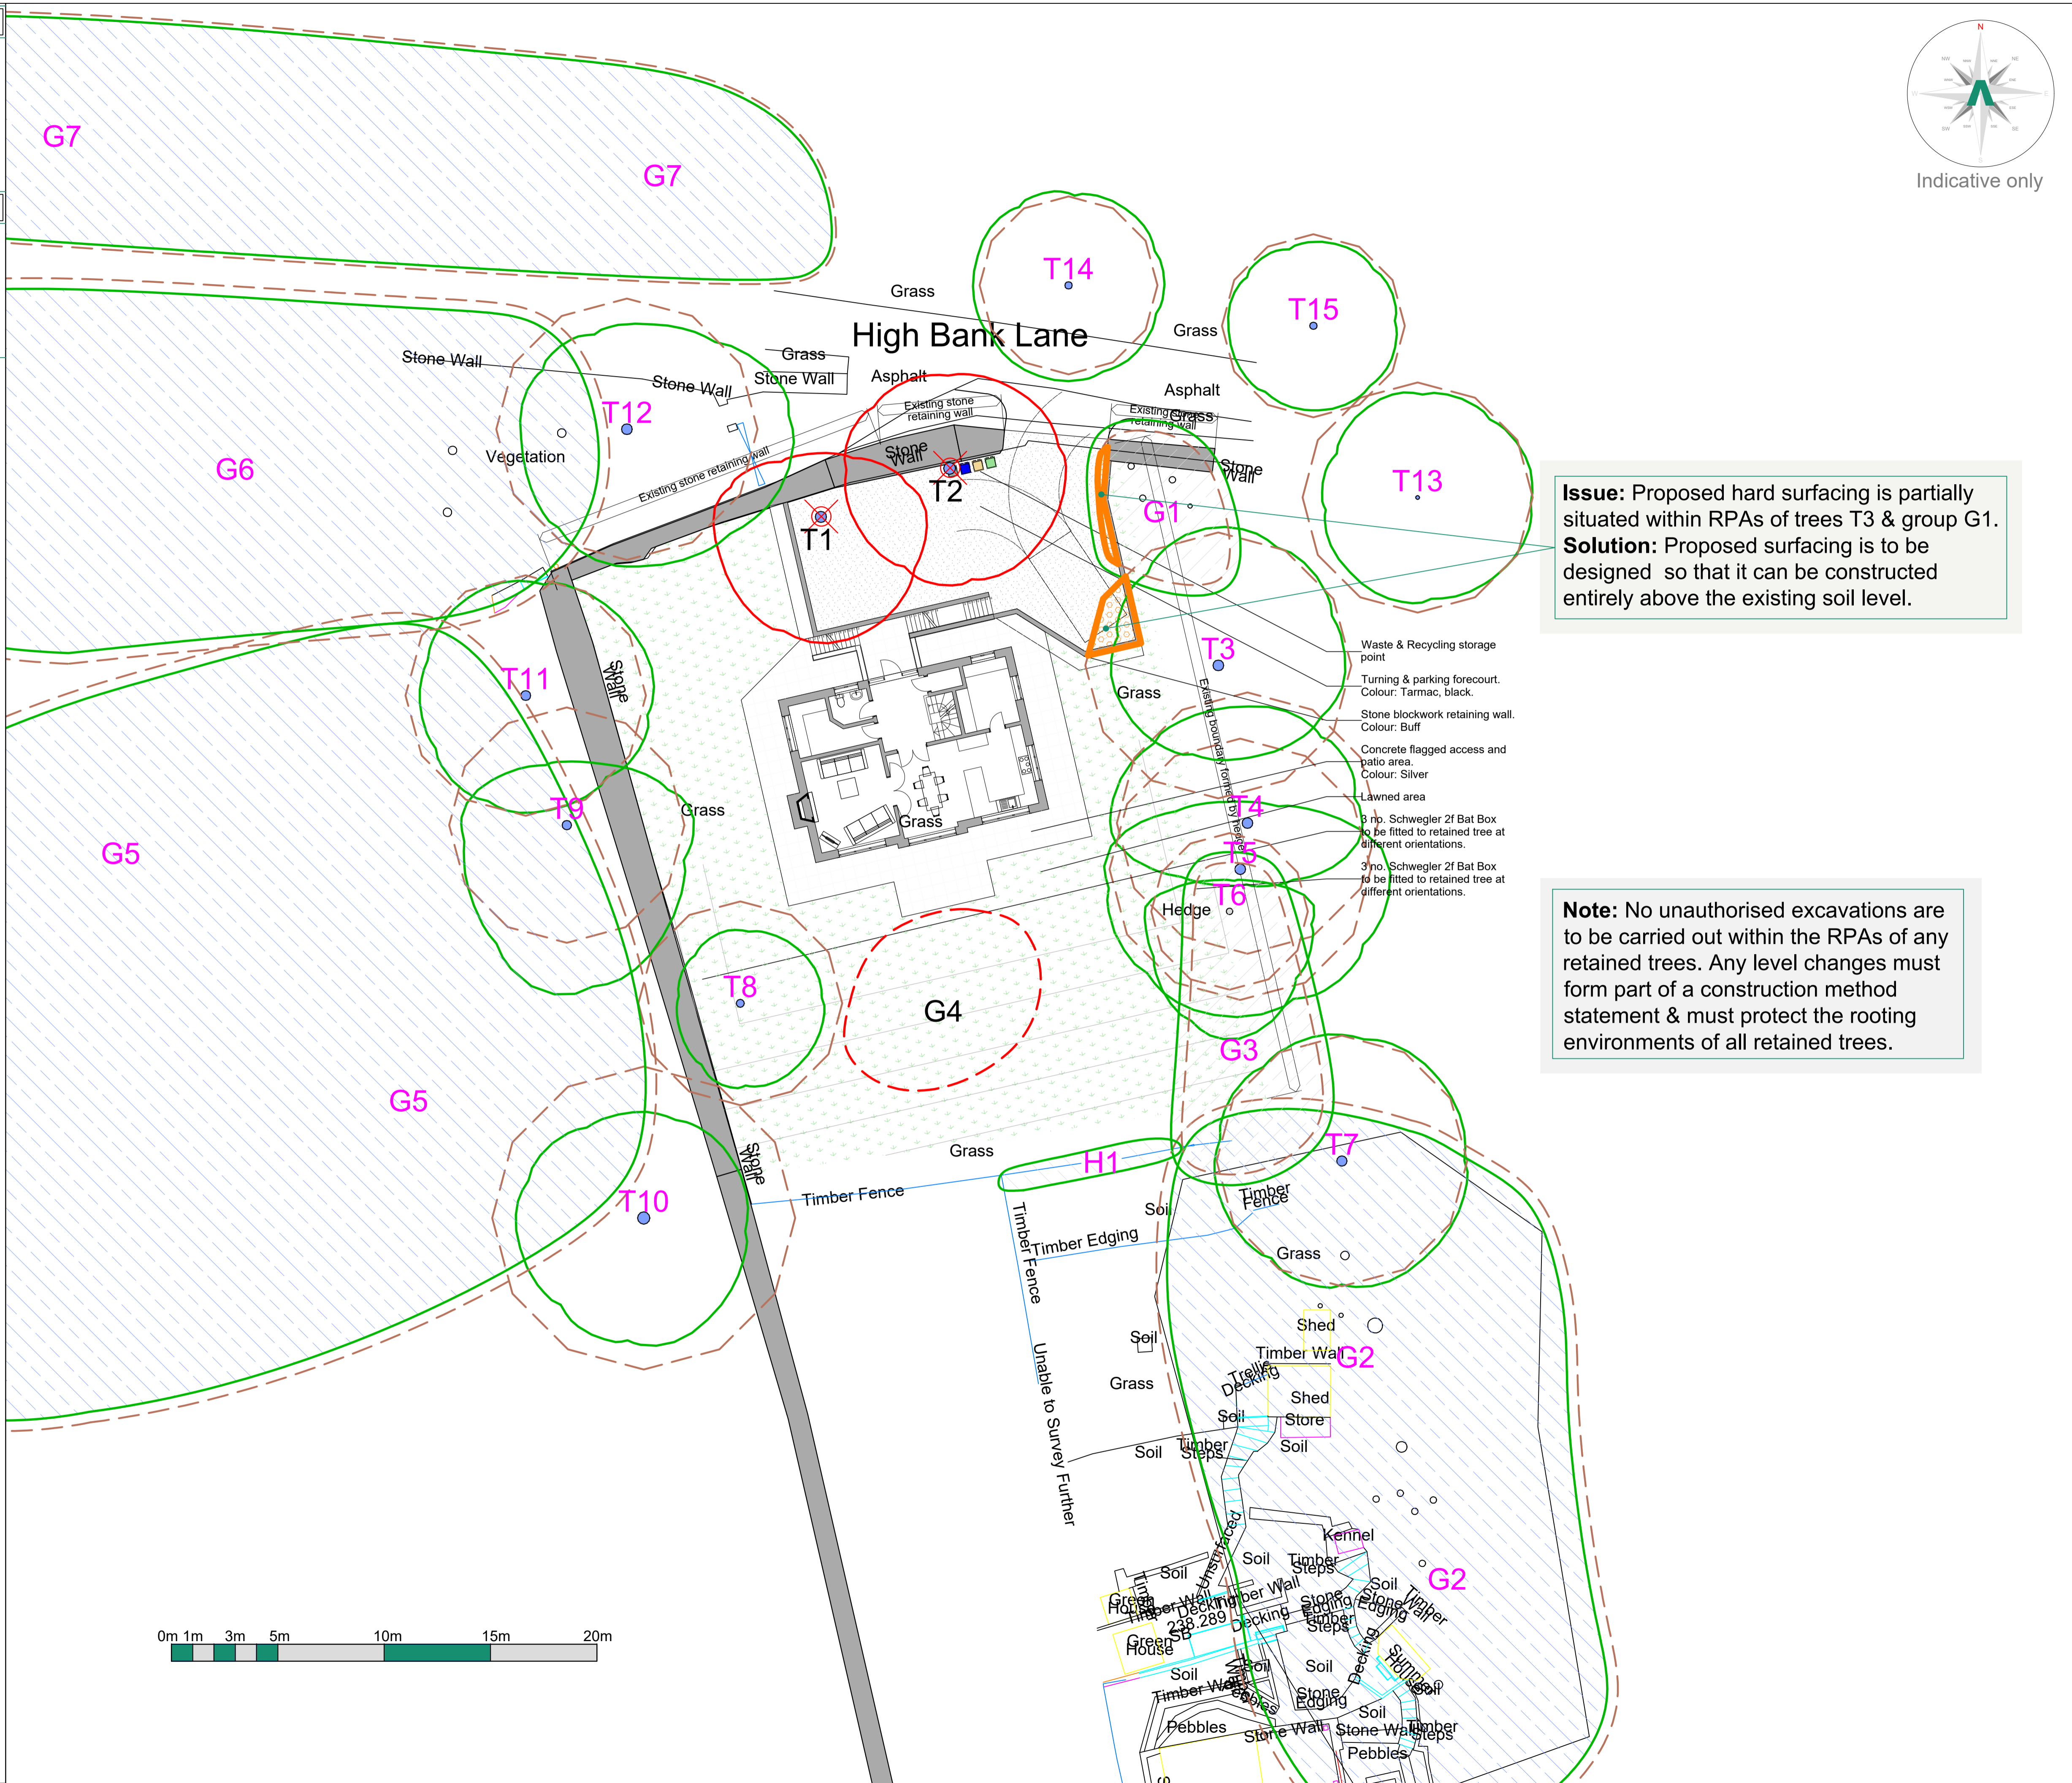
Arbtech AIA 01

Arboricultural Impacts			
Impacts	Nos. of trees		
Trees to be removed	2		
Groups / Hedges to be removed (Partial removal of groups)	1 (0)		
Trees with proposed incursions into RPA's	1		
Groups / Hedges with proposed incursions into RPA's	1		
Trees that will require pruning	0		
Groups / Hedges that will require pruning	1		
Trees to be transplanted	0		
Groups / Hedges to be transplanted	0

No.	Species	Proposed structure	Incursion
T1	Sycamore	Hard surfacing	RPA
G1	Various	Hard surfacing	RPA

Arboricultural Impact Assessment

These impacts can be seen on the Arboricultural Impact Assessment drawing number Arbtech AIA 01.

Tree Number	Species	Structure	Incursion
T3	Sycamore	Hard surfacing	RPA
G11	Various	Hard surfacing	RPA

It is proposed that the hard surfacing within the RPAs is to be constructed above the existing soil level.
