Arboricultural Method Statement to BS5837:2012

Premier Inn Hotels

**Premier Inn, Sheffield Barnsley (M1 J36),
Maple Road,
Tankersley,
Barnsley,
S75 3DL**

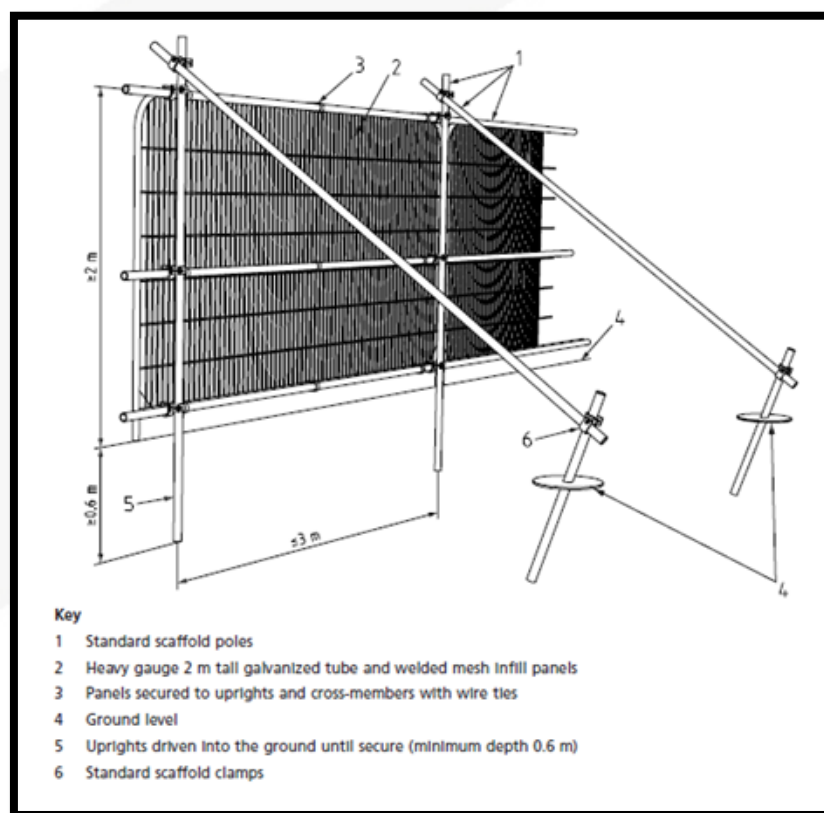
Default specification: To comprise either 2.4m wooden site hoarding; or a 2.3m high scaffold framework, well braced to resist impacts, with uprights to be spaced at a maximum of 3.0m intervals and driven into the ground by a minimum of 600mm. On to this, standard anti-climb welded mesh panels are to be securely fixed to each other with at least two scaffold clamps and to the scaffold frame work with wire.

Figure 2: BS5837:2012 - Figure 2, Default specification for protective barriers.

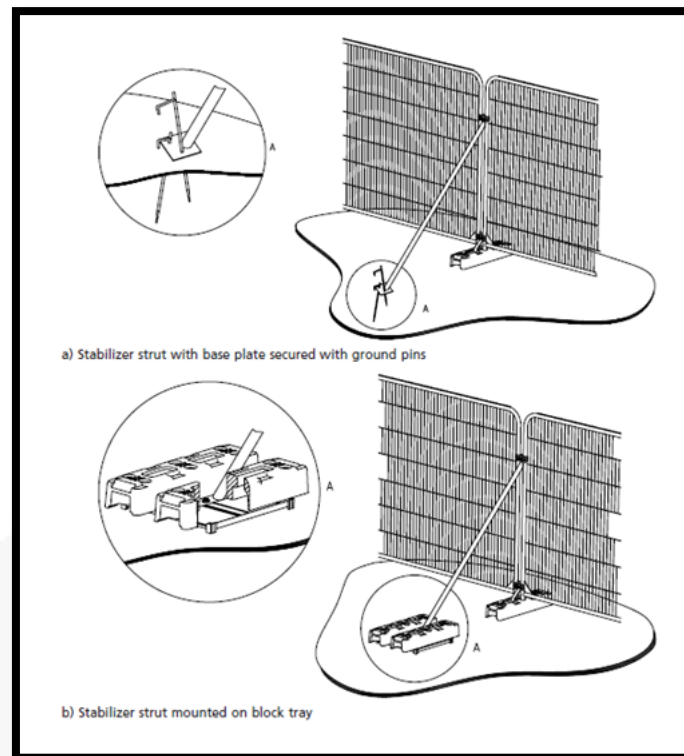
Secondary specification: To comprise of 2m tall welded mesh panels on rubber or concrete feet. Panels are to be joined together using a minimum of two anti-tamper couplers, installed so that they can only be removed from inside the fence. The panels should be supported on the inner side by stabiliser struts, which should be attached to a base plate and secured with ground pins.

Figure 3: BS5837:2012 - Figure 3, Examples of above-ground stabilising systems.

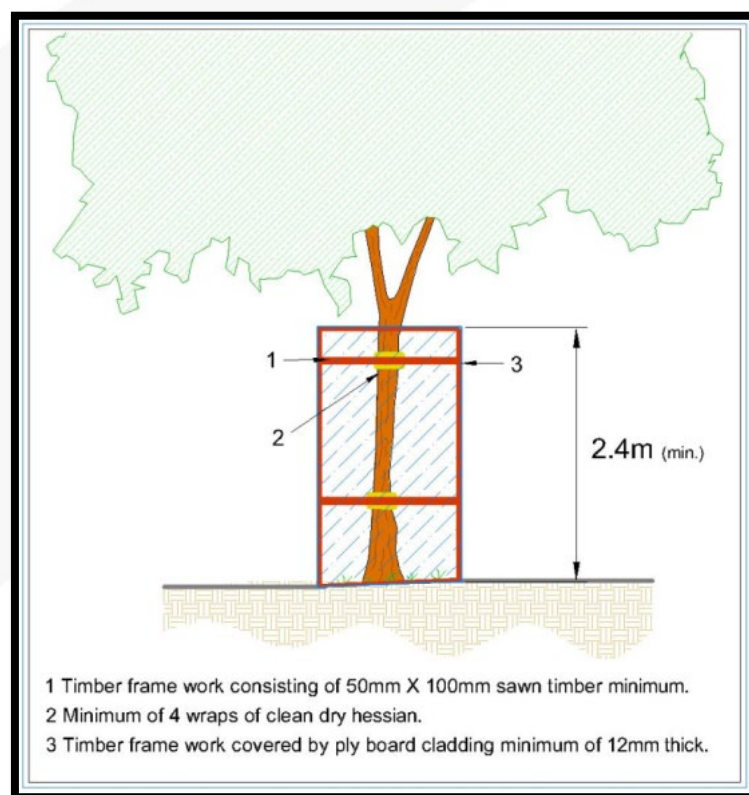
Protective barrier hoarding should be appropriate for the intensity and proximity of the development to protect trees where development activity is in close proximity. To comprise of 2.4m high wooden site hoarding constructed upon a timber framework situated around the outside of the planting pit. Where the timber frame is constructed around the tree trunk a minimum of four layers of clean dry hessian is to be wrapped around the trunk to protect the bark.

Figure 4: Example image of Protective barrier hoarding
