**WATERSLACK FARM, CAWTHORNE.**

**BAT SURVEY.**

**Ref No:- 121175.**

**Date: 7<sup>th</sup> December 2012.**

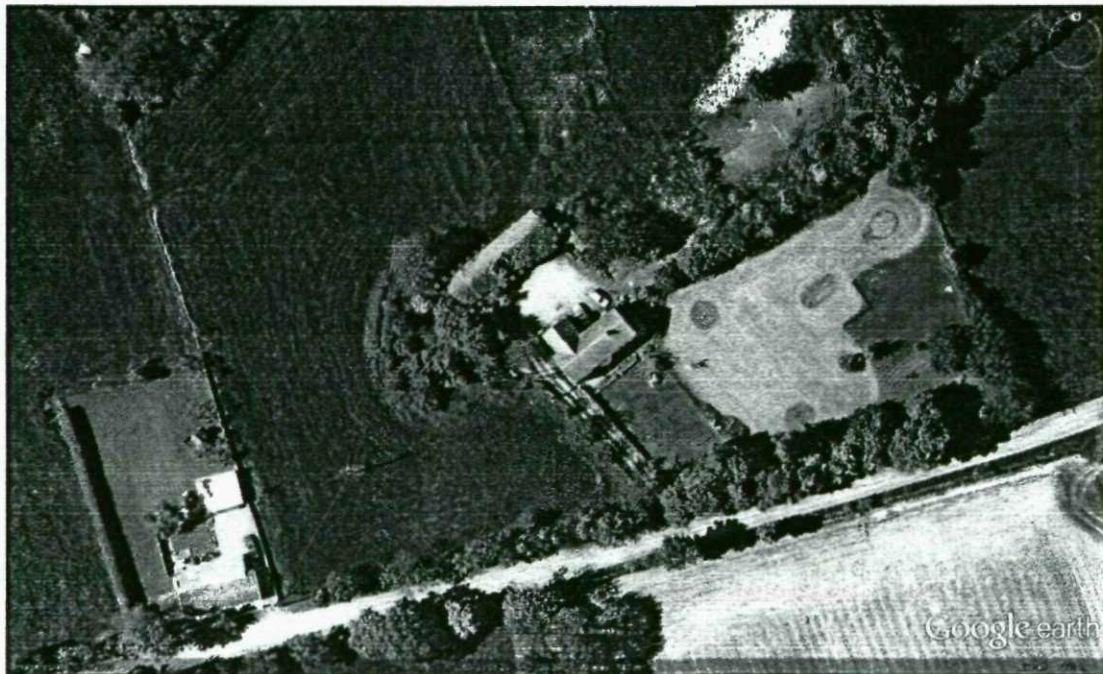
3.2.1. The surveyed area was a barn to the rear of Waterslack Farm in Cawthorne, as shown on the plan below.

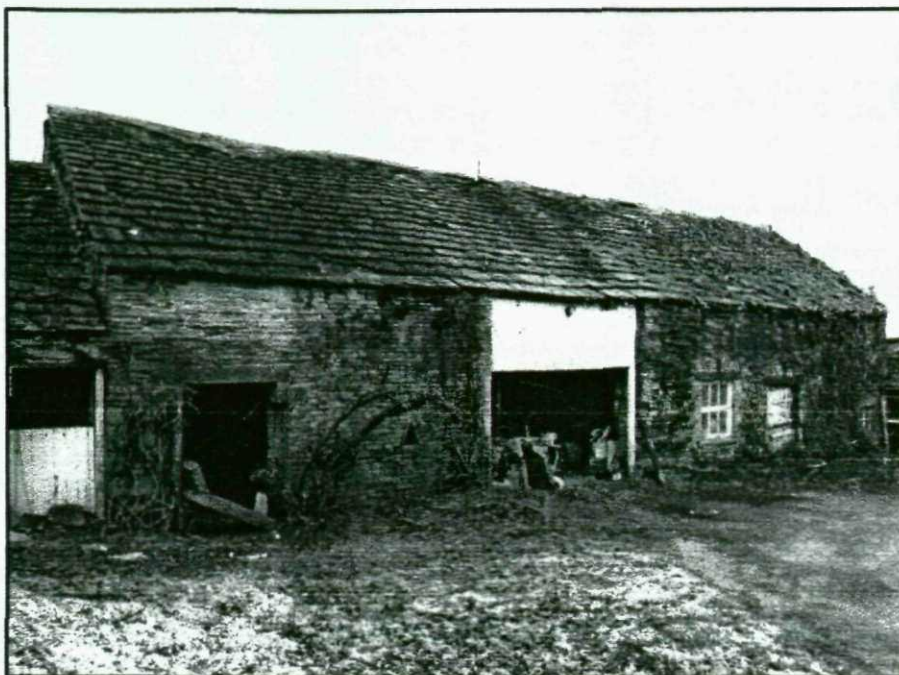
3.2.2. The barn is a single storey stone built barn that is located to the rear of Waterslack Farm and is used for general storage.

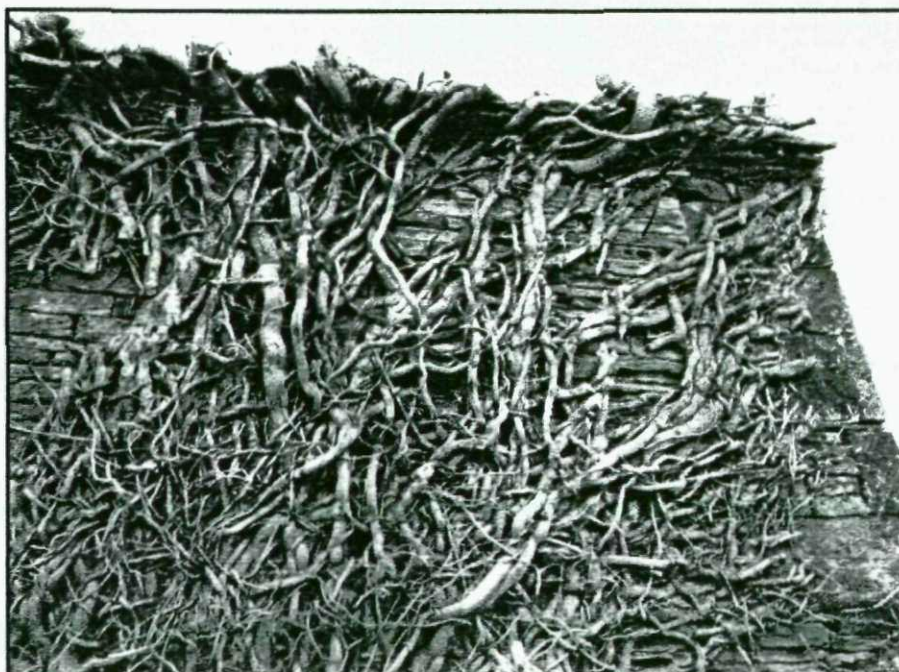
3.2.3. The walls of the building are rubble filled stone walls. There are several windows and doors around the building with the majority of the doors being open. There are also open window voids in both gable ends of the building.

3.2.4. The western end of the building displays ivy trunks where a large amount of ivy has recently been partially removed from the building.

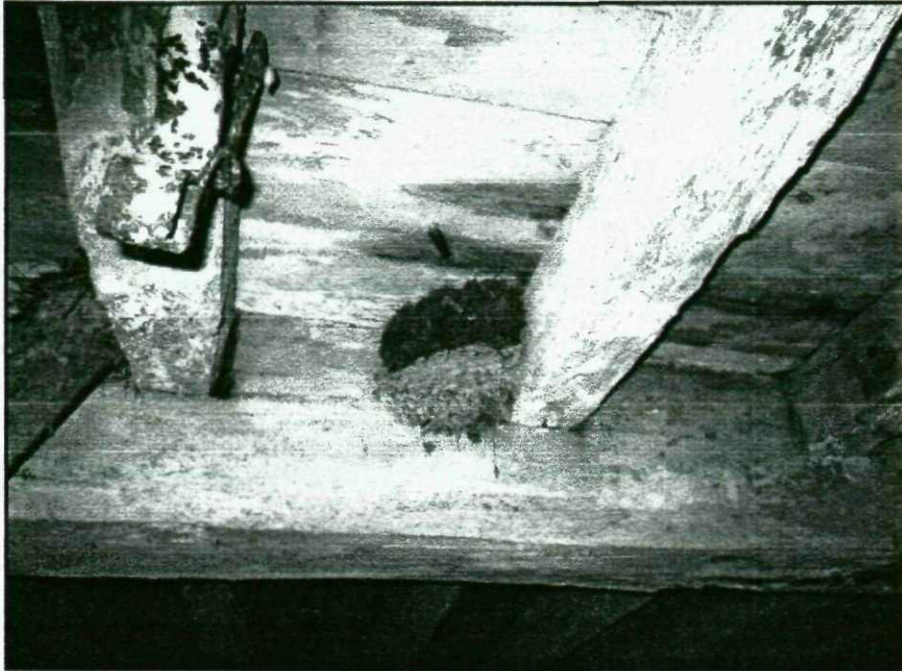
3.3.12. A large number of bird nests were also identified throughout the interior of the building. The nests were assessed as swallow and several other small bird nests with some of the nests displaying quite fresh materials implying use during the previous nesting season.

4.8. Several bird nests were also identified throughout the interior of the building. None of the nests were in use at the time of this survey because the survey was carried out outside the nesting season, which extends from March to September each year.

4.10. The conversion of the building will also potentially remove suitable nesting habitat for bird species such as swallows, which will have an impact on the species.

5.3. It is recommended that any conversion works to the building are carried out outside the nesting season, which extends from March to September each year, or that measures are put in place to prevent birds from nesting in the building prior to the conversion taking place. These measures should be put in place in the winter months.

5.4. It is also recommended that additional swallow nesting opportunities are designed into the converted building to replace the habitat lost during the conversion.
