PLEASE FIND ENCLOSED A RECENT  
BAY SURVEY FOR PENNINE COTTAGE,  
HAZLEHEAD, CROW EDGE, S36 4HJ.

## **Workshop, Pennine Cottage Hazlehead**

### **Bat Survey**

April 2011.

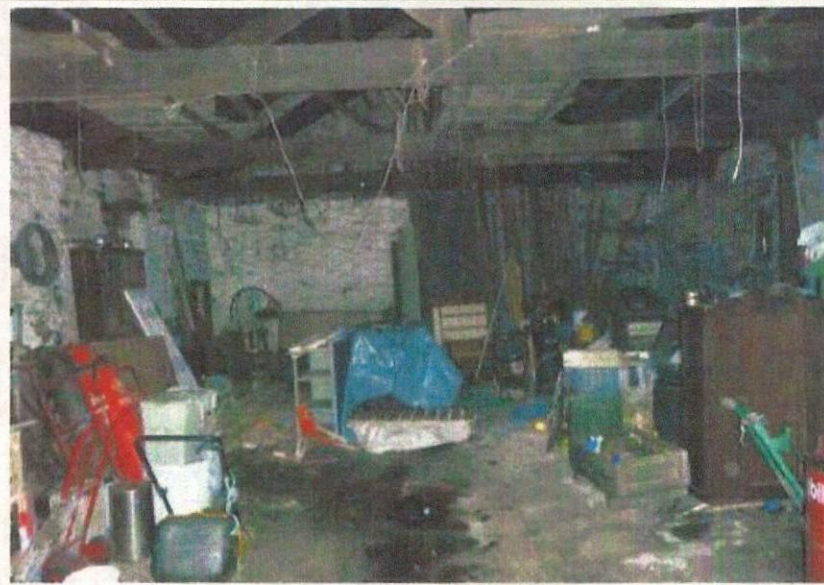
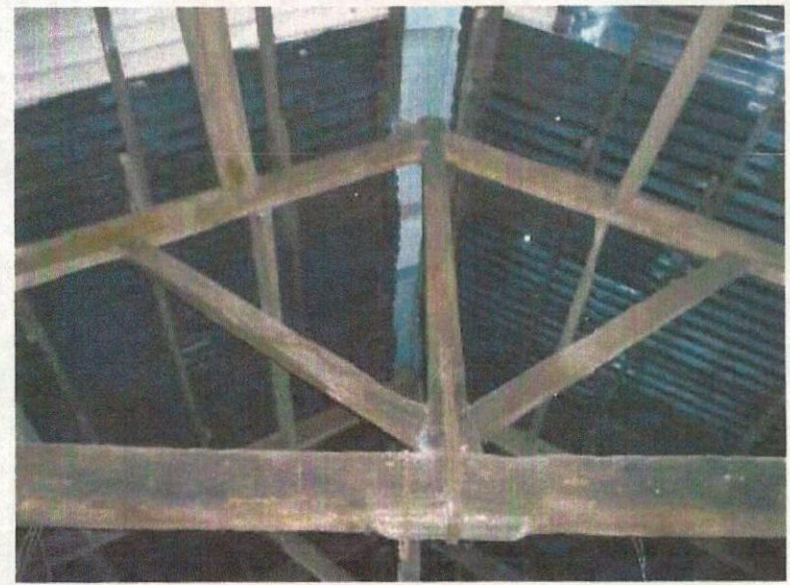
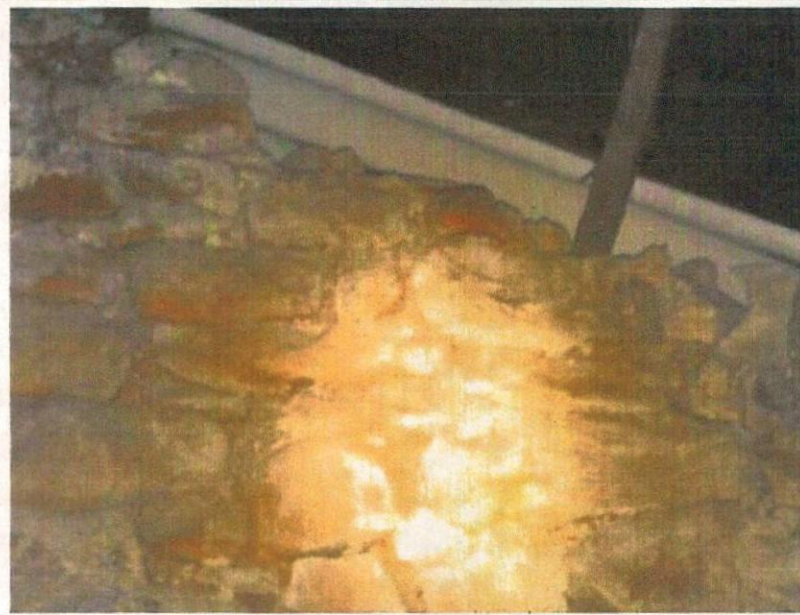
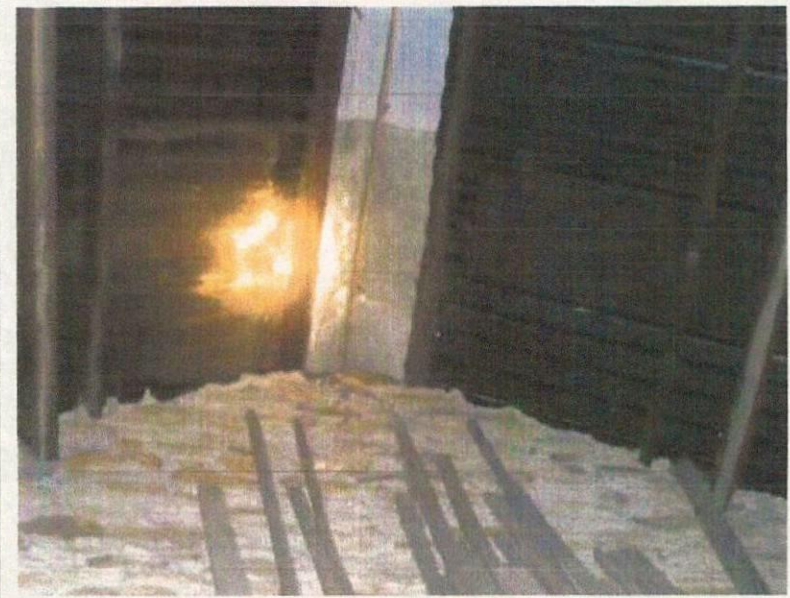
FIG 2

- 7.5 Internally the building was fully open to the underside of the roof. The roof was supported on four timber trusses, two of which were reinforced with steelwork supports. The trusses were sawn timber with no socket holes or mortise joints that might be attractive to bats.

- 7.6 The internal gable walls finished short of the roof sheets leaving large openings along the inside of the verge. These generally appeared too large to be likely to be attractive to bats. The ridge area was open and there was no enclosed ridge tunnel feature normally found in traditional roof construction and which provide the favoured locations for roosting bats. The building itself contained numerous surfaces, plastic covered storage, timber boarding etc. There were no signs of any urine spotting, bat droppings or discarded insect remains to suggest any use by bats. Internally these signs would be expected to persist for many years in the absence of weathering. Internal views are shown in Fig 2.
