## Saunderson Road - Bat Roost Report

Living Ecosystems was commissioned by Nicol Thomas Ltd Architects in January 2013 to assess a former mortuary building at Stottercliffe cemetery in Penistone for its potential as a bat roosting site.

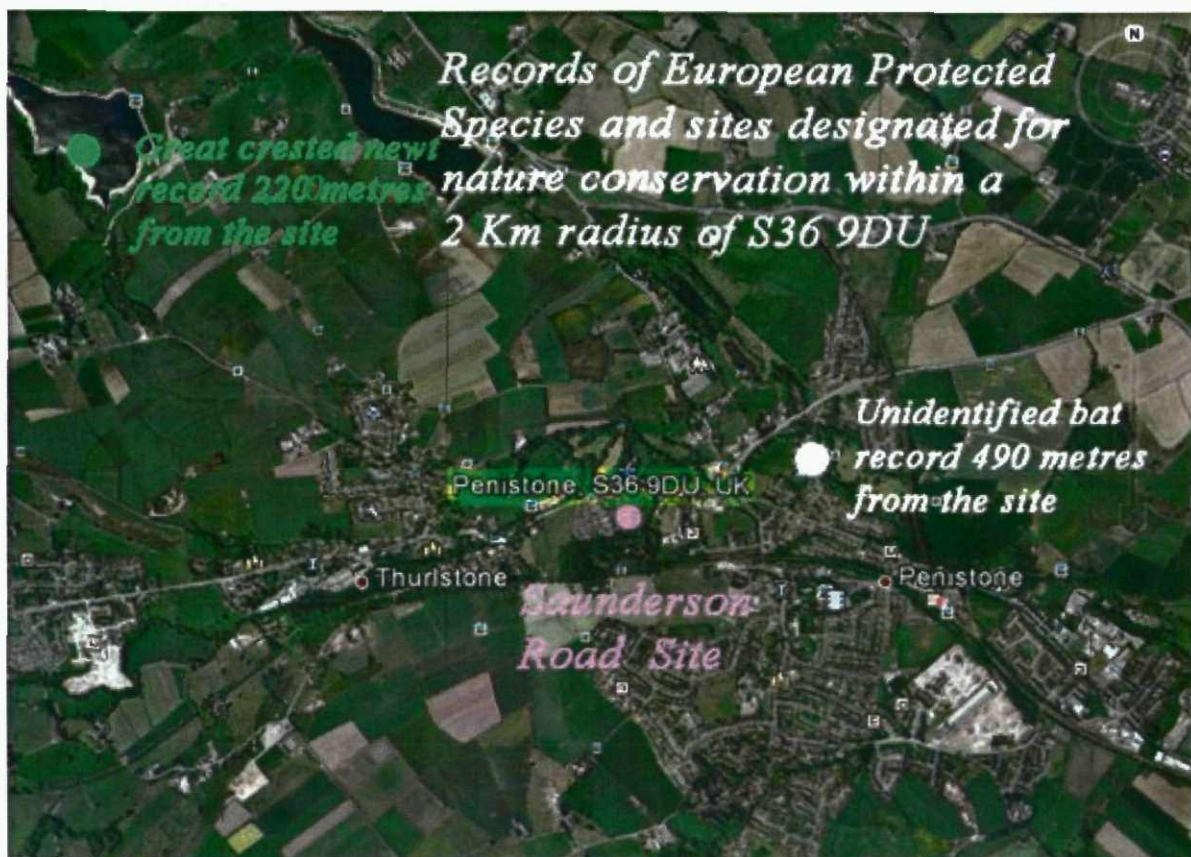
Two relevant local records for protected species were found. There is a record of great crested newts at Royd Moor Reservoir 2.220 metres to the north-west of the Saunderson Road site; and there is also a single record of an unidentified bat 490 metres to the east of the Saunderson Road site [See aerial photograph below].

There was a single local relevant record of an unidentified bat 490 metres to the east of the Saunderson Road site [See aerial photograph above in section 2.1].

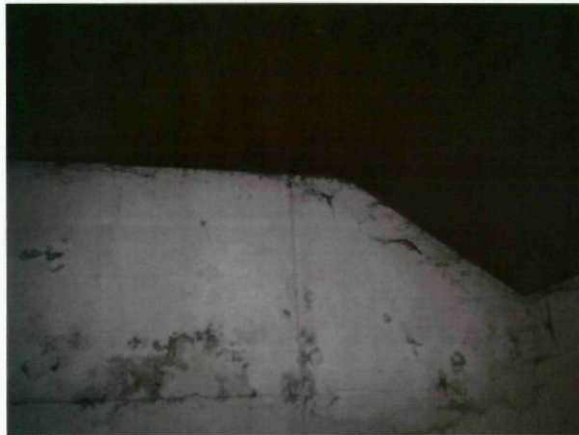
There was no evidence of bat presence or roosts seen during the inspection, ie droppings, carcasses, urine staining, etc. The larger roof void could be seen through a hole in the ceiling however the smaller roof void was not fully visible and therefore could not be inspected.

**View of the interior of the loft**

species and numbers present, it is impossible to make an informed assessment of any impacts resulting from the proposals. Additional surveys would therefore be required to definitively identify the presence of a bats/bat roost. The building itself has features which indicate a high likelihood that bats may be present and the surrounding habitat is of good quality and therefore of value to bats. As the site is relatively small (less than 1 ha) BCT guidelines recommended one transect survey on 3 visits during March to September, the optimum period being June to August. One of the surveys should consist of an emergence and re-entry survey within a 24 hour period. An automated survey is recommended in one location for 3 consecutive nights on 3 occasions during March to September.

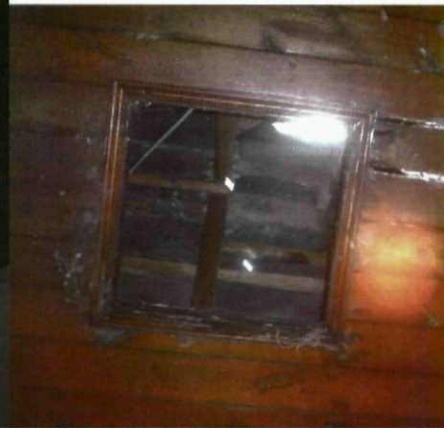
The main constraint however was that there was limited safe access to the roof void. As a result of this the roof void could not be adequately inspected. Additional surveys would be needed to definitively identify the presence of a bats/bat roost. Without more information regarding the presence/absence of bats, including the species and numbers present, it is impossible to make an informed assessment of any impacts resulting from the proposals.

**View from the loft into the roof Void which could not be properly inspected**

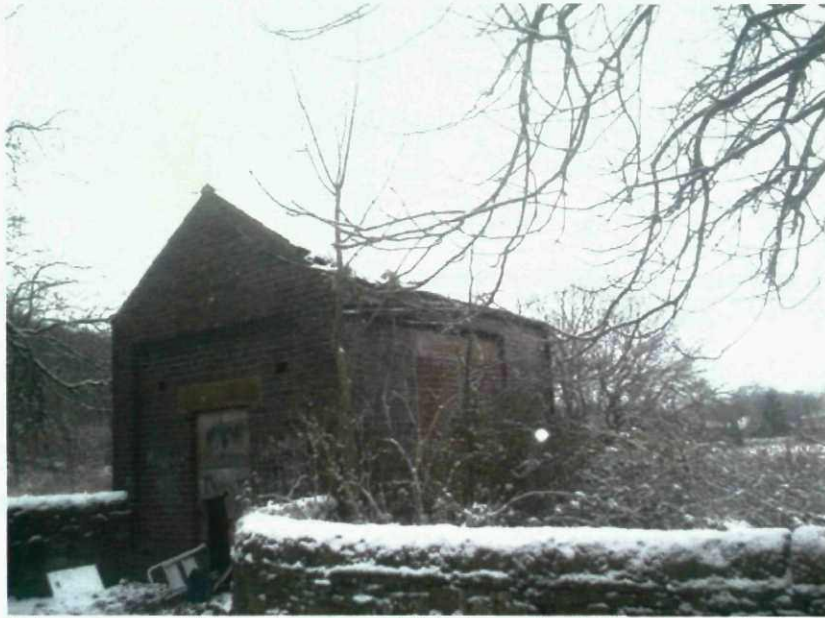
The building itself is an approximately early 20<sup>th</sup> century, solid brick structure with a slate roof and some roof insulation was noted through holes in the ceiling. There were some crevices and potential access points noted in the south east facing brickwork just below the roof (See photographs). Due to the snow covering the roof it was unknown whether there were sufficient gaps in the slate roof. There is known to be a low level of human disturbance as the building had been boarded

up and reportedly not used for the past 30 years. Due to these features there is a high likelihood that bats would be present at some point during their annual cycle.

**Structure with bat potential [above] at the Saunderson Road site.**

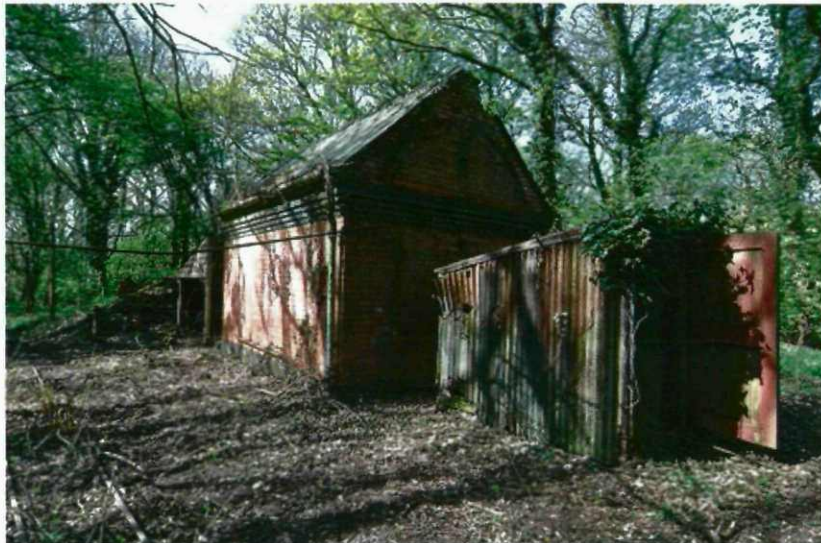
**A very similar Structure [above] in woodland near Wigan contained a colony of brown long eared bats when surveyed in 2010.**
