**THE BUNGALOW, SHEFFIELD ROAD,  
OXSPRING.**

**BAT SURVEY REPORT.**

**Ref No: 230815/1**

**Date: 1<sup>st</sup> September 2023.**

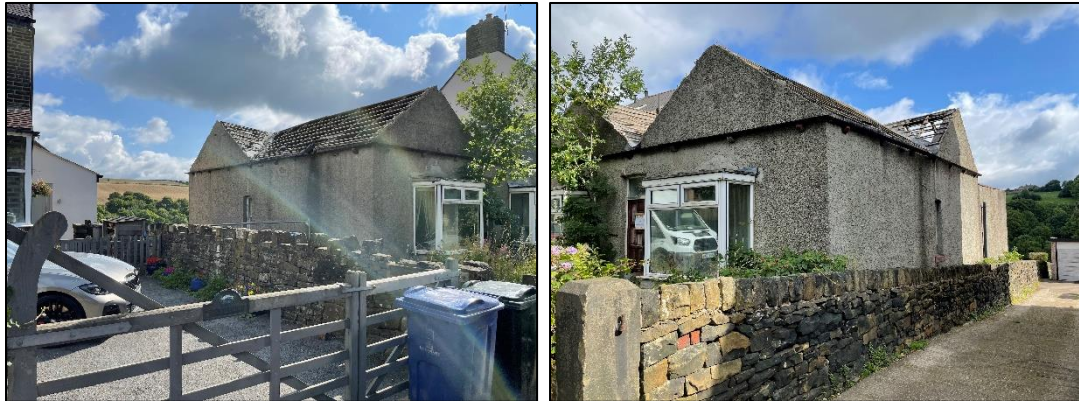
3.2.3. The two photographs below show the bungalow as seen from the main road.

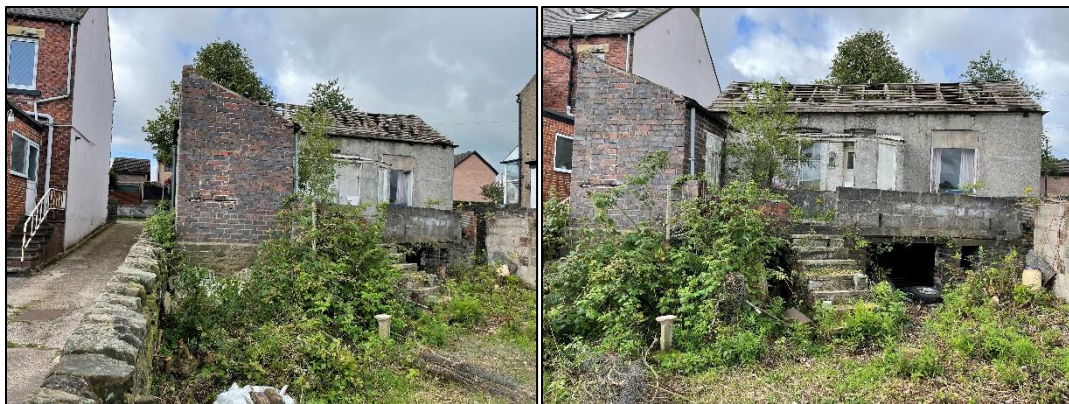
3.2.4. The two photographs below show the rear of the bungalow facing the garden.

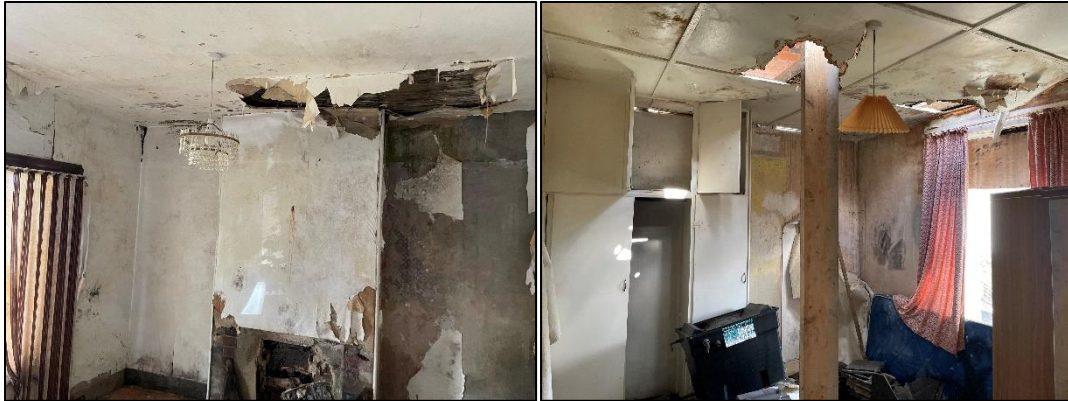
3.3.2. The roof of the bungalow is in a very poor condition with missing slates and torn underfelt. This has allowed water penetration throughout the internal of the bungalow resulting in patches of ceiling fallen in, as shown below. Everything internal is running in water.

3.3.3. Because the property is so badly exposed to the weather, the roof has gone but the walls are remarkably sound, the building is assessed to have negligible potential for roosting bats in line with the Bat Conservation Trust Good Practice Guidelines.

5.1. The existing bungalow is in a very poor condition and is assessed to have negligible potential for roosting bats. Therefore, no further surveys are recommended and there is no requirement for a mitigation strategy or for a Natural England licence in connection with the proposed demolition.

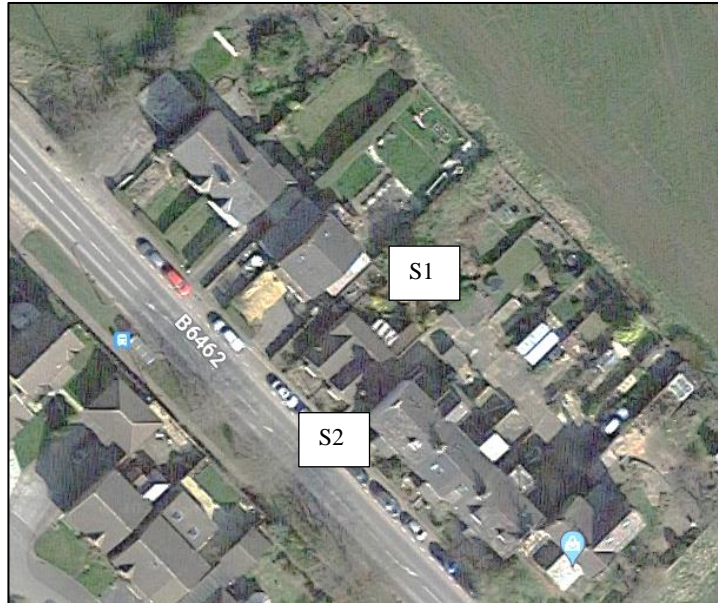
3.4.3. The position of the surveyors and the static Anabats are shown on the aerial photograph below where S is a surveyor.
