**Site:** Cheesebottom Sewage  
Treatment Works

**Survey:** Ecological Impact Assessment  
Report

**Client:** Yorkshire Water

Reference: 150\_23\_RE01  
Date Submitted: 22<sup>nd</sup> May 2024  
Version: V1

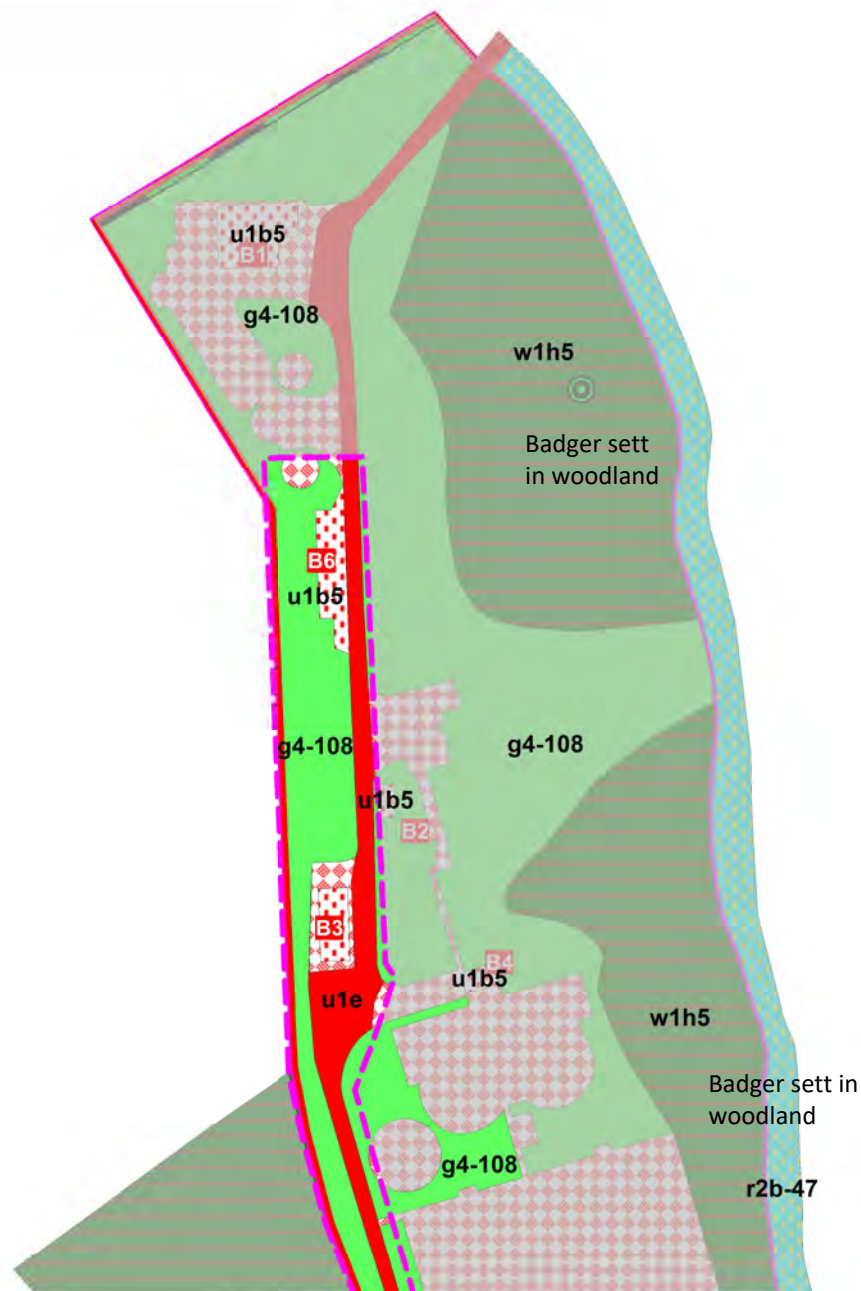
- 4.2.1 Habitats found during the UK Habitat Classification Survey are shown on Figure 2. All are common habitats found across the UK, with no rare flora or communities recorded during the survey. Table 4 below details the habitats found on the site and consideration of the faunal groups/species that could be present.

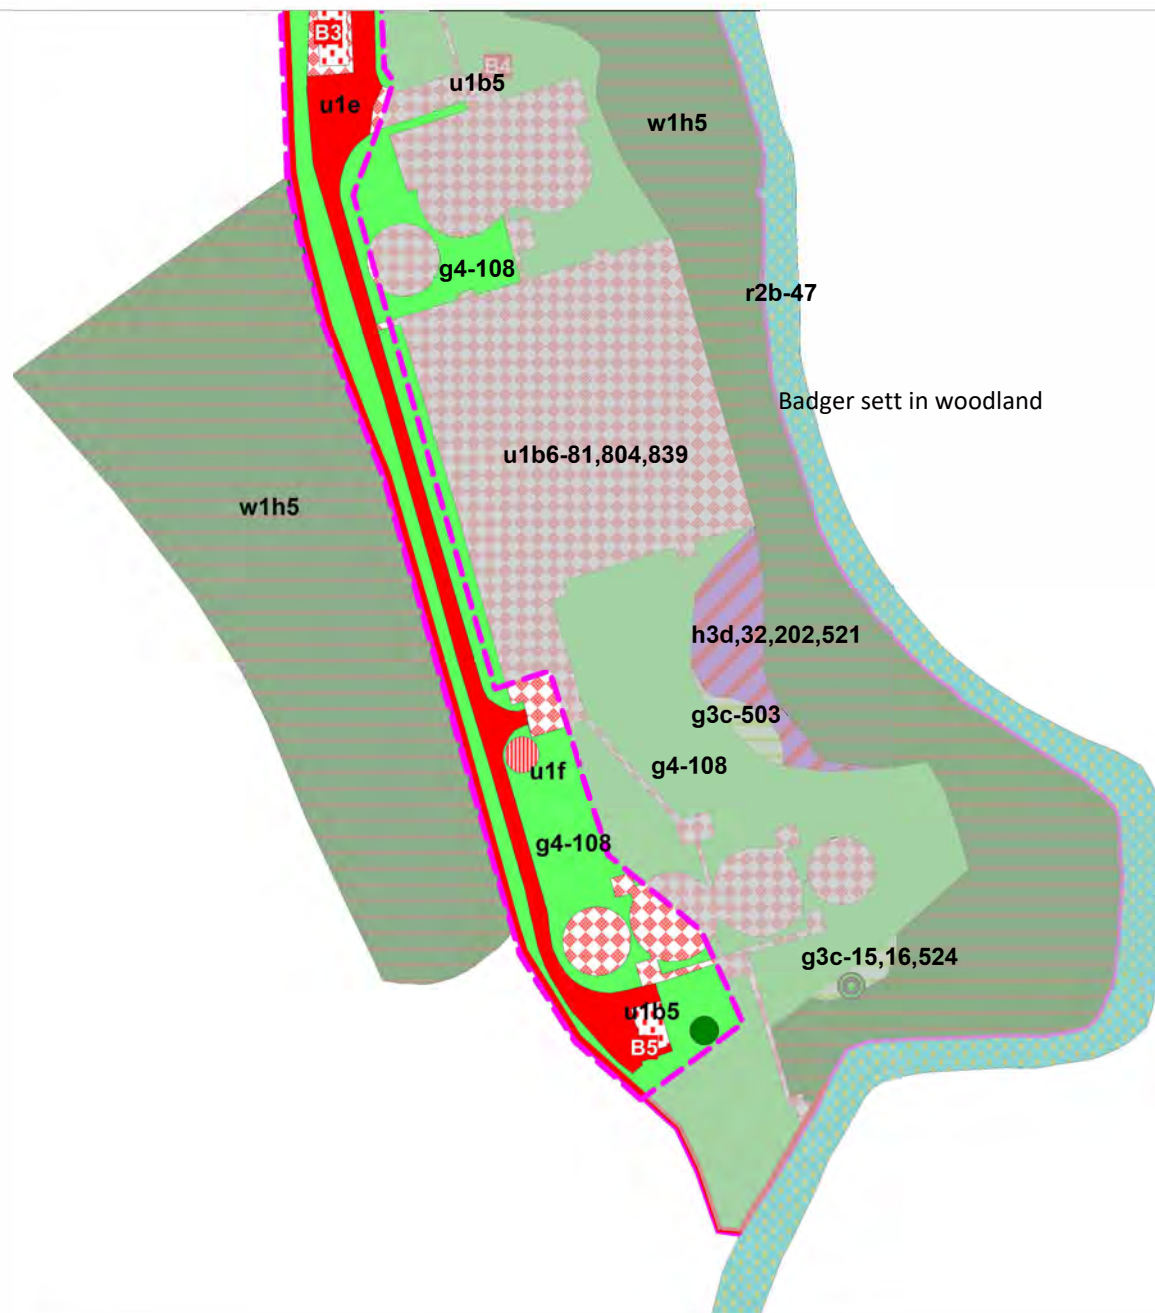
### Legend

- Site boundary
- Works area
- w1h5 - Mixed woodland, mainly broadleaved
- g4 - Modified grassland
- r2b - River
- h3d - Scrub
- u1e - Built linear features
- Buildings
- u1b6 - Other developed land
- g3c - Neutral grassland
- u1f - Sparsely vegetated urban land
- Line of trees
- Fence
- Semi-mature oak
- Himalayan balsam

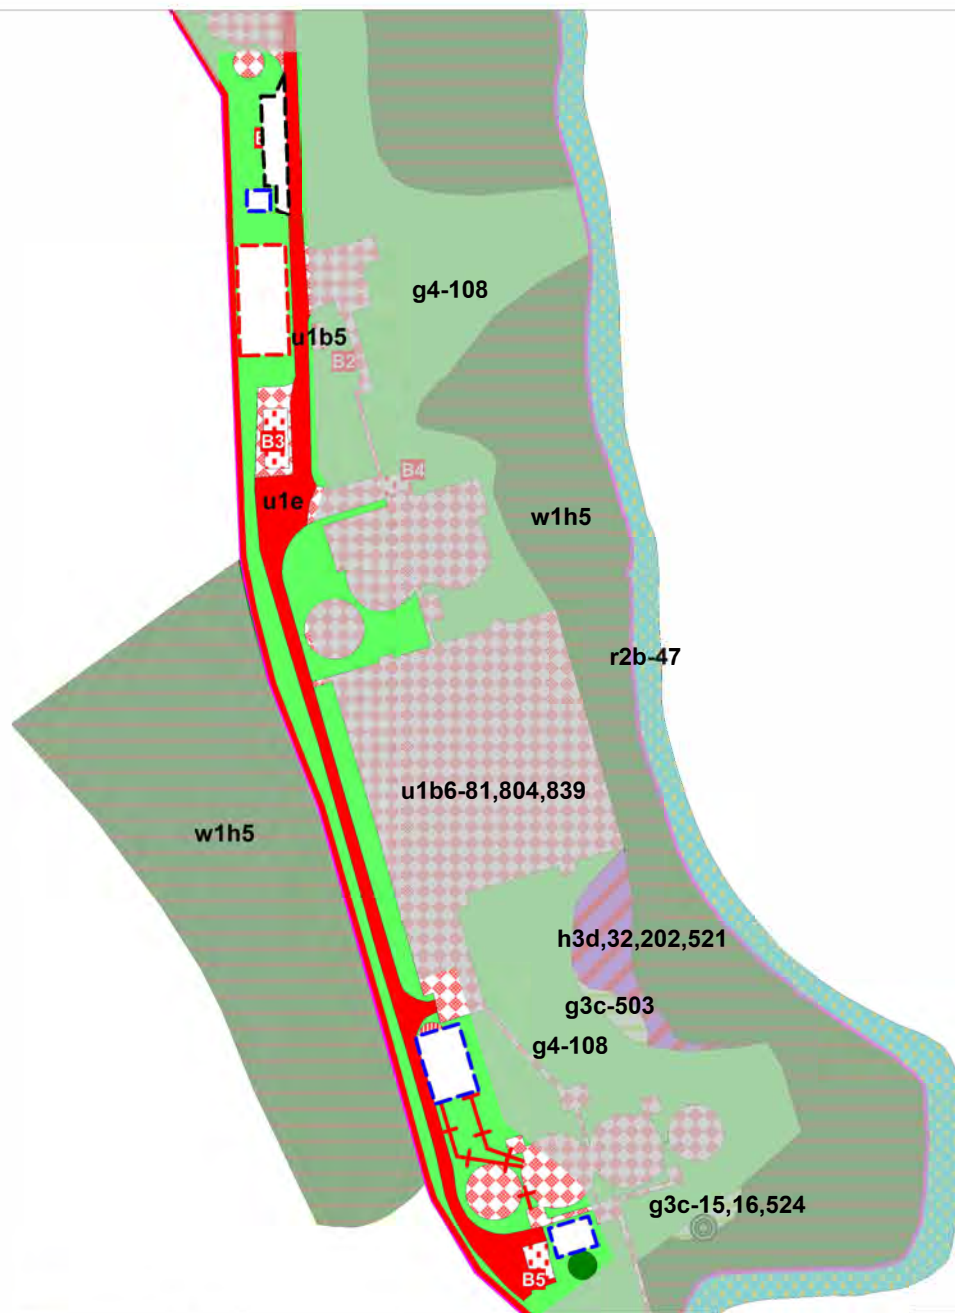
- 5.1.1 The development footprint will cover less than 0.21ha of the 5.95ha site; and it is expected that 0.12ha of this footprint will be returned to its pre-development state once completed (works locations are mapped on figure 4). The impacts and recommendations are based on the development design at the time of writing; if the size, location or nature of the development changes, the impacts and recommendations should be reassessed.
