**ARBORICULTURAL IMPACT ASSESSMENT  
to BS 5837:2012**

**Land off Lidgett Lane  
Pilley  
Barnsley  
South Yorkshire  
S75 3AG**

Barratt & David Wilson Homes  
Yorkshire West

**JCA Ref:**

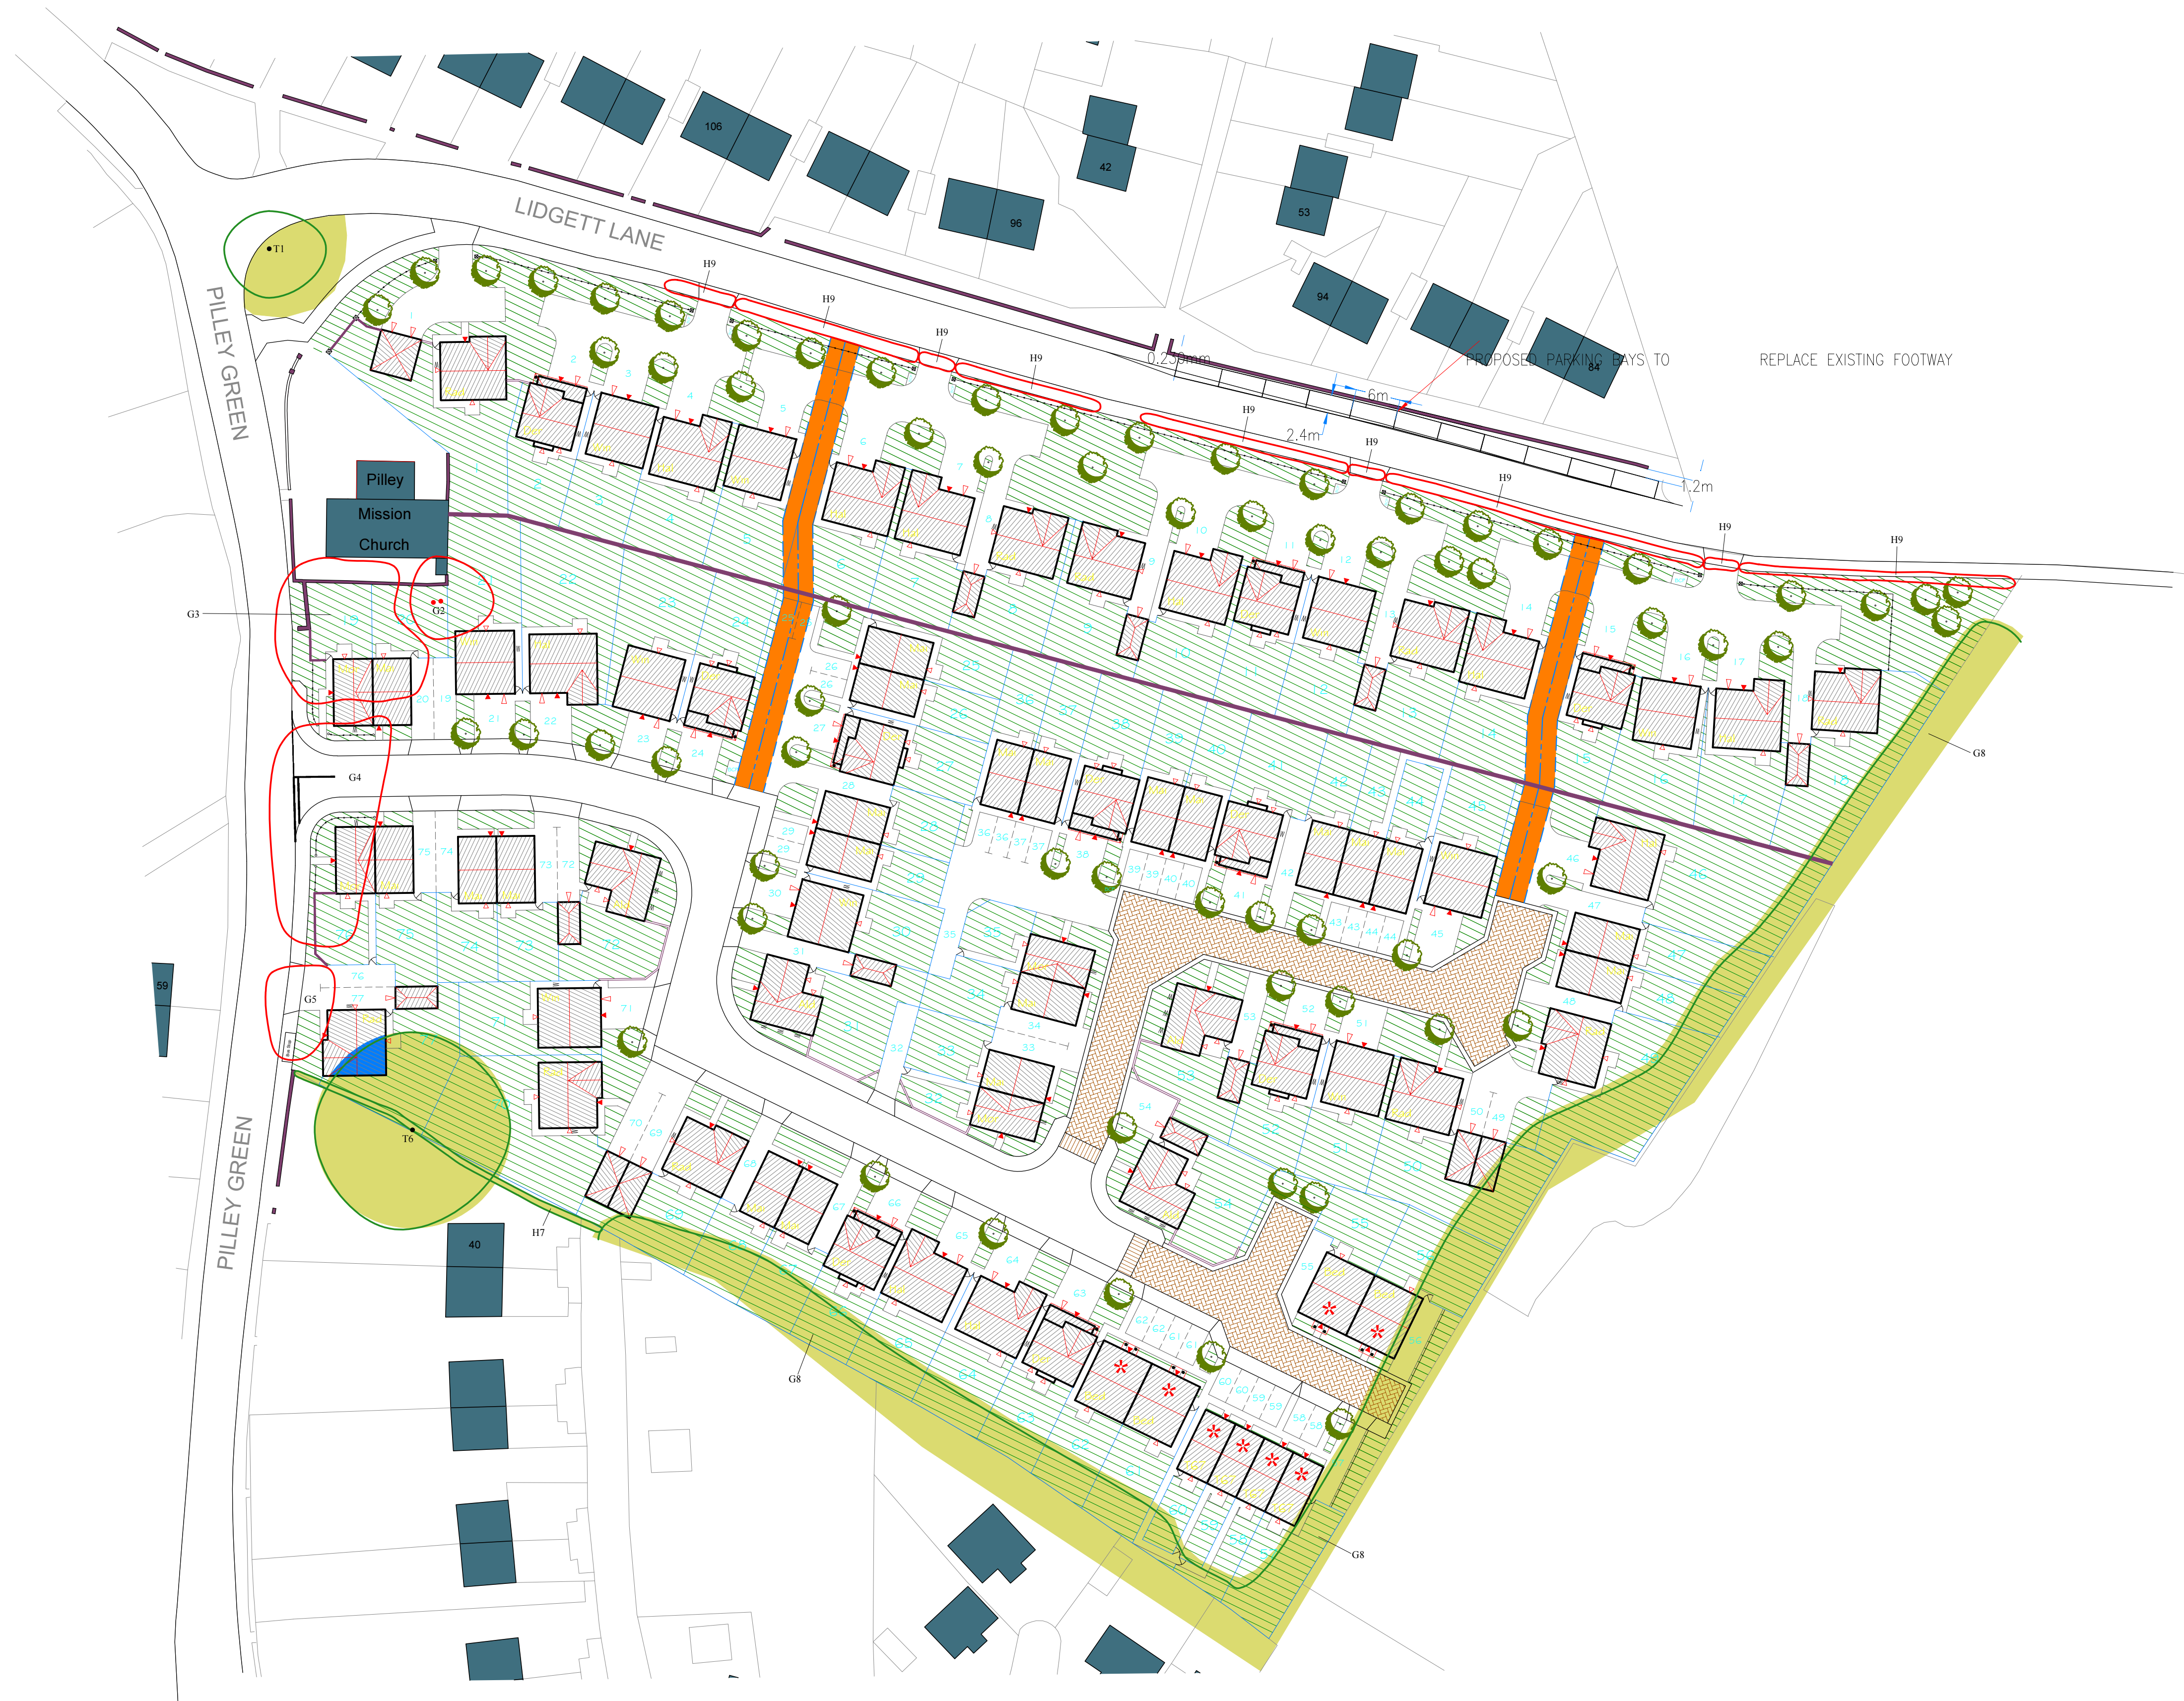
**Appendix 7: Arboricultural Implications Plan**  
**ADDRESS:** Land off Lidgett Lane, Pilley, Barnsley, South Yorkshire, S75 3AG.  
**JCA REF:** 14254a/ChC

- 3.4.1.3 Where work is required within the RPA of a tree which is to be retained, specialist measures must be adopted during the construction phase to avoid ground compaction and minimise root damage. Such areas are highlighted in blue on the Arboricultural Implications Plan at **Appendix 7**.

- 1.3.1 This report is compiled in accordance with *BS 5837:2012 'Trees in relation to design, demolition and construction – Recommendations'* and is based on an objective assessment of the existing vegetation.
- 1.3.2 The specific design of the proposed development has been considered within the Arboricultural Implication Assessment in **Section 3** and is detailed on the Arboricultural Implications Plan at **Appendix 7**.

- 4.3 The arboricultural implications of the development have been considered and are discussed in **Section 3**.
- 4.4 Some trees require removal or pruning works in order to facilitate the proposed development. These works are included at **Appendix 1** in *italics*. These are also discussed in **Section 3.2** and their locations are shown on the Arboricultural Implications Plan at **Appendix 7**.
