Bolton upon Dearne Railway Station. Ecological Scoping Survey.

Report Prepared By;	Date
Chris Needham BSc. (Hons) MSc. MIEEM	May 2008

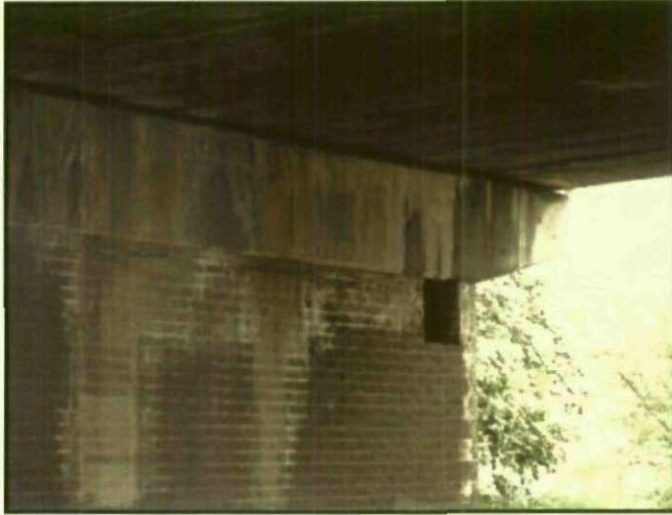
The structure of the bridge is made of concrete and brick and is well maintained. However, as part of the design of the bridge there are gaps within the bridge structure (refer to Appendix A, Photograph 1.). For this reason the bridge was assessed as having moderate potential for bats.

Photograph 1.
Gaps within the bridge that may be suitable for roosting bats.

A bat survey is recommended.

A bat survey can be carried out at dusk from the railway station platforms.

Possession of the line or surveying from the lineside is not required.

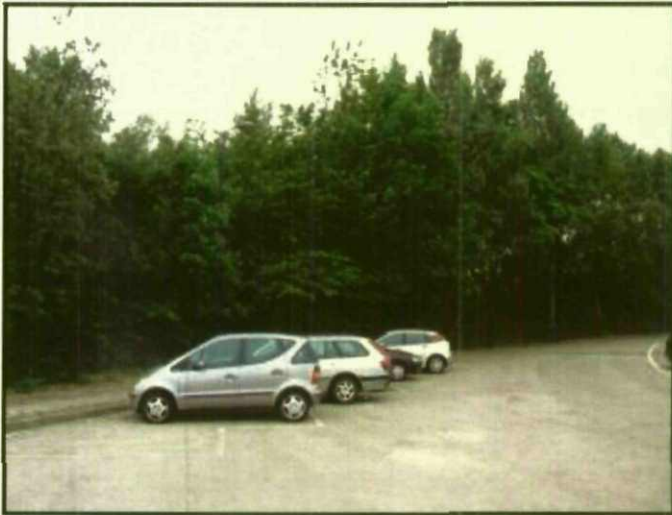
Between Lowfield Road and the railway station car park there is a triangular shaped area of semi-mature trees (refer to Appendix A, Photograph 2.). There is evidence in the wood that children use the site (refer to Appendix A, Photograph 3.). This will cause disturbance and deter some forms of wildlife occupying the site. Although the woodland contains breeding birds (see above section 4.01) the woodland has no other ecological value. If the trees have to be removed as part of the proposed development then the clearance should be undertaken outside of the bird breeding season (mid February to end August), however, avoidance of unnecessary clearance would be the most appropriate measure to minimise the impact upon the local ecology.

Photograph 2.
Triangular shaped woodland area containing semi-mature trees next to the car park.

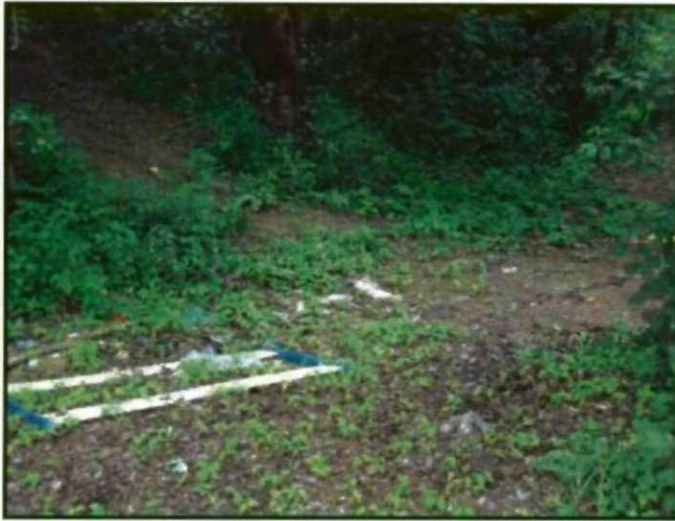
Photograph 3.

There is evidence within the triangular shaped area of woodland that it is used by children playing. The picture shows bottles and other items littering the floor of the woodland.

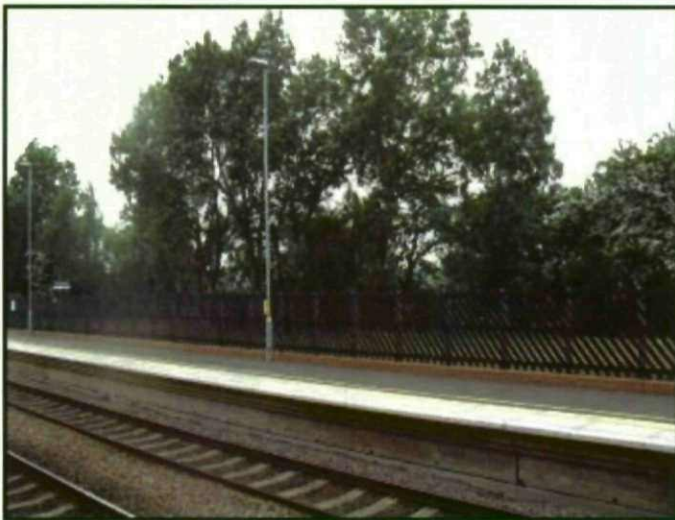
Photograph 4.

Large mature poplar trees along the eastern side of the station.
