20 Tivy Dale, Cawthorne

Bat Survey Report

20<sup>th</sup> June 2024

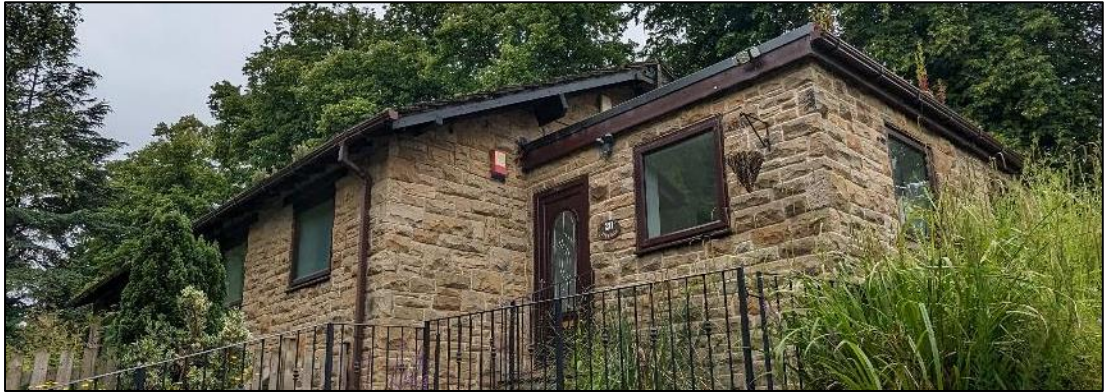
**Plate 1. Eastern corner of dwelling**

- 5.2.3 The dwelling comprised a c.1970s stone built bungalow with cavity walls. The main section of the bungalow had a dual-pitched concrete tiled roof, with a flat-roofed extension on the northeast gable and part of the northwest elevation (Plates 1-3). The main section of the house had over-hanging eaves with fascia boards and barge boards. The wall tops and base of the roof were tightly sealed across the building. On the flat roofed section of the building was a uPVC fascia board with an integrated vent behind. Doors and window frames were uPVC, with double glazed windows throughout. Skylights were present in the roof. Guttering was plastic.

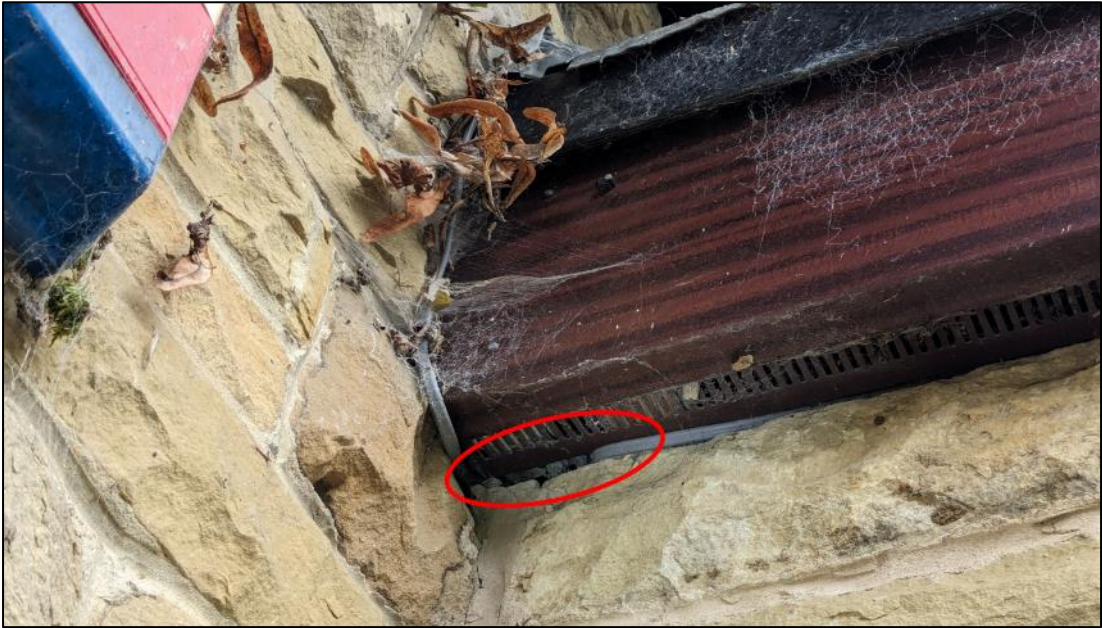
- 5.2.4 A range of potential bat roosting features were recorded from the exterior of the dwelling. These features included the following:
- Occasional gaps between vents and the wall behind the fascia board on the flat roofed section of the dwelling (Plate 4).
  - A ventilation brick and an alarm box on the southwest gable (Plate 5).
  - An uncovered ventilation duct opening on the southeast elevation.
  - Very occasional gaps between roof slates.

**Plate 4. Gap behind insect guard on back of fascia board**

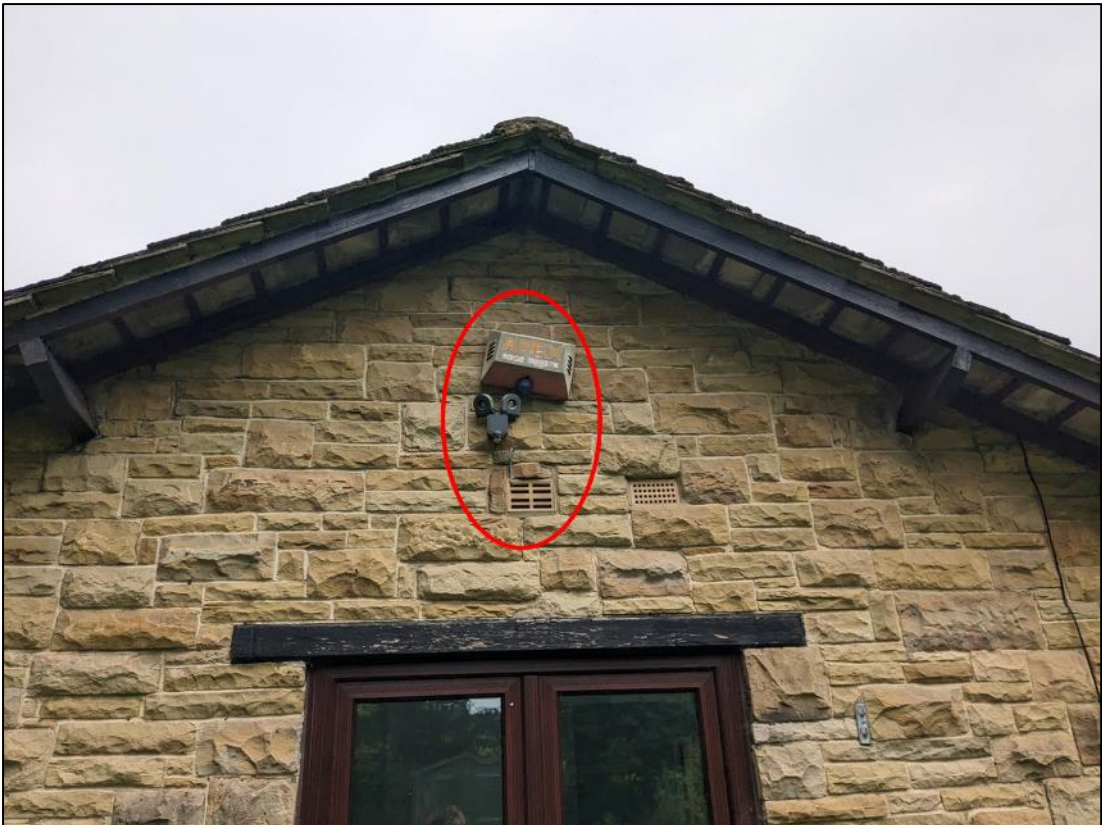
**Plate 5. Air brick and alarm box on southwest gable**

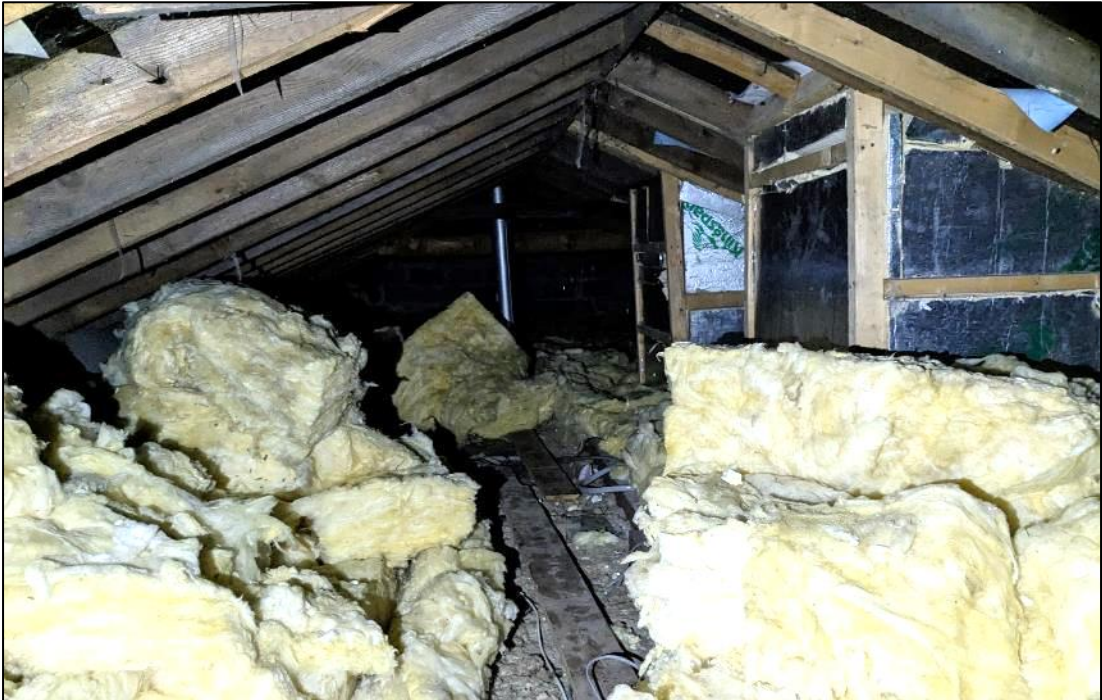
Plate 6. Looking south in roof void

- 5.2.5 The roof was lined with Type 1F bituminous felt and suspended on a ridge beam, rafters and battens (Plate 6). The void was c.1.2 m high and c. 400 mm of glass fibre insulation was present on the ceiling. No signs of bat presence were noted, however, occasional tears were present in the felt.
- 5.2.6 The dwelling was considered to display a low level of bat roost suitability.

6.3.3 Over time bats will often get into new buildings, accessing roofing materials. In addition it is apparent that strong bat populations of multiple species are present in the immediate area surrounding the dwelling. Bats have been shown to regularly become entangled and die in the component filaments of standard modern woven roofing membranes (Appendix 1). There are however now a number of modern roofing membranes (i.e. Siga Majcoat 200 SOB) which have been shown to be relatively safe

for bats. As a result, it is recommended that one of these 'bat safe' felts should be used.

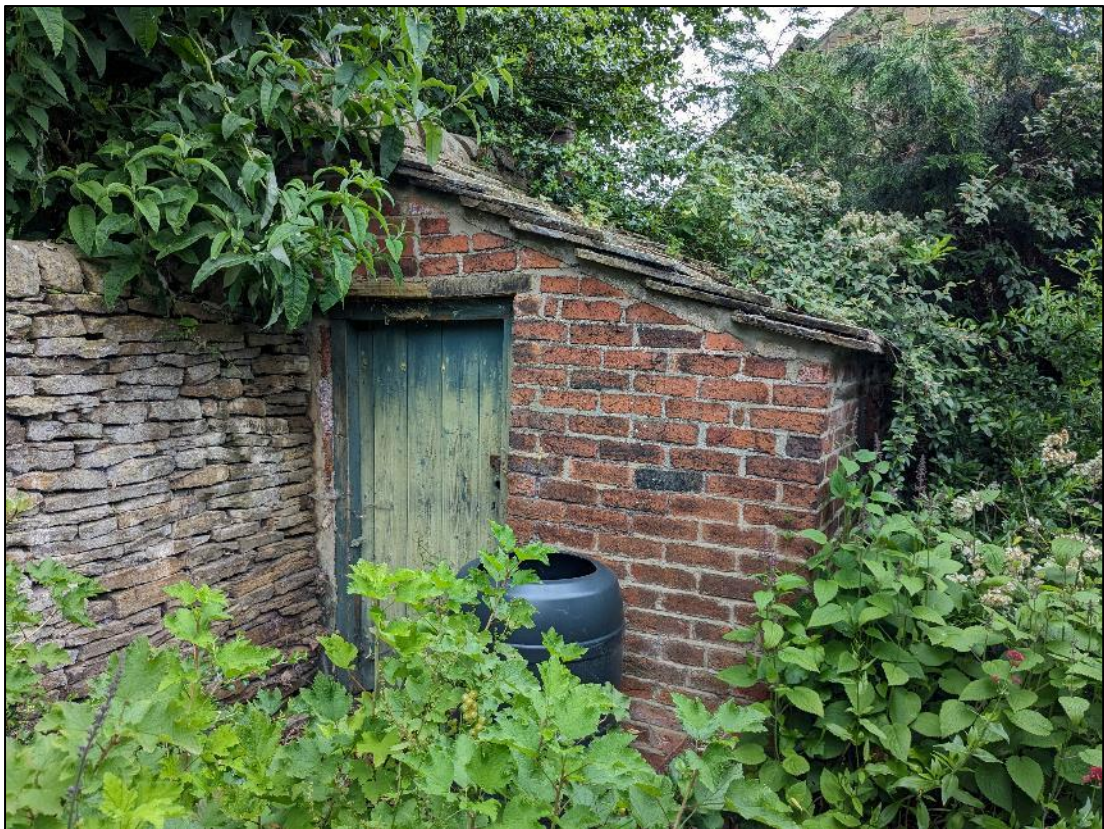
**Plate 7. South corner of outbuilding**

- 5.2.7 The outbuilding comprised a small single-storey brick structure with a single-pitch stone-slate covered roof (Plate 7). The verge was mortar filled and there was a wooden door on the southwest elevation. Vegetation was growing over the northern end of the building.

- 5.2.8 The only potential bat roost feature noted comprised gaps between the stone slates. These could be comprehensively inspected with a torch, with no evidence of bats seen.

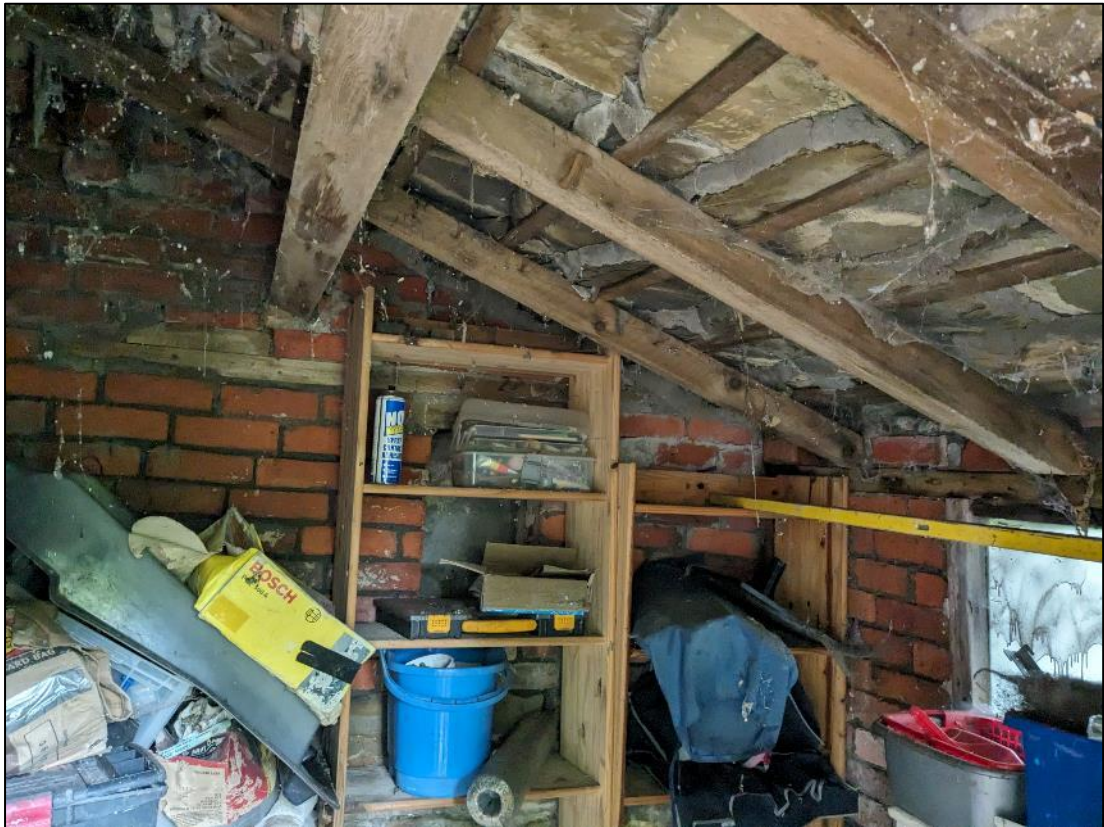
**Plate 8. Interior of outbuilding**

- 5.2.9 The roof of the outbuilding was unlined and suspended on rafters and battens. The structure had been used for storage.
- 5.2.10 The outbuilding was considered to display low bat roost suitability, however, comprehensive inspection during the visual inspection was possible to give confidence in bat roost absence.

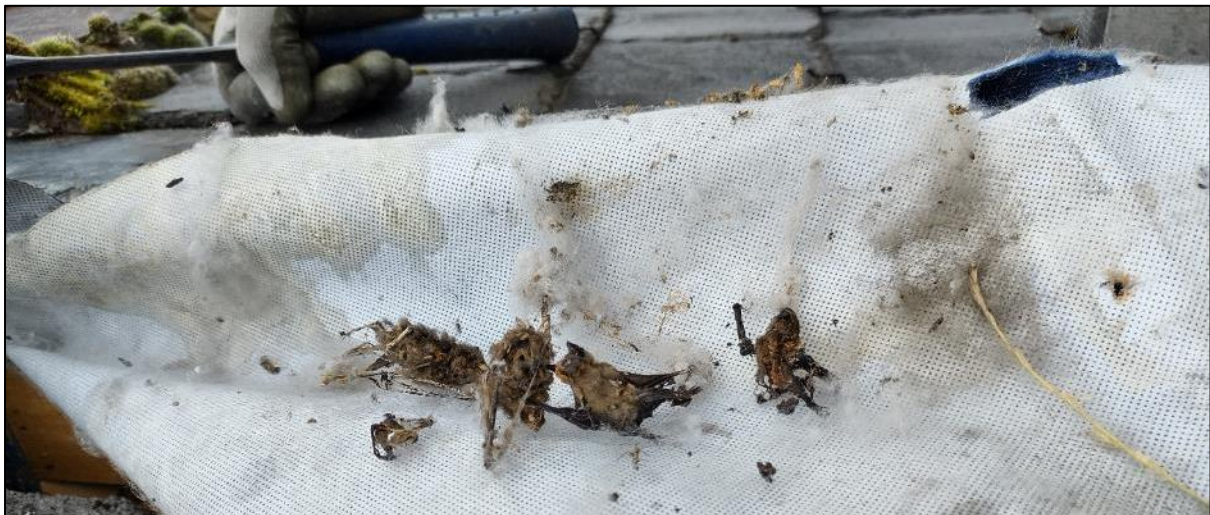
Non-bitumen coated membranes used below roof slates and tiles present a significant problem for bats. Over time, strands are pulled away from the surface of these materials as bats crawl over them. These fuzzy strands are very strong and can tangle and trap bats, sometimes causing the death of bats over multiple years<sup>1</sup>.

One example we have encountered comprised a pipistrelle roost which formed in a building extension constructed in 2009. Over the course of just 13 years the roofing felt degraded to the extent that it trapped and killed more than 10 bats. Fortunately, the problem in this roost was identified and remedial work was undertaken to replace the roofing membrane in 2022.

### Plate A1.1. Four dead pipistrelles tangled in breathable roofing felt

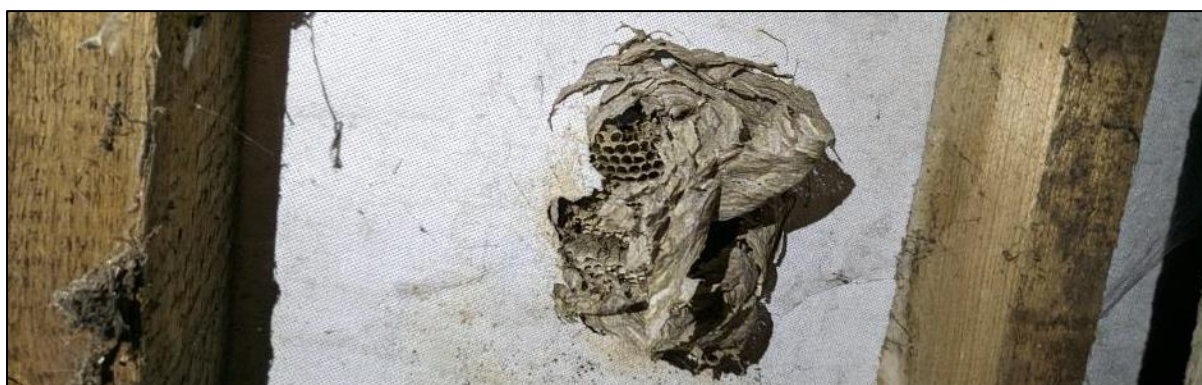
In recent years a fairly substantial proportion of the lofts we have surveyed which had existing breathable felt, were found to have been damaged by wasps (Plate A2.2). In these situations, the wasps appear to have chewed holes in the felt and formed nests in the holes. This doesn't appear to be a problem associated with the traditional bitumen coated roofing felt. Obviously, any holes within roofing felt would be likely to significantly reduce its functionality as a secondary weather barrier. Where bats or birds do come into contact with breathable roofing membranes, they can damage the membrane causing it to leak and they can also significantly reduce the breathability of the felt in that location.

### Plate A1.2. Damage to a breathable roofing membrane adjacent to a wasp nest
