**GEOTECHNICAL AND GEO-ENVIRONMENTAL  
SITE INVESTIGATION**

**PHASE 3, BARNBURGH LANE, GOLDTHORPE**

**GLEESON DEVELOPMENTS LTD**

2 September 2020

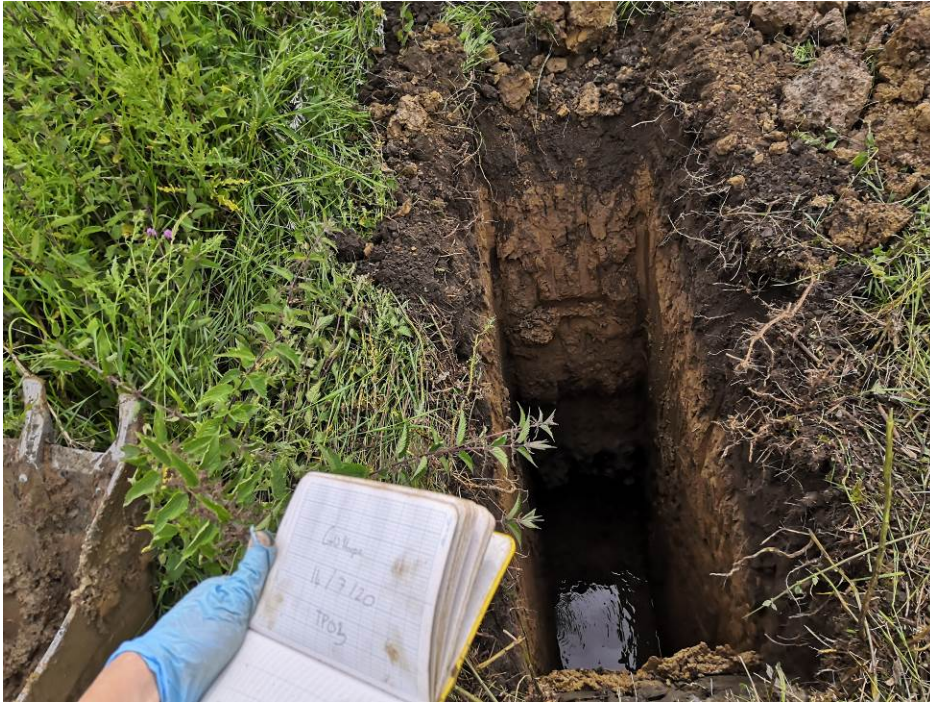
TP03

Within the trial pits, coal was found in TP02 and TP03, both excavated near the southern boundary where the Shafton seam is expected to be at its shallowest. Within TP02, 100 mm of coal was encountered at 2.1 m, on top of the mudstone bedrock. In TP03, a 300 mm thick band of coal was found at 2.9 m, again overlying the mudstone.

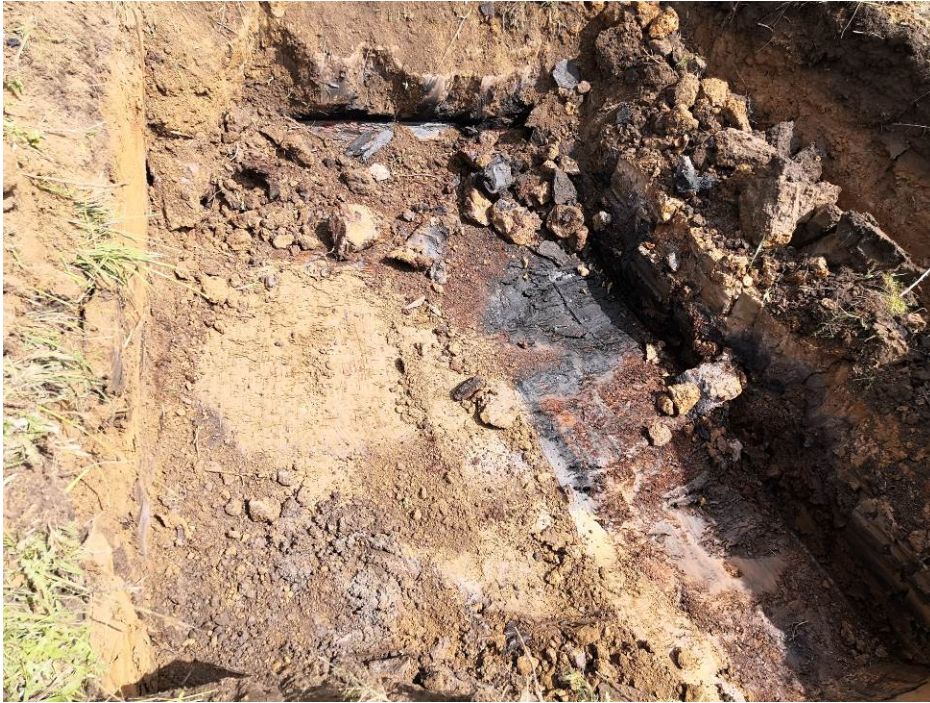
A suspected crown hole feature was identified during the excavation of TP05. Reduced strength clays were also encountered in TP03 close to BH09 where broken ground was recorded within 2.5 m of the surface. Given the above, the reduced strength clays in TP03 may have been influenced by the near surface disturbance and/or the effects of water softening as a result of surface depressions and standing water.

TP05 suspected crown hole

5. A crown hole was encountered in TP05. Other mining features and unrecorded shafts are expected. During the topsoil surface strip, an inspection of the ground surface should be undertaken to look for evidence of mining features.
