Ref C220/04/GS

**Ref: Intrusive Mining Investigation on land off Bismarck Street, Worsbrough Common, Barnsley.**

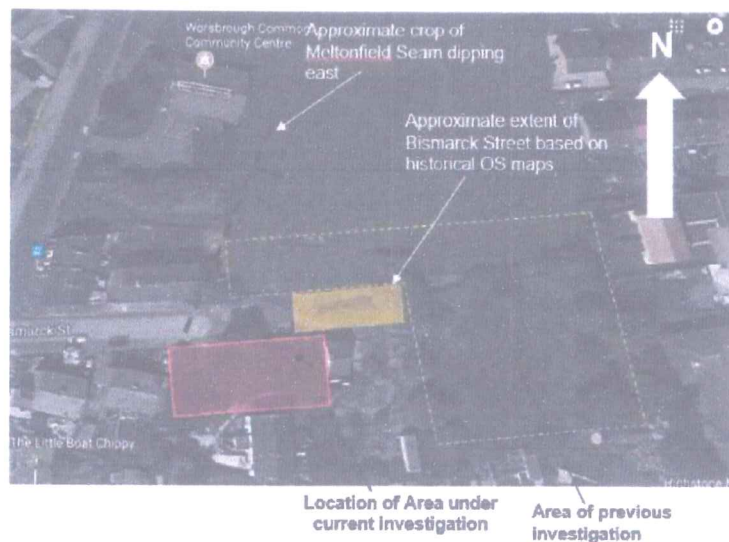
The site is located in Worsbrough Common, approximately 1km south of Barnsley town centre, South Yorkshire. The site is accessed off Bismarck Street, which runs adjacent to the northern boundary of the site, as shown below. The site is a disparate part of a larger area, where it is understood that a submission for planning is to be made for residential development; at the time of writing of this report, a proposed layout drawing is unavailable, and therefore comments/recommendations contained herein may be subject to review and change in due course.

Intrusive investigation work of the larger area (shown outlined by the yellow dotted line, above) has previously been carried out, and reported by G&M under separate cover, Report Ref C220/02/GS, dated 10<sup>th</sup> September 2017. This current report should be read in conjunction with the historical report, the latter of which provides more extensive details of the mining risk assessment and available geological information, which are pertinent to both parcels of land. However, for completeness, a summary of information relevant to the current investigation is presented below.

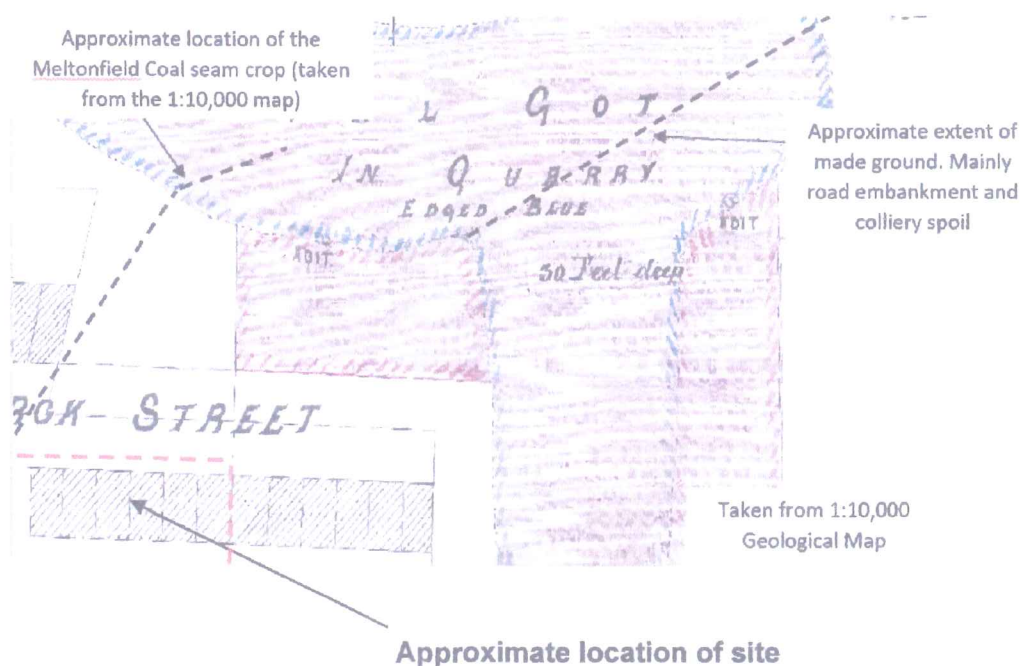
Information kindly supplied by the Coal Authority, included an abandonment plan (Ref 5002), shown below, which appears to indicate that a brickpit/quarry extended in close proximity to the site under current investigation extending past the line of houses along Bismarck Street (now partially demolished), towards the eastern boundary of the site. It is understood that the blue hatching indicates where coal was removed from the quarry face and that the red hatching possibly indicates shallow workings. These indicate that the shallow workings do not extend beneath the part of the site under current investigation.

The 1:10,000 geological map indicates that the Meltonfield Coal seam crops to the north west edge of the site (shown above) and dips, probably at a shallow angle towards the east; i.e beneath the site.

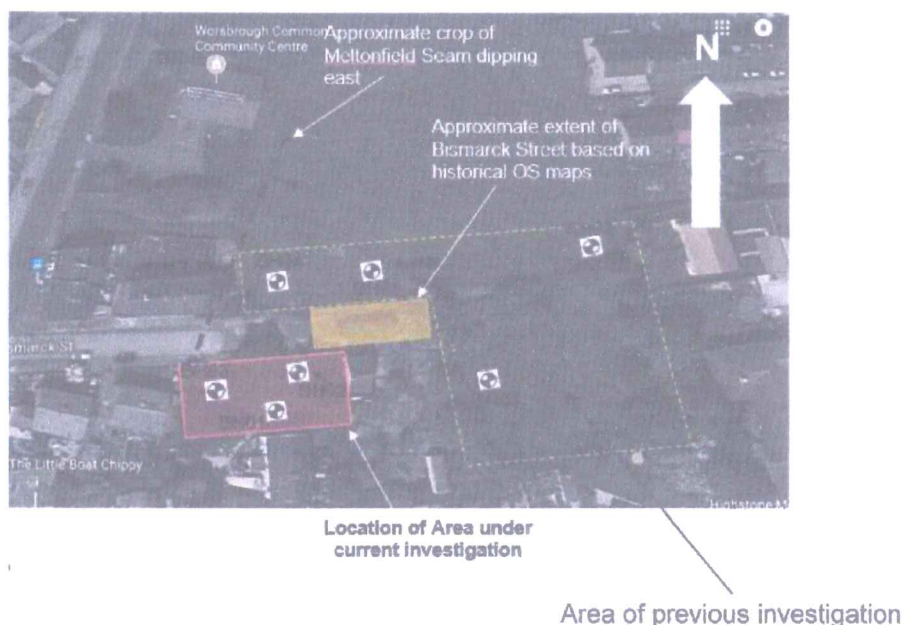
A plan showing the exploratory hole locations in the area of current investigation (highlighted in red), is shown below.
