**Barnsley College
Honeywell House**

Centre for Sustainable Construction & Renewable Energies

Ecology Phase 1 Habitat Survey
Tree Condition and Value Report

Project No: A057544

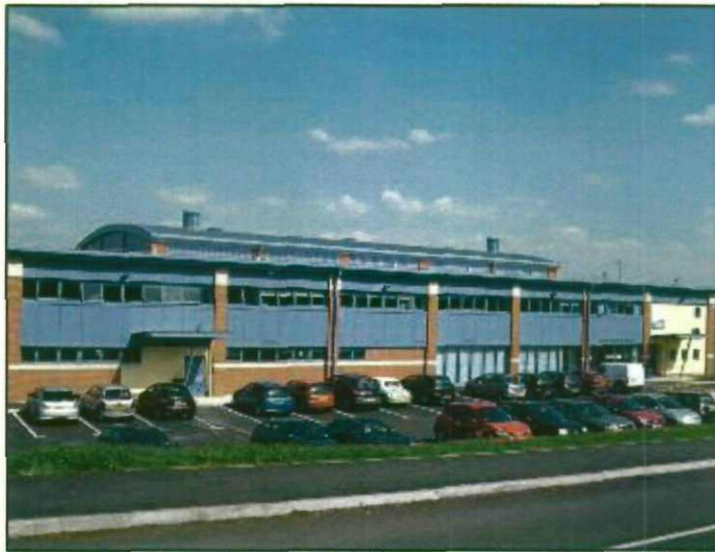
Plate 1 Barnsley College Sports Ground Facility

The Barnsley College Sports Facility, two portakabins and Performing Arts building have no notable bat access points. The walls are well pointed, the roofs are flat with no void and the windows are well sealed. No evidence of bats was found externally. These buildings were therefore considered as having **negligible potential** for supporting roosting bats.

The Barnsley College Sports Facility, two portakabin buildings and Performing Arts building were surveyed as having **negligible potential** for roosting bats. No further surveys are therefore recommended at this time, and bats are not considered, at this stage, to pose a constraint to works proceeding on these buildings. In the unlikely event bats are identified at any time during works, all works should stop and an experienced bat ecologist should be contacted for advice immediately.

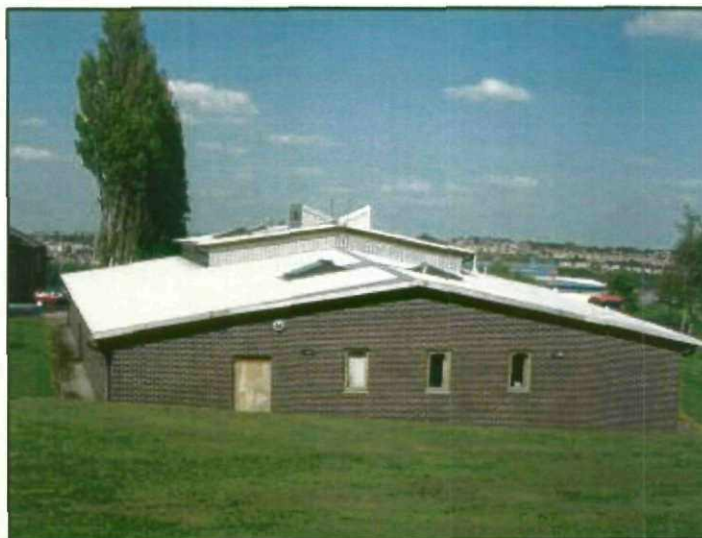
Plate 3 Music Rooms building

The Music Rooms building has limited potential access points suitable for bats. The only gaps evident are into the wooden soffits where there is an apparent space between the soffit and wall (see Plate 15). No evidence of bats was found externally. This building was therefore considered as having **low potential** for roosting bats.

The Barnsley College Honeywell building, Music Rooms building and sub-station were surveyed as having **low-moderate potential** for roosting bats. It is therefore recommended that an internal survey (where access can be gained) and nocturnal bat activity surveys (comprising dusk emergence and dawn re-entry surveys) be undertaken on these buildings prior to any construction/demolition works to determine the presence or likely absence of roosting bats.⁶

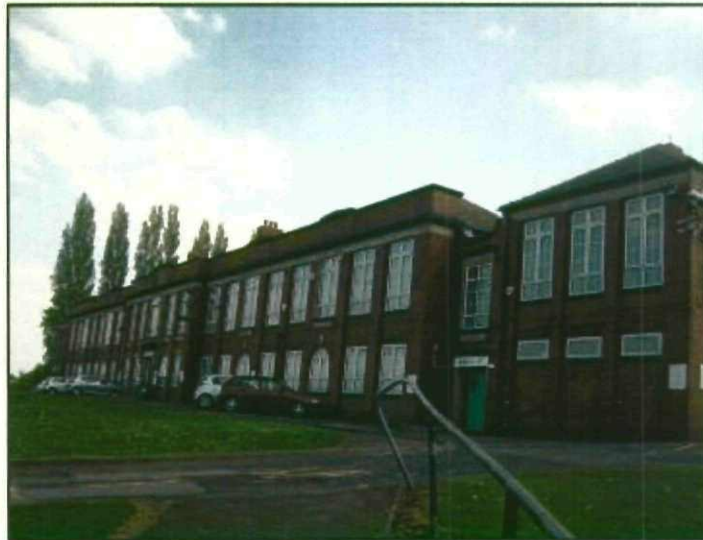
Plate 4 Barnsley College Honeywell main building

The Barnsley College Honeywell building is primarily a two storey, brick-built building with wooden windows. The roof is pitched and hipped with clay ridge and slate roof tiles and sky lights erected in parts (Plate 4). Towards the north-western corner of the building, the building is single storey and flat roofed (Plate 5). The south-western corner of the building comprises a modern metal framed structure (Plate 6).

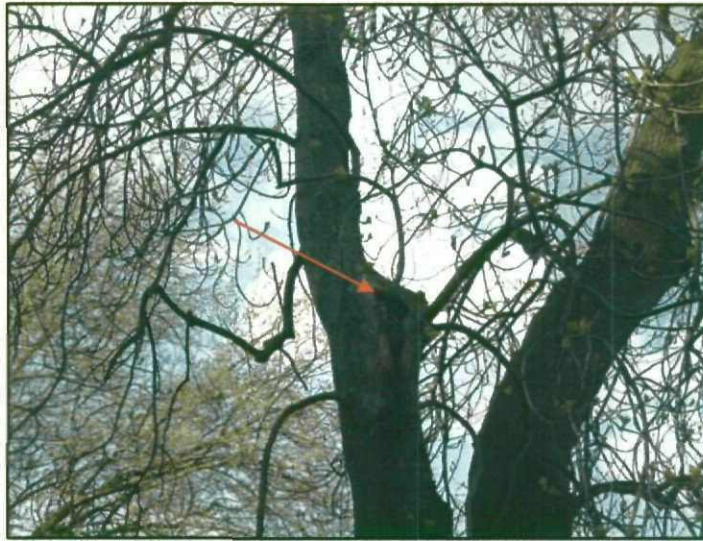
Plate 19 Crevice into mature ash tree on site suitable for roosting bats

Two trees on site (Tree 80 ash and Tree 158 Norway maple - refer to Arboriculture Report, WYG 2009) were surveyed as having potential for roosting bats. The ash and Norway maple tree were rated as having **moderate potential** and **high potential** for roosting bats respectively. The survey was undertaken from ground level and both trees were observed to have discernible crevices. It is therefore recommended prior to any felling of these trees that on the first instance an internal endoscopic survey be undertaken at height to further determine the potential for roosting bats where possible. Depending on the results of the internal survey, nocturnal bat activity surveys (dusk emergence and dawn re-entry surveys) may subsequently also be required.

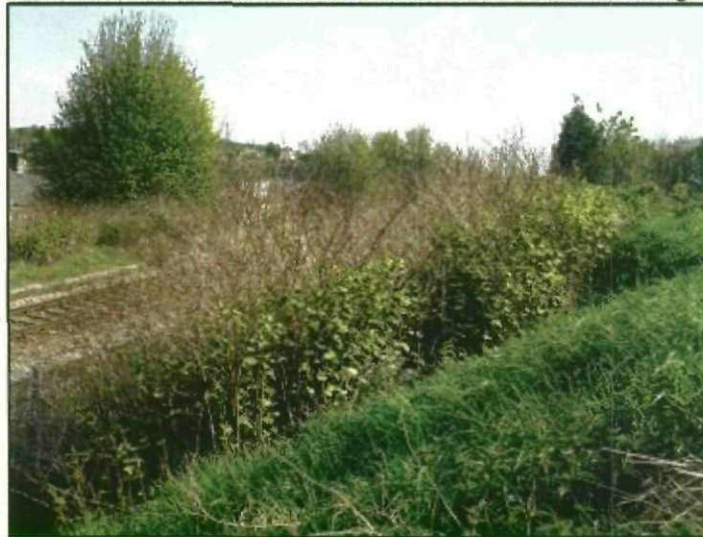
Plate 20 Japanese knotweed Stand 1

Japanese knotweed was recorded on site. The Wildlife and Countryside Act 1981 (as amended) provides the primary controls on the release of non-native species into the wild in Great Britain. It is an offence under section 14(2) of the Act to 'plant or otherwise cause to grow in the wild' any plant listed in Schedule 9, Part II, which includes Japanese Knotweed. This could include cutting the plant or roots and disturbing surrounding soil if not correctly managed. Japanese knotweed is classed as 'controlled waste' under the Environmental Protection Act 1990. This requires disposal at licensed landfill sites and it should not be included with normal household waste.

Even if Japanese knotweed will not be directly disturbed by construction there is the risk it may subsequently spread within the site potentially resulting in damage to new structures on site in the longer term.

It is recommended that further advice should be sought as soon as possible on the management of Japanese knotweed at this site taking into account the nature of site proposals and the programme of works.
