Bat Survey Report
Pea Field Cottage Stable, Bromley.
4th June 2015

Middleton Ecological Consultancy, 33 Wilthorpe Road, Barnsley S75 1JA

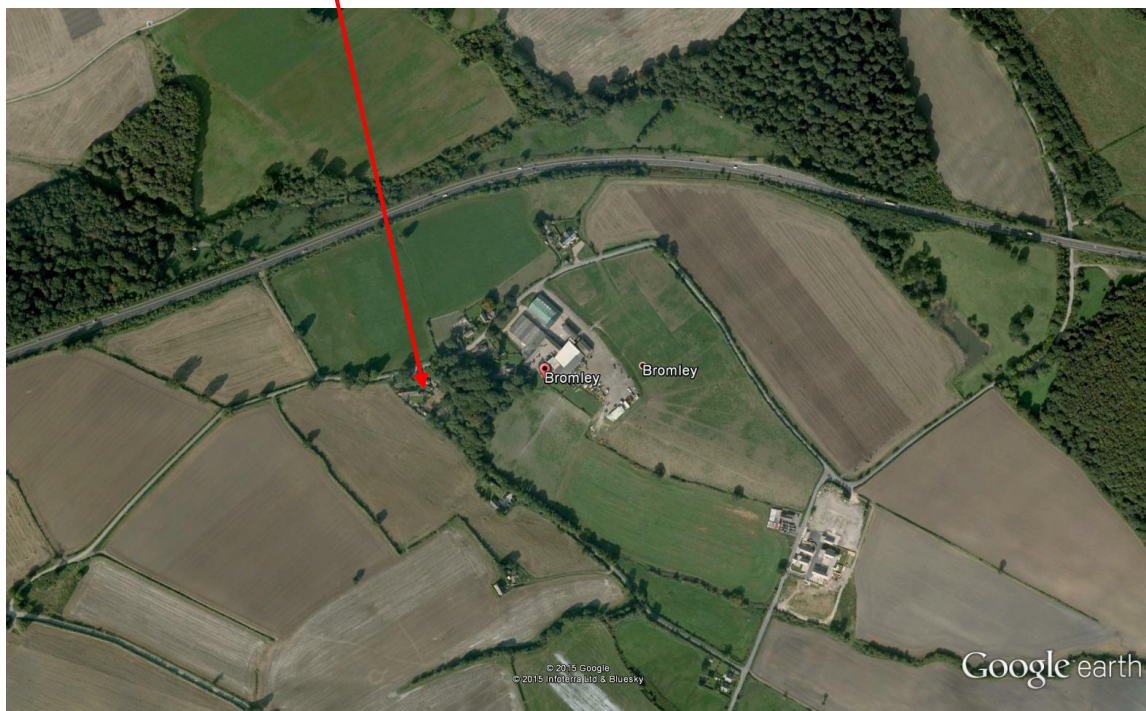
Plate 1 Pea Field Cottage

- 3.2.1 The surrounding area is predominantly arable together with grassland and woodlands. Table 1 outlines the habitats present, adjacent to and further afield to Pea Field Cottage Stable at Bromley (see plate 1).

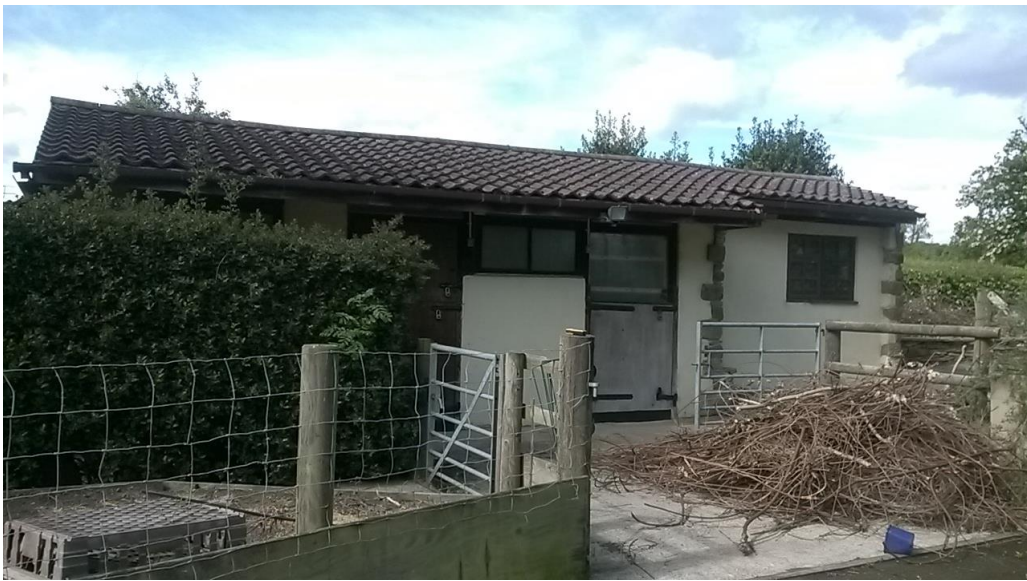
Plate 2 Northeast elevation

- 3.1 The site is situated in a rural location within a small hamlet (Bromley). The site consists of a relatively small single storey stable built of concrete blocks that is cement rendered on the façade. The stable has a pitched roof with a ridge and gables and has a covering of concrete pan-tiles (see plate 2). There are three compartments each having its own doorway plus an adjoining section with a corrugated galvanised metal roof.

5.3.1 There are no potential features within the walls of the cement rendered elevations or the exposed concrete block wall at the rear. However, there are gaps beneath ridge tiles and the tile ends above the gutter that have not been mortared. Also, the southwest elevation has a wooden fascia with a gap beneath in several places. However, the gap was found to be very 'cobwebby'.

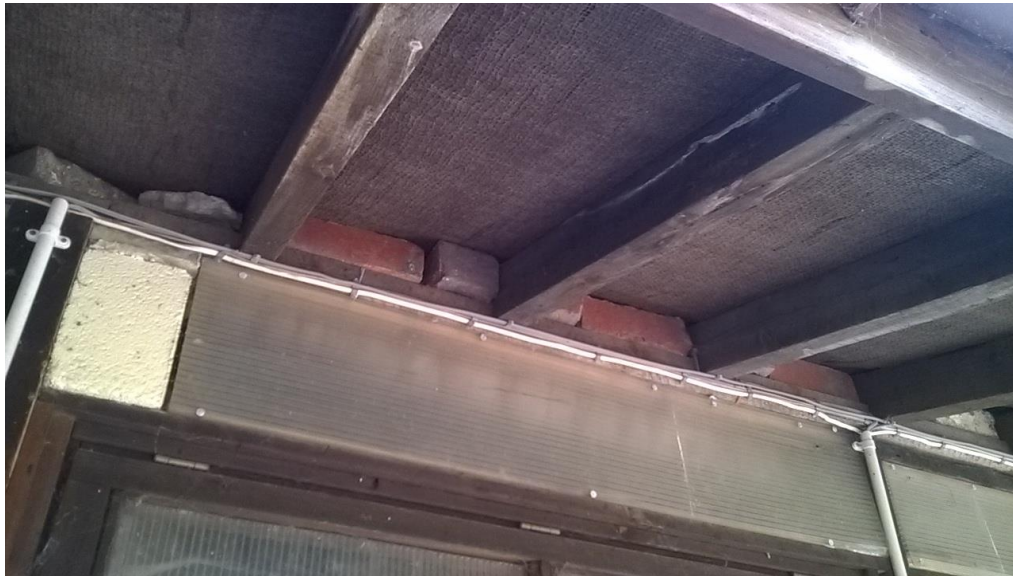
Plate 3 Bricks positioned to exclude swallows but bats can still access.
