**Carlton Road, Barnsley, South  
Yorkshire**

Archaeological Desk-based Assessment

ARCUS report 1313.1(1)

September 2009

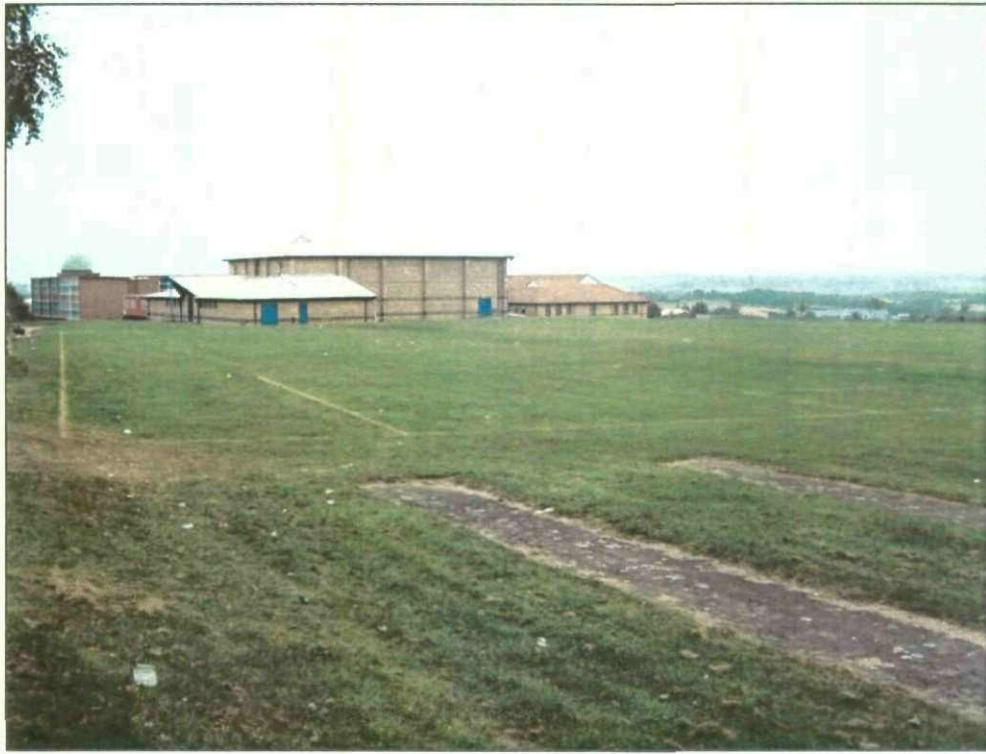
Plate 5 – St. Michael's School, looking north-east from school playing field. Substantial area of made ground identified to right of buildings.

St. Michael's playing field is located to the south of the school buildings and has also been marked out for the playing of a variety of sports (**Plate 5**). The areas of made ground identified by geotechnical survey are suggested by substantially different ground levels within the playing field, indicating that extensive landscaping works occurred in association with its creation (**Plate 6**).

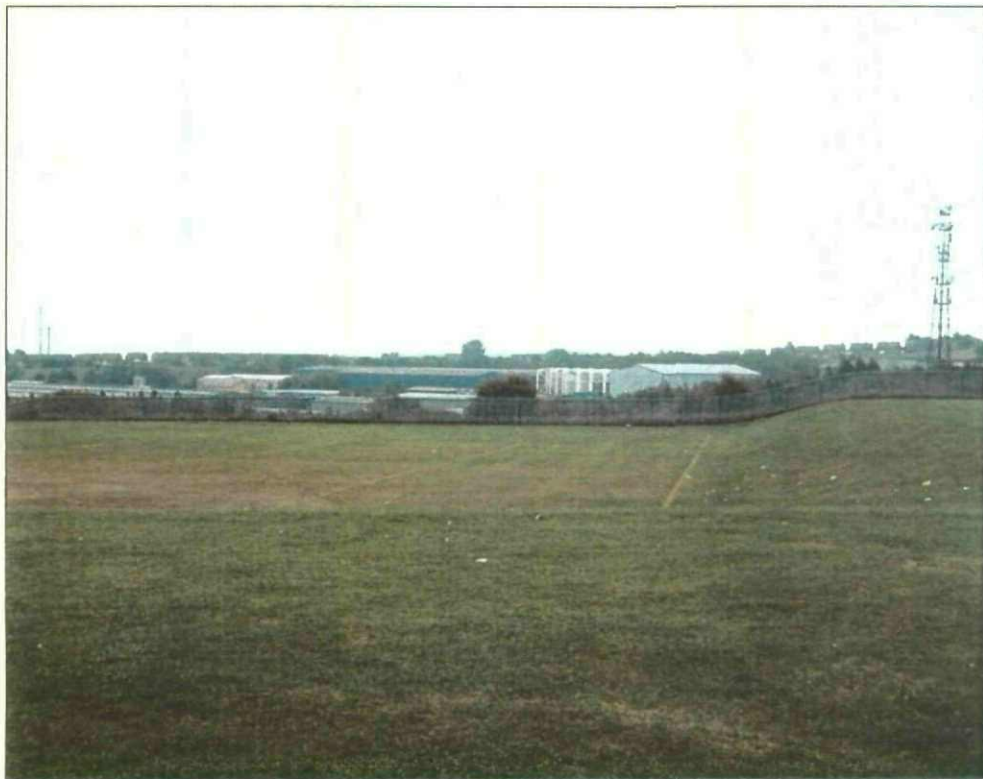
Plate 6 – St. Michael's playing field, looking south-east. Made ground and landscaping in this area associated with creation of field.

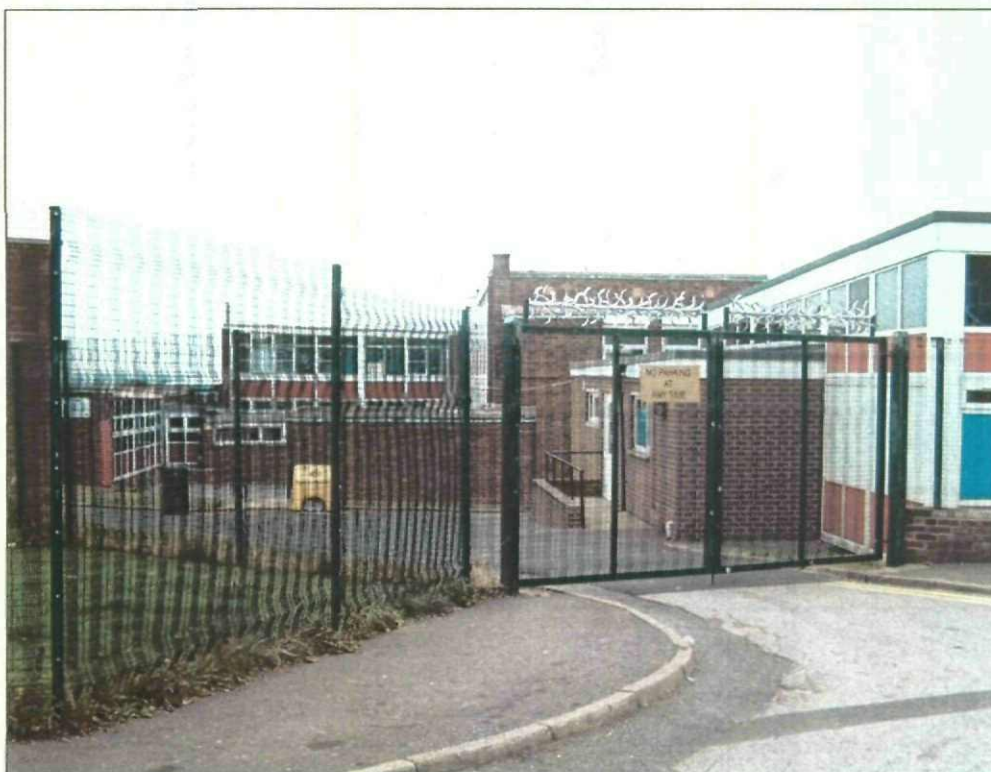
Plate 7 – Edward Sheerien School, looking north-east. Note varying ground levels in site.

modern metal security fence demarcates the school grounds, which are dominated by a variety of one- and two-storey blocks (**Plate 7**). Ground level varies substantially throughout the areas occupied by the principal buildings, indicating that extensive excavation is likely to have occurred in this area during the school's construction. Tennis and basketball courts are located at the north-west of the school (**Plate 8**), with a playing field situated to the south-east (**Plates 9 and 10**). Varying ground levels suggest that landscaping works also occurred in the latter area.

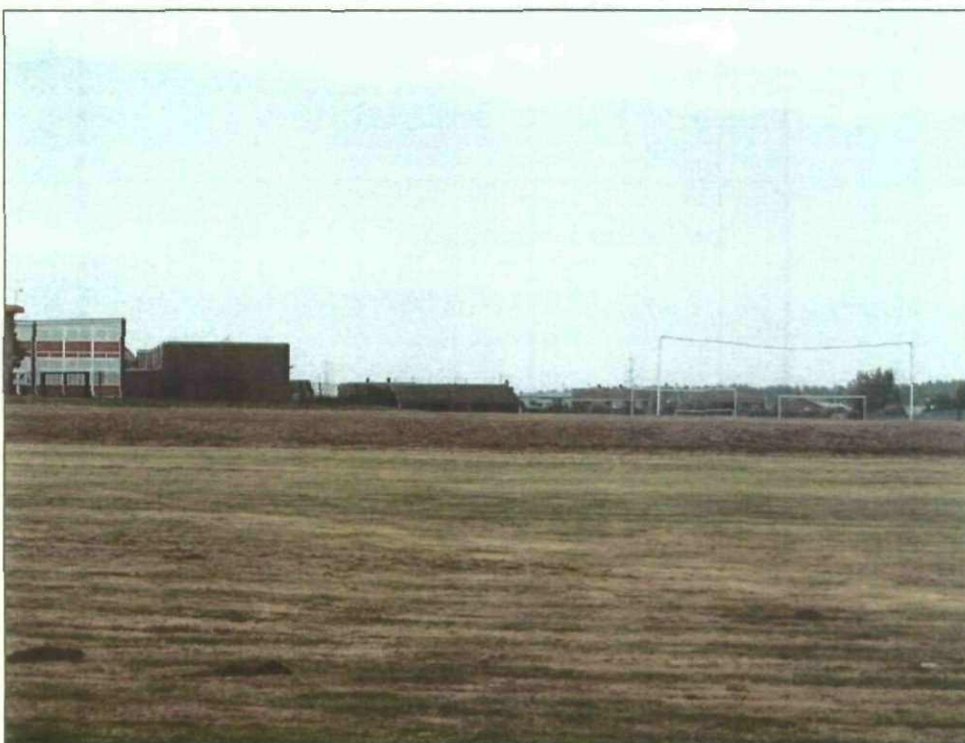
Plate 10 – Edward Sheerien playing field, looking north-west. Note landscaping in association with creation of field.

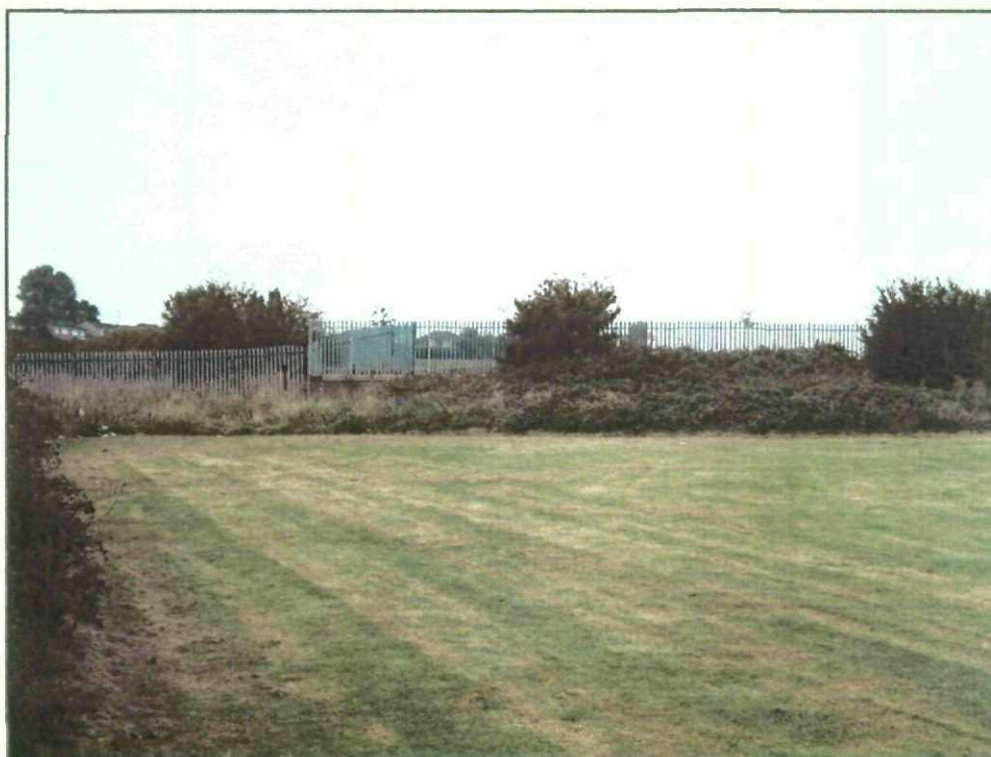
Plate 11 – Junction of Edward Sheerien and St. Michael's playing fields, marked by brick wall at centre-left. Contrast between school field and land to south-east indicates extent to which site was modified in association with construction of schools.

Although geotechnical investigation suggested that made ground was not present in the south-east of the site, landscaping works also appear to have taken place in this area. The extent of these works is indicated by the contrast between the school field and the land immediately beyond the site boundary, where a bund topped by a modern metal security fence separates the school property from the scrub and woodland to the south-east (**Plate 11**). Ground levels are uneven throughout the latter area, the majority of which is substantially lower than the level of the playing field. However, prior to the development of the schools, the playing field area formed part of the same plot as the scrub and woodland and is likely to have been similarly uneven, rough terrain.

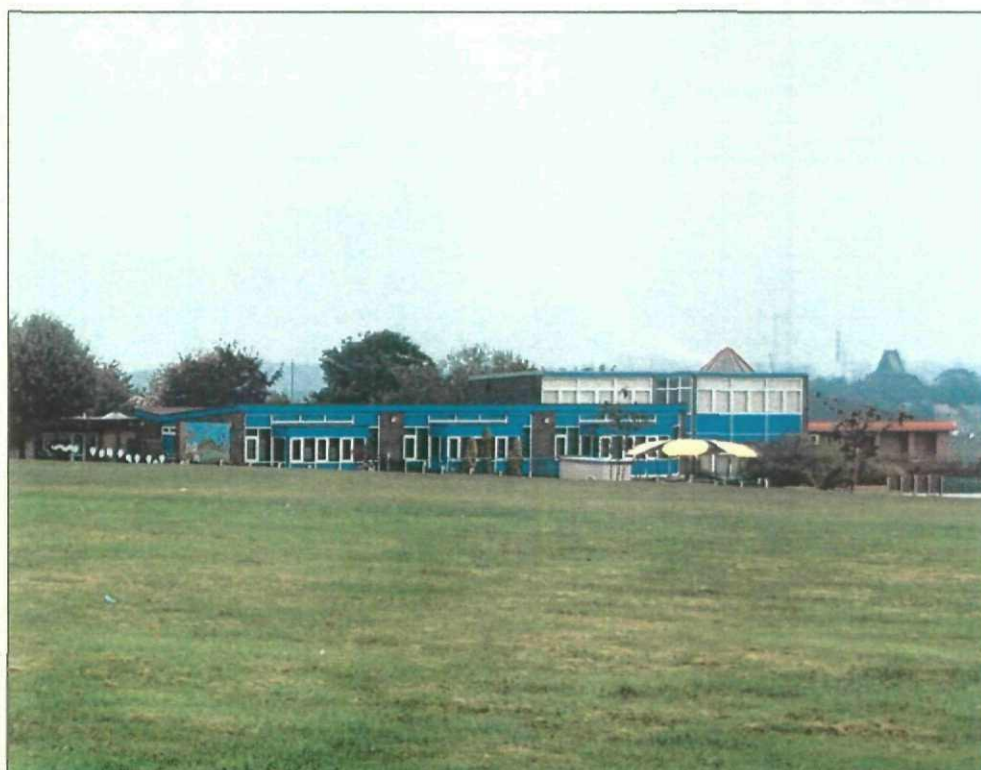
Plate 12 – St. Dominic's School, looking north-east. Made ground identified in this area by SYMAS report.

St. Dominic's School is located to the south-east of Edward Sheerien School and east of St. Michael's (**Plate 12**). The school is situated on an area of level ground that has been excavated from the field's north-west/south-east slope, and comprises a variety of one- and two-storey blocks. A large, level, rectangular area is located to the south of the school buildings, with a modern, open-sided playground feature at the west (**Plate 13**).

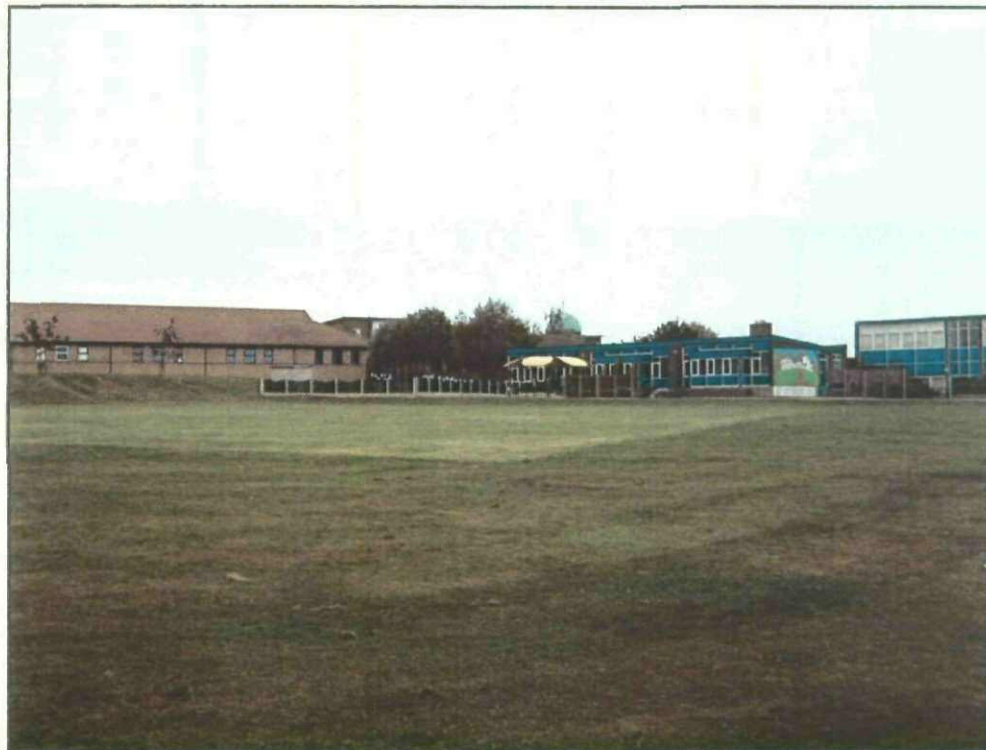
Plate 14 – St. Dominic's, looking north-west. Note embankment at left separating playing field from St. Michael's. Made ground imported during creation of field in this area.

A metal fence demarcates the school buildings from the playing field to the south. A large, flat playing area and a substantial embankment to the west indicate the extent to which the playing field has been landscaped (**Plate 14**). Mature trees, shrubbery and a variety of playground features are located throughout the site.
