# **Balfour Beatty**

## **Utility Solutions**

West Melton – Storrs Wood, Storrs Mill Lane, Barnsley. Nearest postcode S71 5EG

Cable theft from 2x towers (pylons) located inside the Storrs Wood. Work is needed to construct 2 new sealing end platforms and replace oil filled cable with XLPE cable. The 2 towers are situated either side of a rough track, which runs through the middle of the wood. The wood is covered by a woodland protection order. Site meetings with the landowner and Barnsley council have taken place.

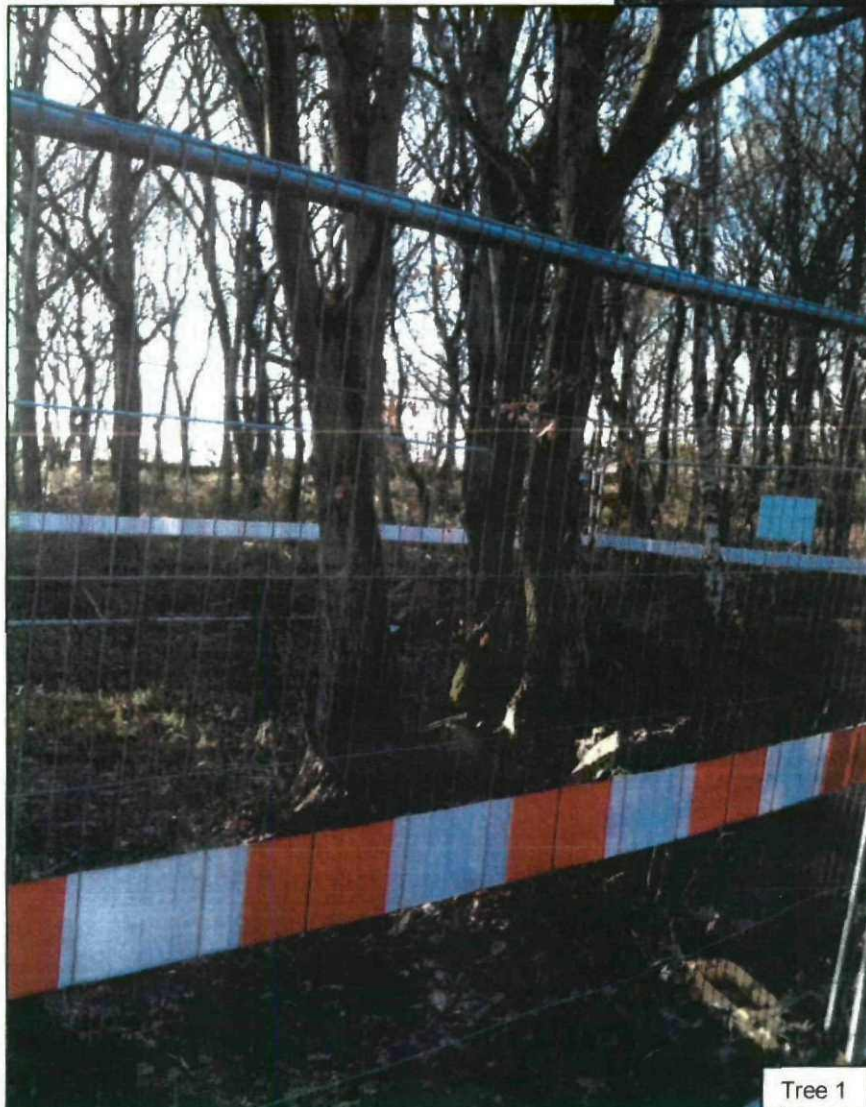
### ● Tree 1

Tree 1 is located in close proximity to the tower 1. It is in the direct path that will be used to replace the cable, between tower 1 and 2. Due to the heavy machinery involved, the tree may be exposed to damage. Ed was happy this tree could be removed to give us access.

KS explained the scope of the works to EJ and gave an idea of the type of heavy machinery needed, to construct the new platforms. A couple of small trees are in close proximity to the existing towers, and may need to be pruned / removed in order for us to gain access. Ed was happy the trees we may have to prune/remove were of no significant value in regards to the species / age / amenity value. He advised no licence was needed to removed the trees. However, I suggest an application is made as and extra precaution.

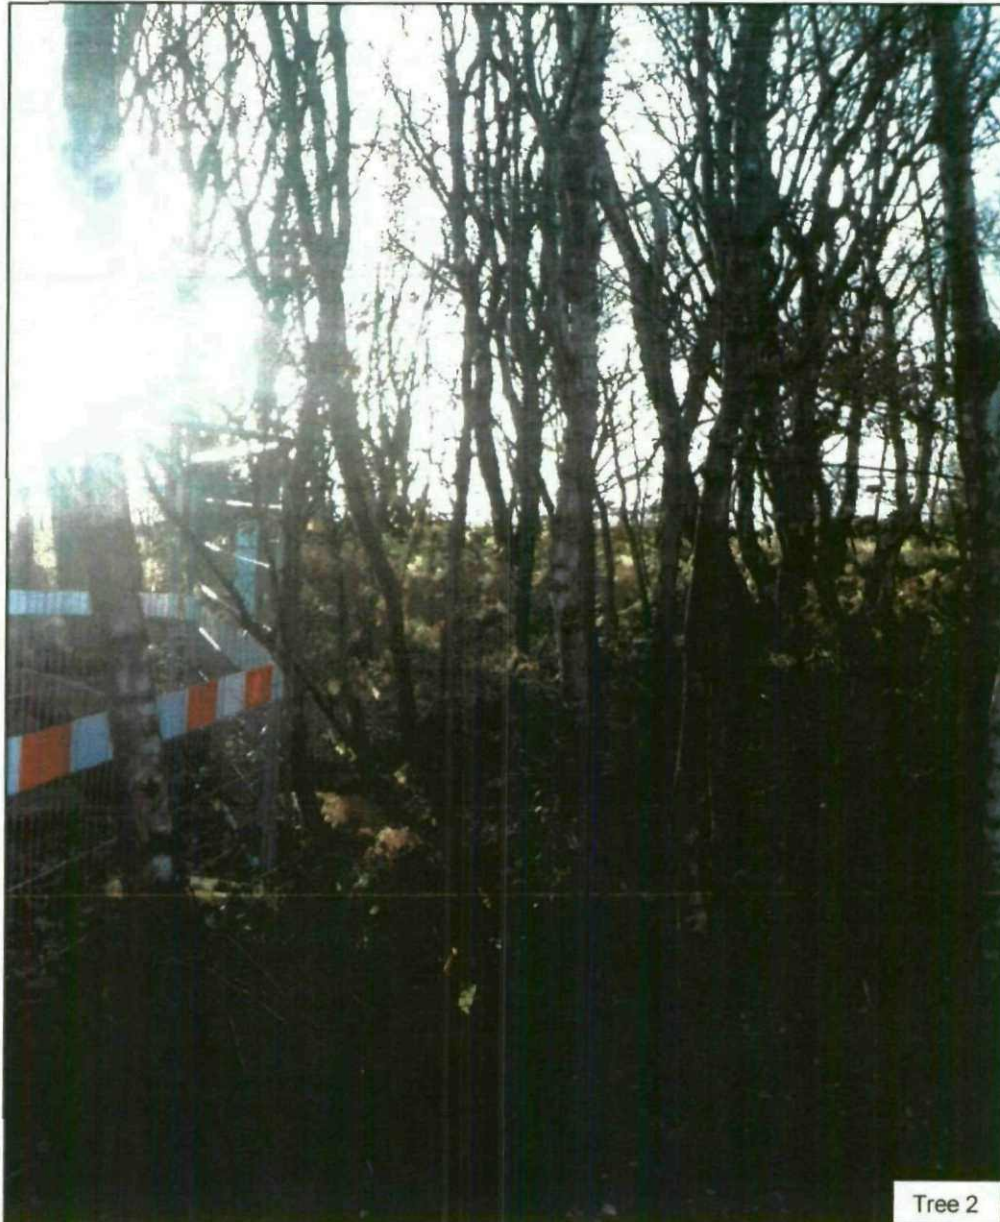
### ● Tree 2

Tree 2 is a group of small trees located close to tree 1. This group may not need to be removed if access is clear if tree 1 is removed.

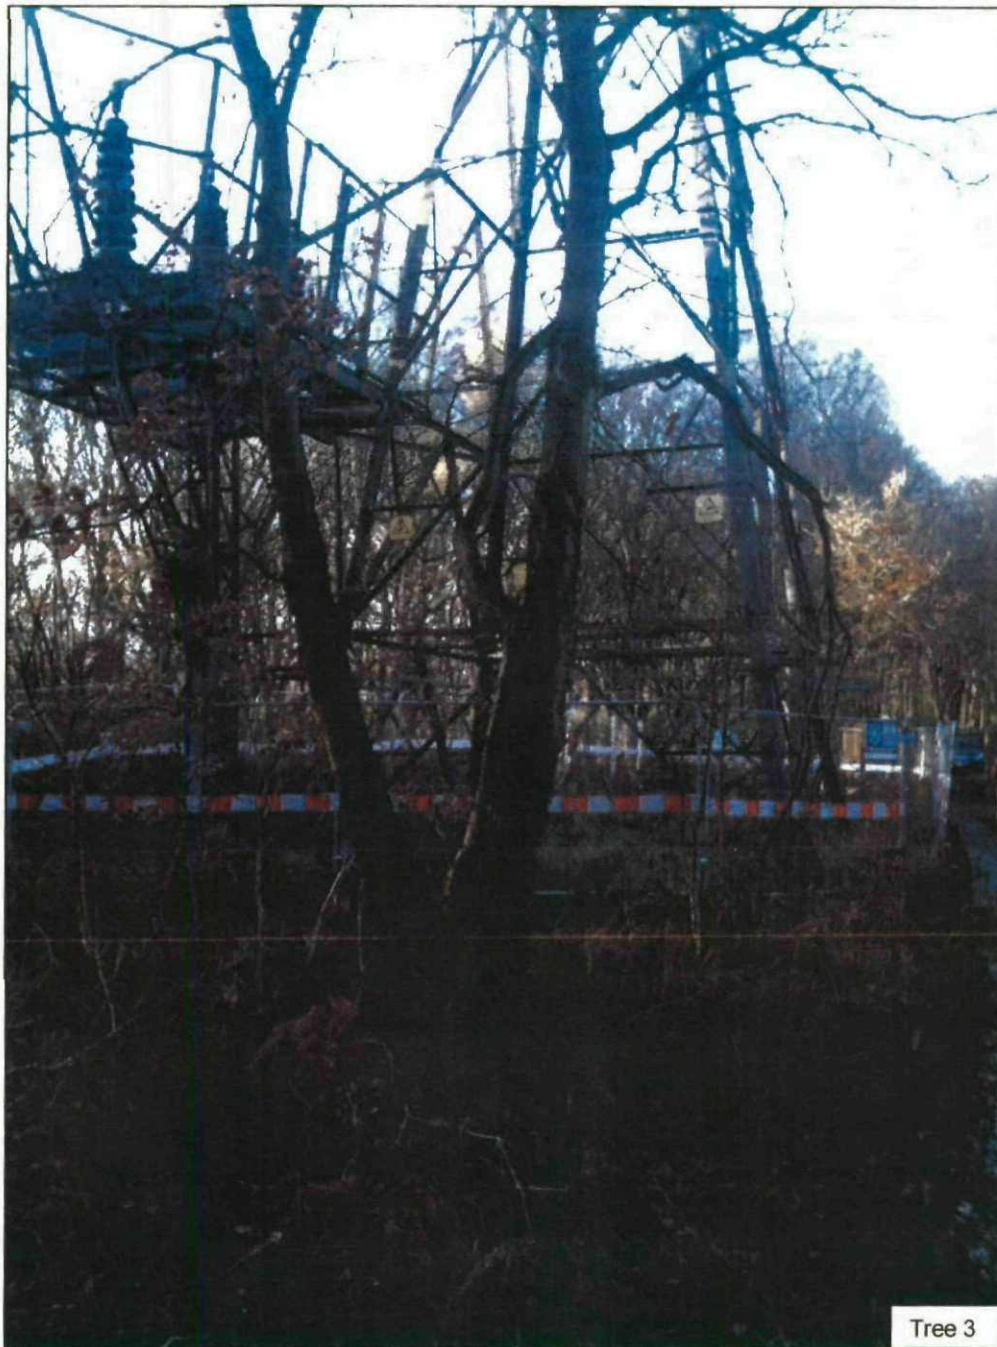
### ● Tree 3

Tree 3 is located at the opposite side of the tower to Tree 1 and 2. To gain access to construct the new platform, this tree would need to be removed.

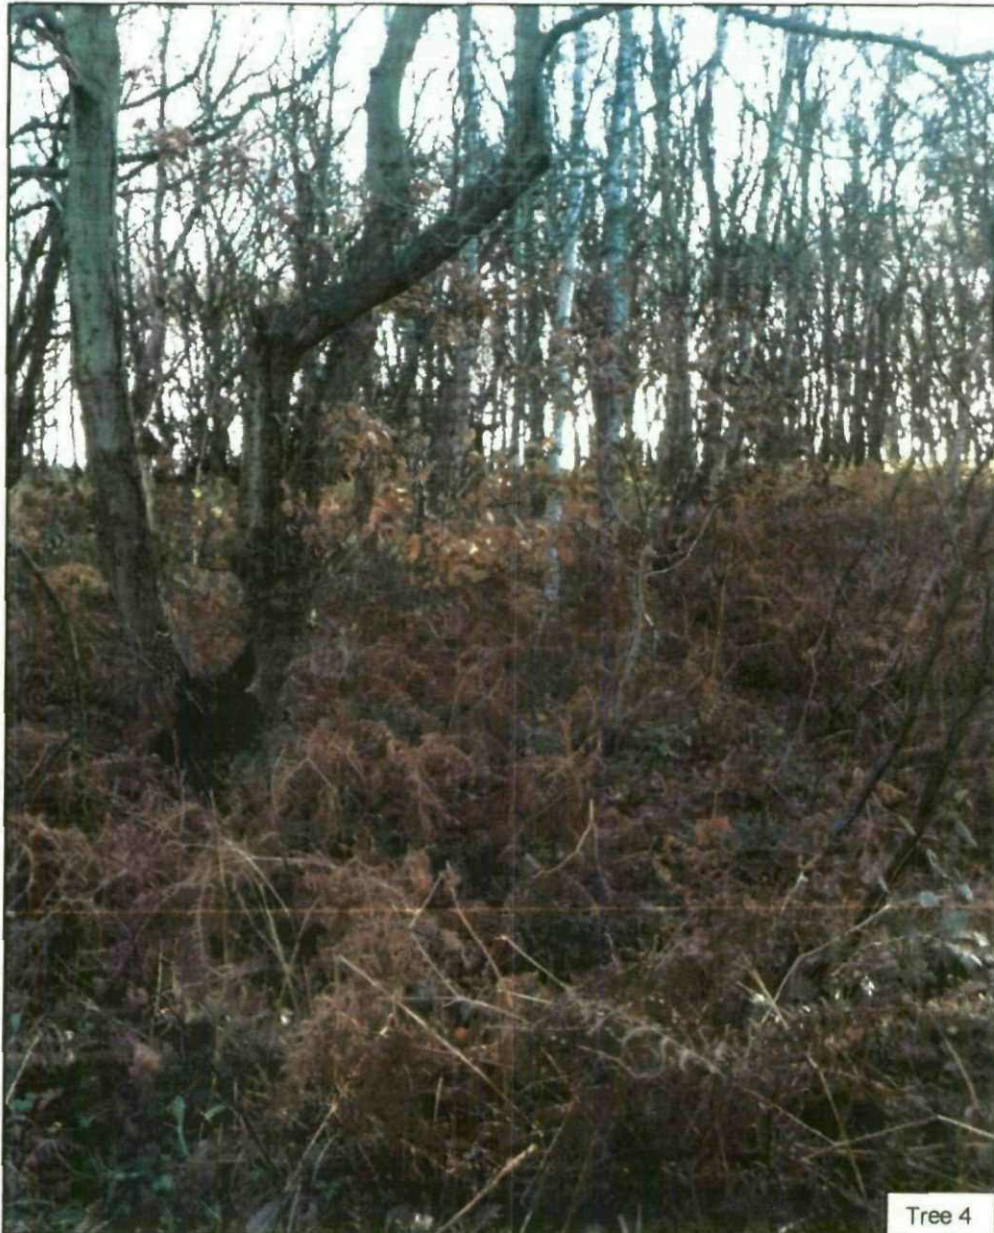
### ● Tree 4

Vegetation clearance and possible tree removal. Vegetation clearance must take place before March 2012.
