GEOENVIRONMENTAL GROUND INVESTIGATION

Phase 2 Capitol Park Junction 37 – M1 Barnsley

Reference	JP/GI/2450-5.v1
Date	June 2017
Version	1

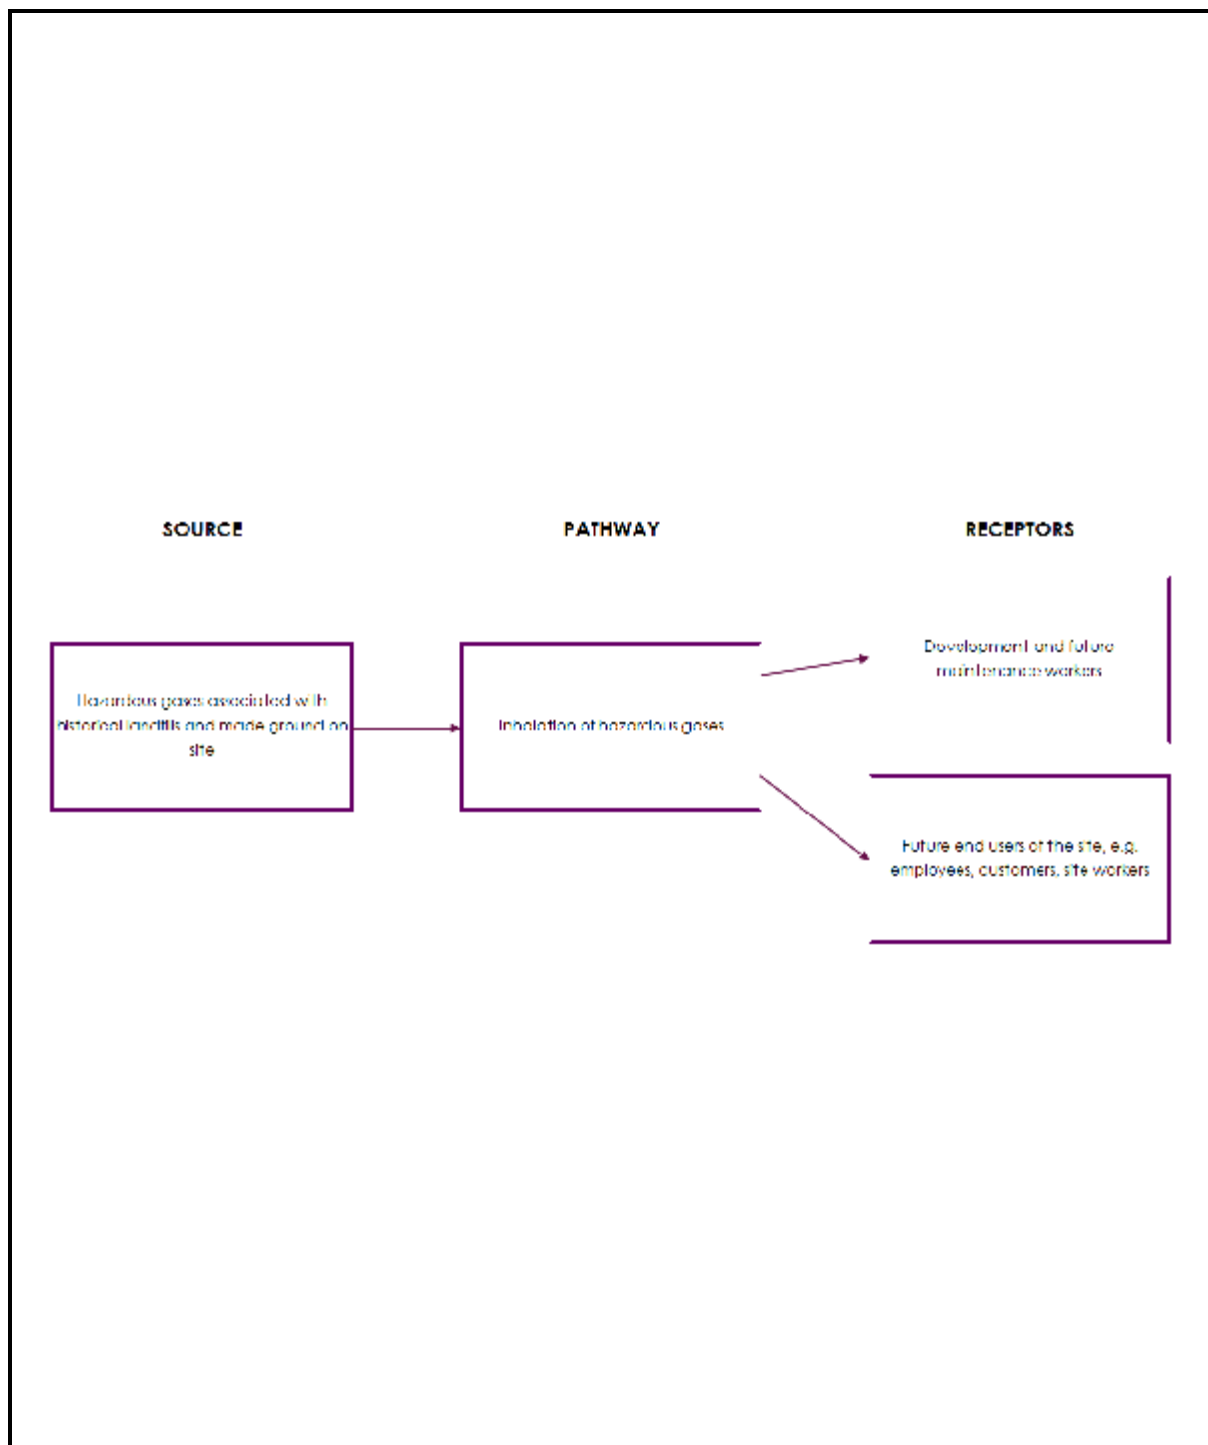
Figure 3 – Conceptual Site Model

- Sources – The presence of substances (potential contaminants/pollutants), in or under the ground, that may cause harm or pollution.
- Receptors - The presence of a receptor which may be harmed, e.g. the water environment or humans, buildings, fauna and flora; and
- Pathway - The existence of a linkage between the Source and the Receptor.

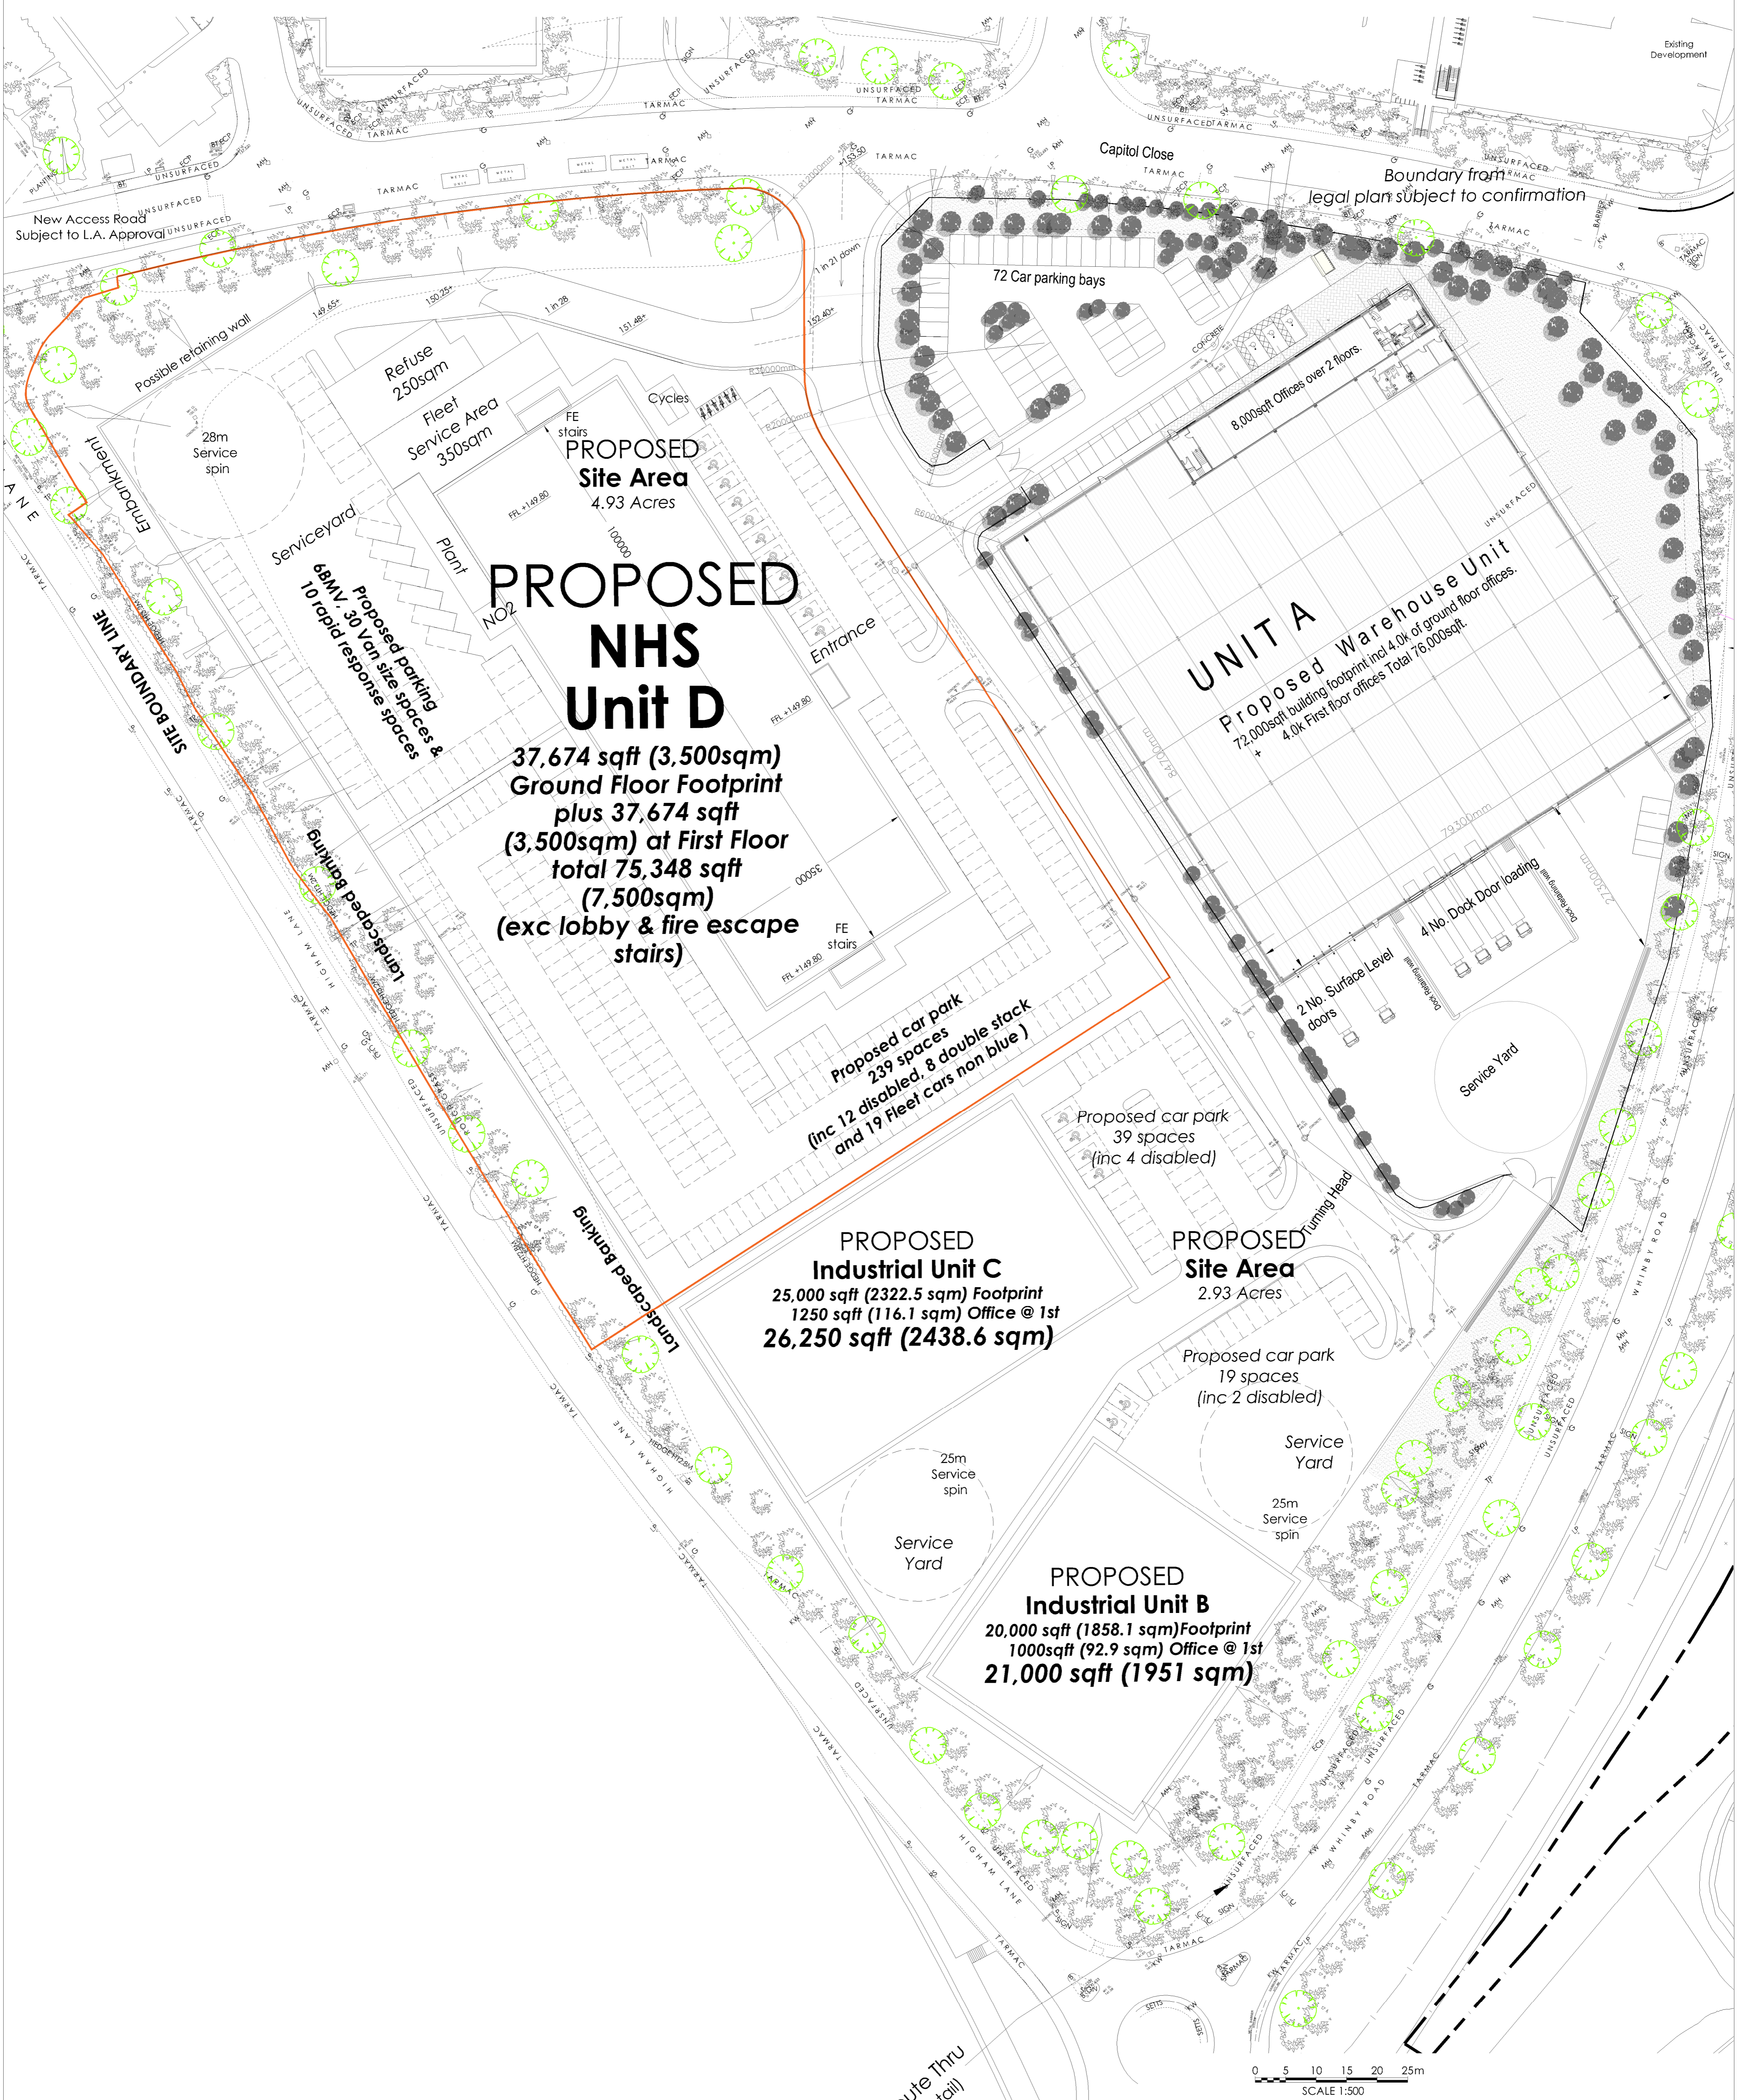
PROPOSED NHS Unit D

37,674 sqft (3,500sqm) Ground Floor Footprint plus 37,674 sqft (3,500sqm) at First Floor total 75,348 sqft (7,500sqm) (exc lobby & fire escape stairs)

A development masterplan is available for the site. It is proposed to develop the site for a commercial end use comprising two industrial units and one two-storey office block, referenced Unit B, Unit C and Unit D respectively. The plan is referenced below and a copy is contained in Appendix A.

- The Harris Partnership. Proposed Development Masterplan, Capitol Park, Junction 37 - M1, Higham Lane, Barnsley. Proposed Site Plan. Job Dwg No 14120-043, dated 12.04.2017.
