# Proposed Lidl, Cross Keys Lane, Hoyland

## Phase 2 Ground Investigation Report

Curtins Ref: 078794-CUR-00-XX-RP-GE-001-V01

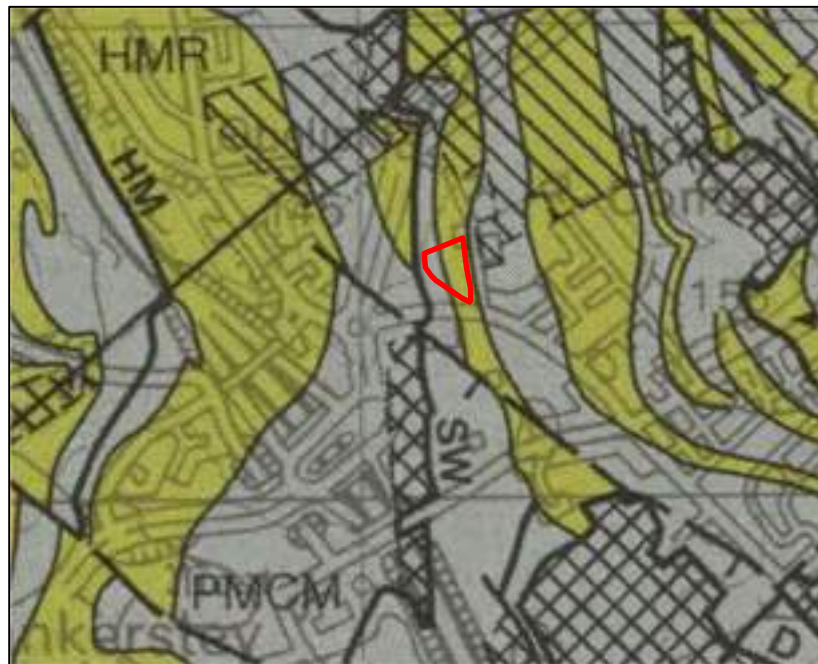
Figure 2.3 Map Extract from 1:50,000 scale BGS Map Sheet 87 'Barnsley', dated 2008

The 1:50,000 scale BGS Map Sheet 87 'Barnsley', dated 2008 indicates the coal outcrop to the west of the site to be the Swallow Wood Coal which is indicated to be between 0.2 and 3.7m thick. The Swallow Wood Coal is underlain by the Haigh Moor (Kexbrough) Rock, a named sandstone unit between 0.0 and 28m thick. Further coal seams (Top Haigh Moor Coal, Haigh Moor Coal and Low Haigh Moor Coal) are indicated to be present within the lower part of the sandstone unit.

Approximately 100m to the southwest of the site a fault line is indicated, orientated northwest to southeast with the downthrown side to the southwest (As shown on Figure 2-3).
