## GeoEnvironmental Investigation

Stairfoot

Barnsley

**Report Ref: A3520/21/SI**

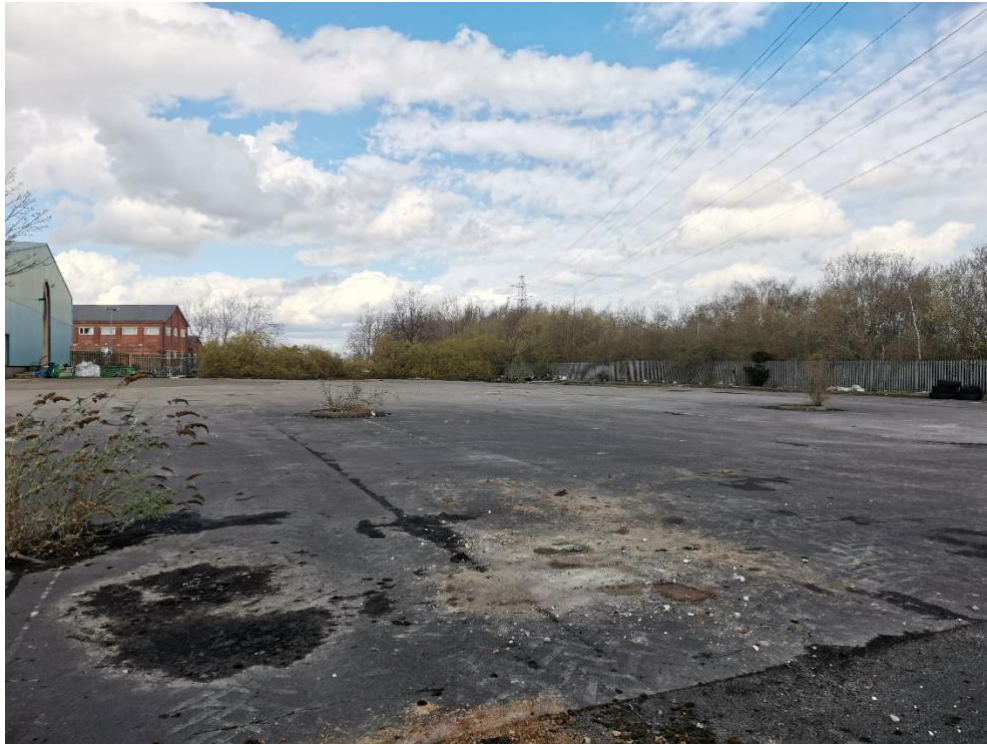
**Figure 2: General Site Photographs**

At the time of the investigation, the site was covered in hardstanding with markings for a car park.

Areas of fly-tipped materials were present across the site.

View across the site, looking north east

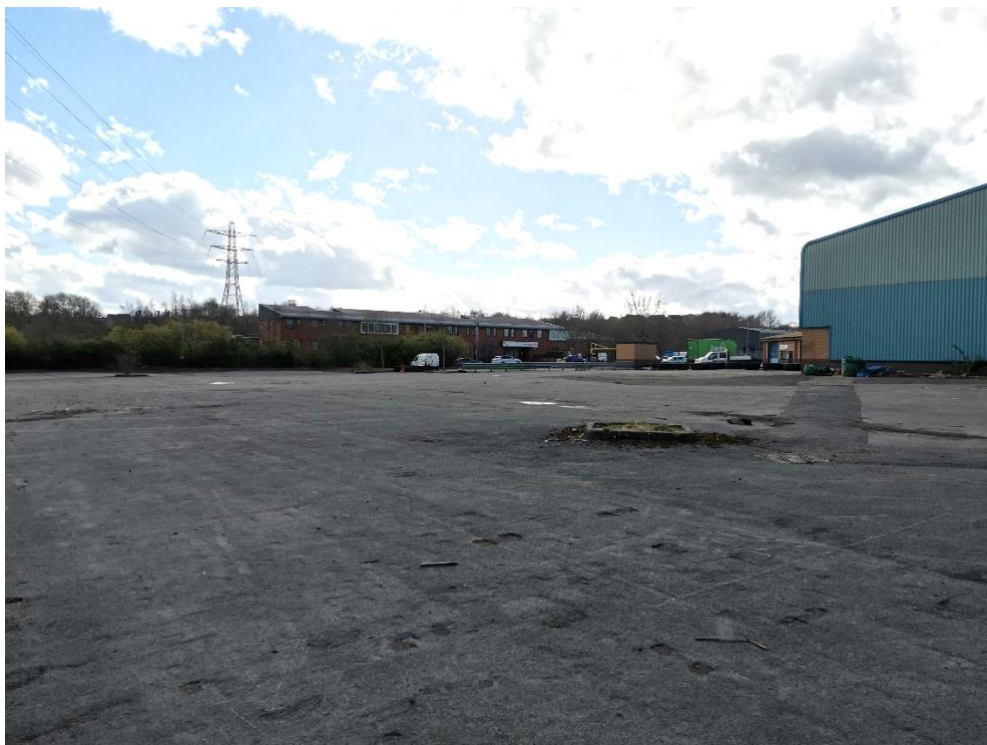
View across the site, looking south west

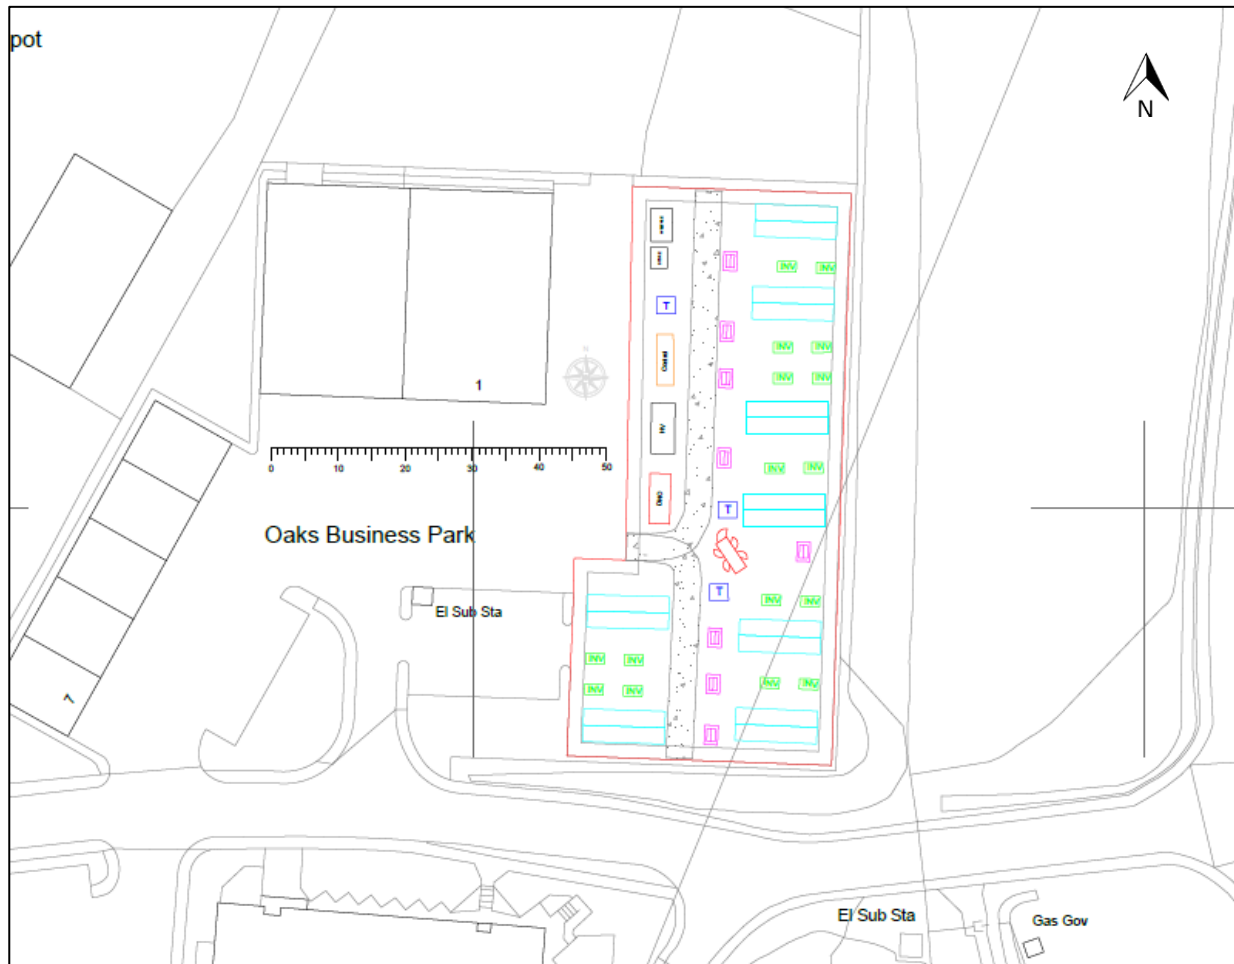
**Figure 3: Proposed Development Plan**

It is understood that the client intends to construct a battery storage facility including substations,

transformers and engines alongside other energy features and welfare facilities.
