Location:  
**Doncaster Road,  
Goldthorpe**

Report Type:  
**Arboricultural Method Statement  
inc. Impact Assessment**

Ref:  
**ARB/CP/2046**

Date:  
**December 2021**

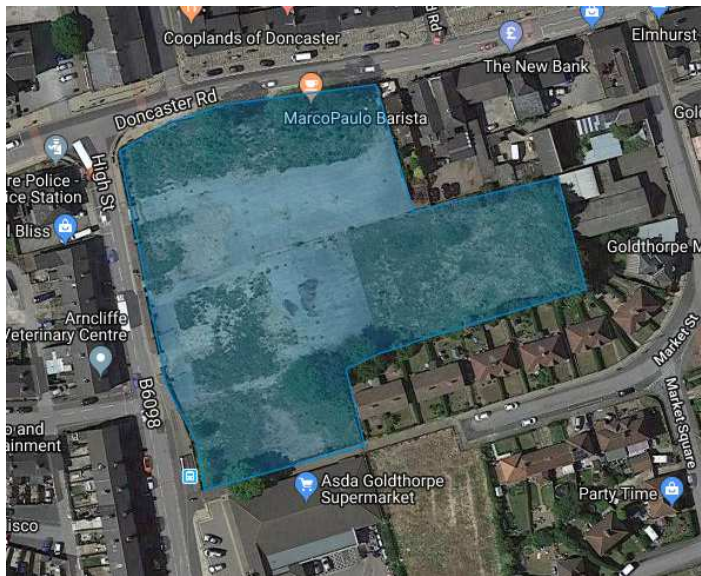
Figure 1: Area Surveyed (highlighted)

- 2.1 The area surveyed and the extent covered by this method statement is the site of the former Dearne Goldthorpe Primary School on the corner of Doncaster Road and High Street in Goldthorpe. Figure 1 shows the extent of the area.

- 2.2 The site was cleared of the school structures a number of years ago with only some areas of tarmac and concrete remaining. Rough grasses and scrub has established on the areas of soft ground.
- 2.3 The trees surveyed are primarily located along the site perimeter. Images on the internet reveal that additional trees had been present within the school grounds but have since been removed.
- 2.4 There are a small number of trees located upon adjacent property but which have an influence within the site; details of which are upon the Tree Protection Plan, Appendix 3.

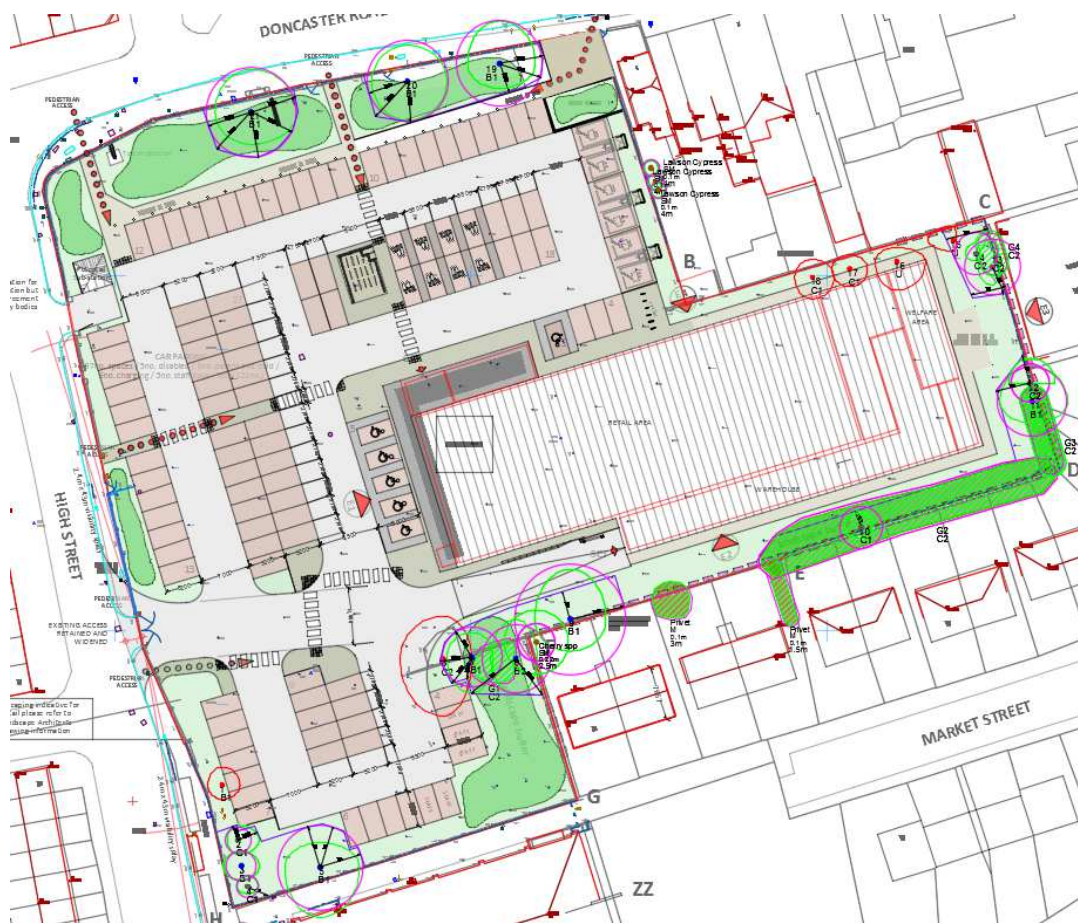
**Figure 2: Proposed Layout**

- 4.1 This section concentrates on the proposed development and how it relates to the current tree population within the site. Any conflict issues between the proposed layout and existing trees are discussed and remedial options, where possible, suggested.
- 4.2 As displayed within Figure 2 it is proposed that a retail development with supporting infrastructure will be created within the site.

As shown within Figure 2 the construction of the proposed layout will necessitate the removal of six individual trees.

**Mitigation / Countermeasure:** One of the trees requiring removal were classified as Category B; three trees as Category C and two trees as Category U. The remaining fifteen trees and four groups within the site can be retained. In arboricultural terms, the magnitude of impact from the tree removals is considered to be low.

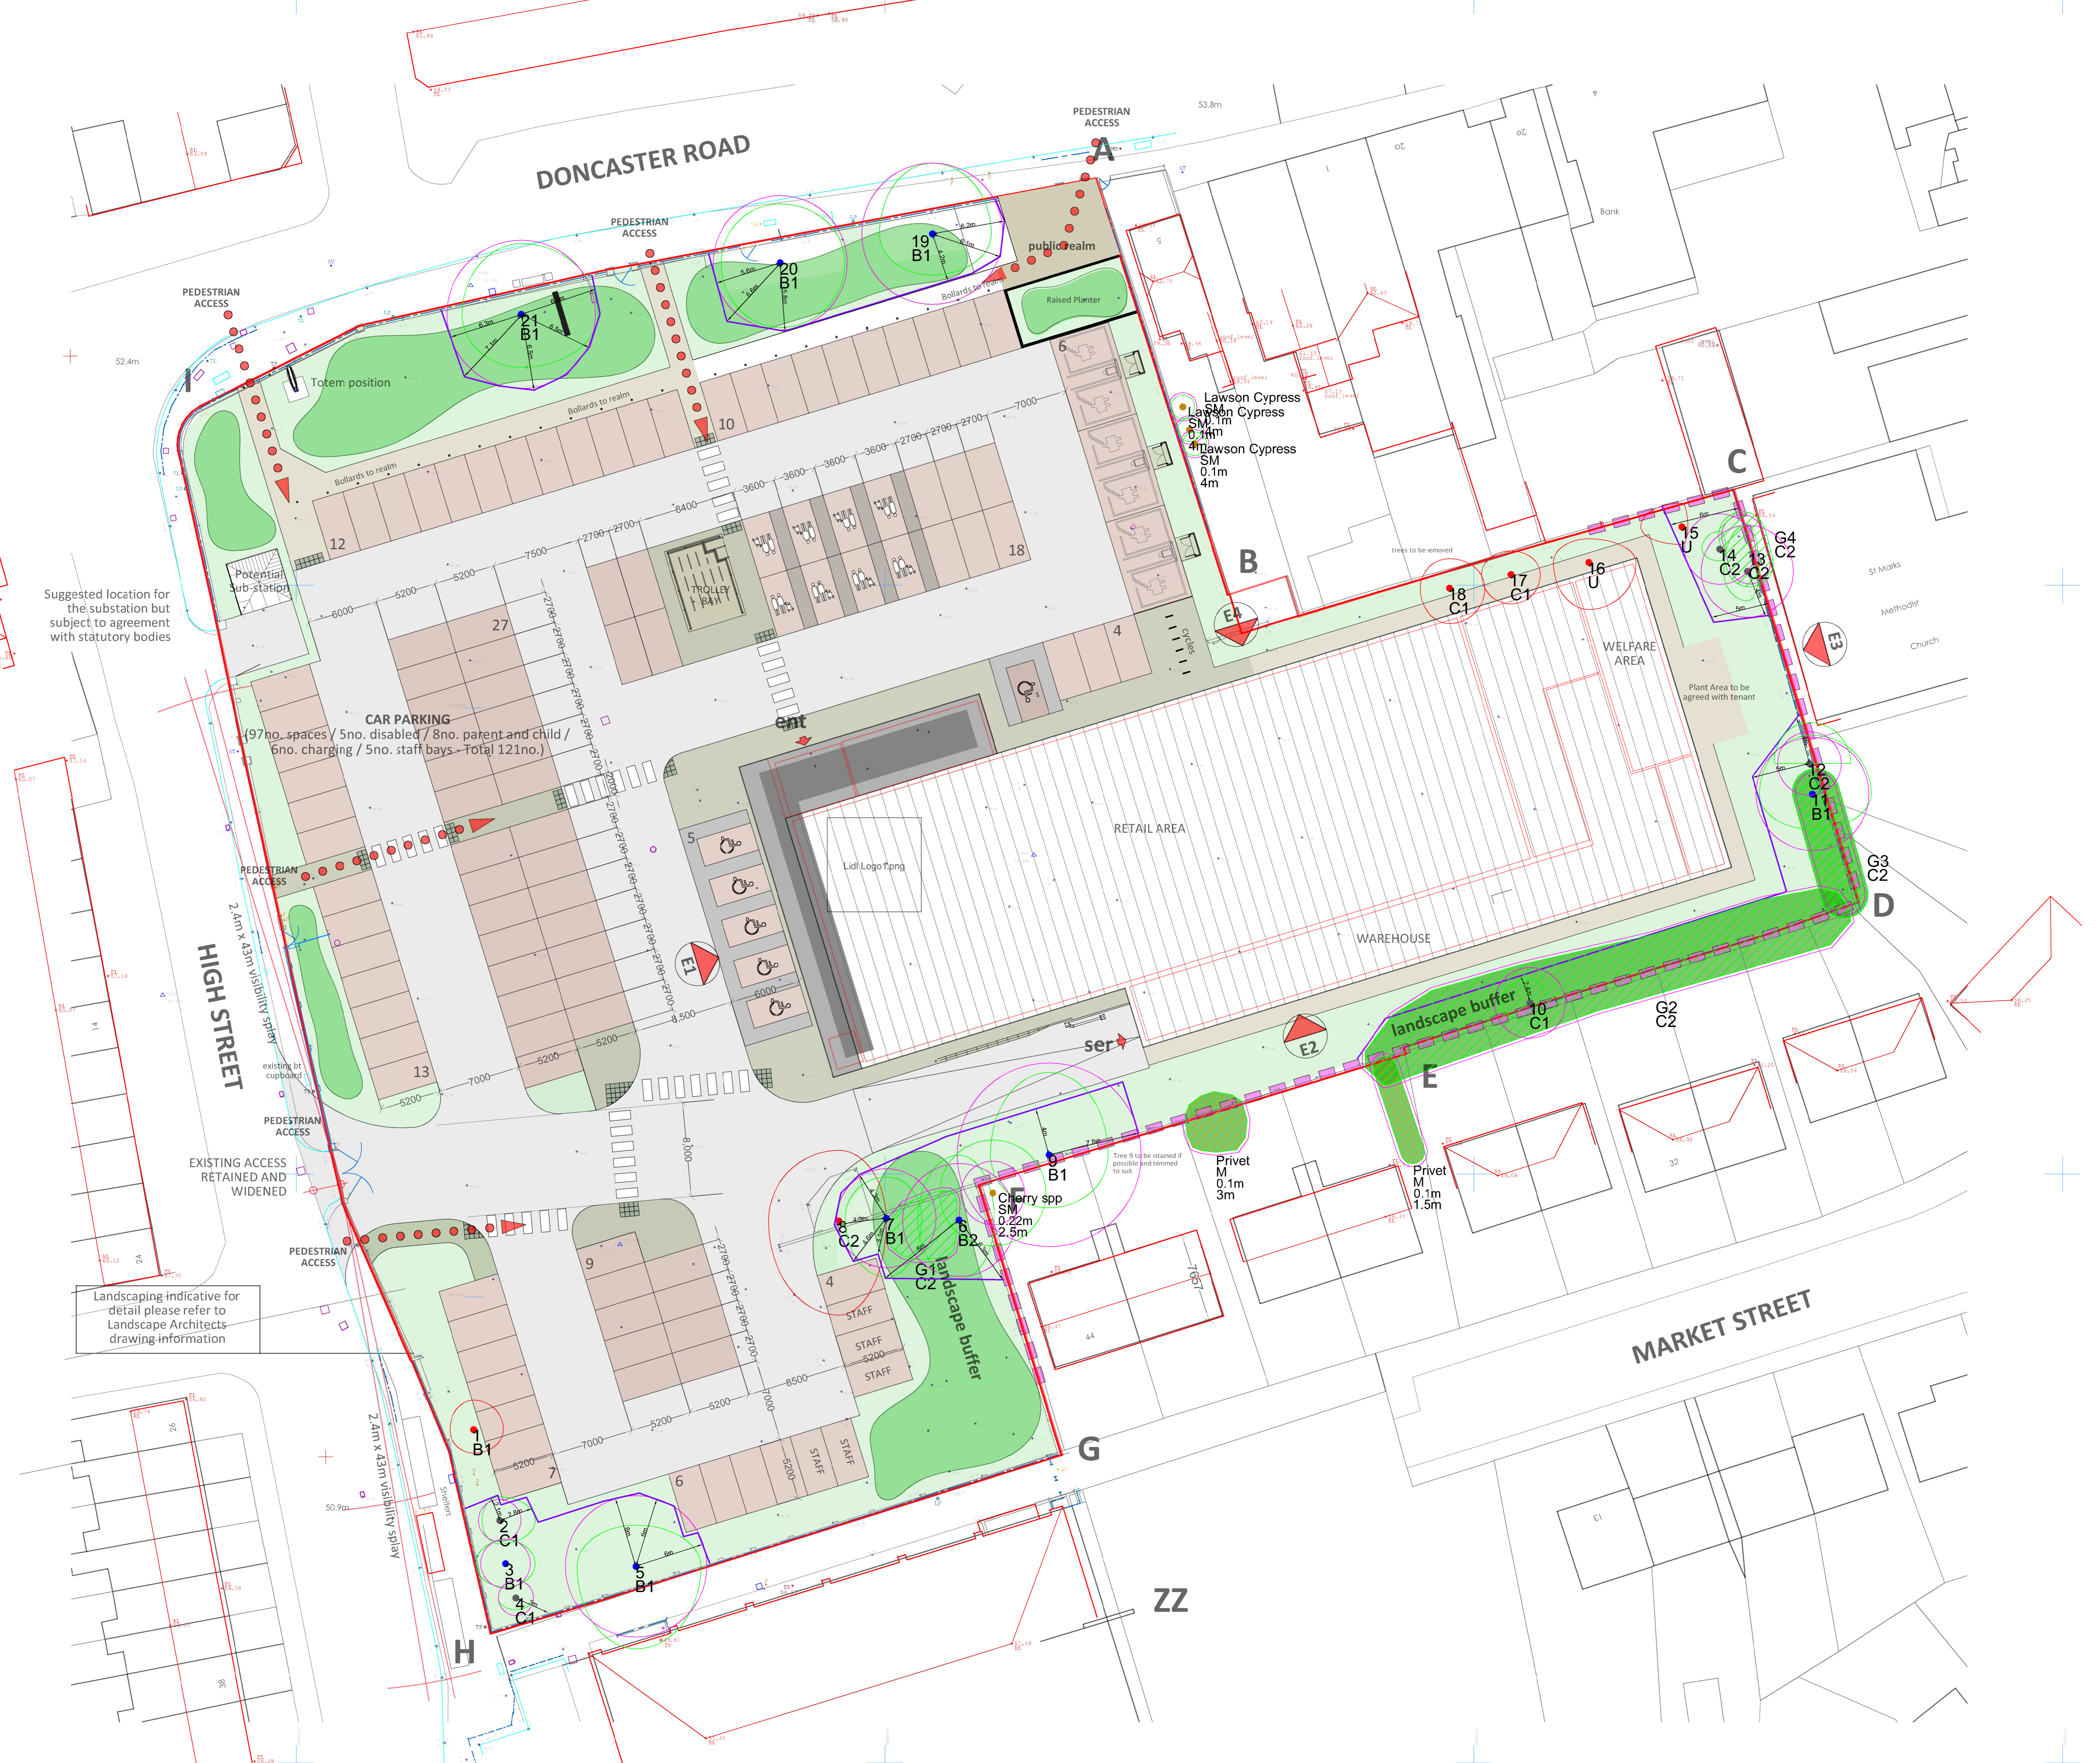
Suggested location for the substation but subject to agreement with statutory bodies

Landscaping indicative for detail please refer to Landscape Architects drawing information

- 5.3 Once the aforementioned tasks have been completed and prior to any site work the tree protection barriers need to be erected as per the Tree Protection Plan (Appendix 3). The barrier must encompass the root protection areas and crown extents of the retained trees to ensure that these areas remain free from disturbance.

- 5.3.1 The barriers needs to be installed according to the locations found on the Tree Protection Plan, Appendix 3 and conform to the specification within Appendix 4, unless a suitable alternative is agreed with the Local Planning Authority. All weather notices should be attached to the fencing marked with the following: '*Construction Exclusion Zone - Keep Out*' (a notice is provided within Appendix 7).
