**DESK STUDY & PHASE I COAL
MINING RISK ASSESSMENT
FOR
PARKSIDE, HOYLAND**

Client:	Newlands Developments
Report Title:	Desk Study & Phase I Coal Mining Risk Assessment for Parkside, Hoyland
Report Number:	HOY-AG-VGT-XX-RP-CE-AG3080D-20-AK84
Report Status:	Validated Issue 1
Date:	August 2020

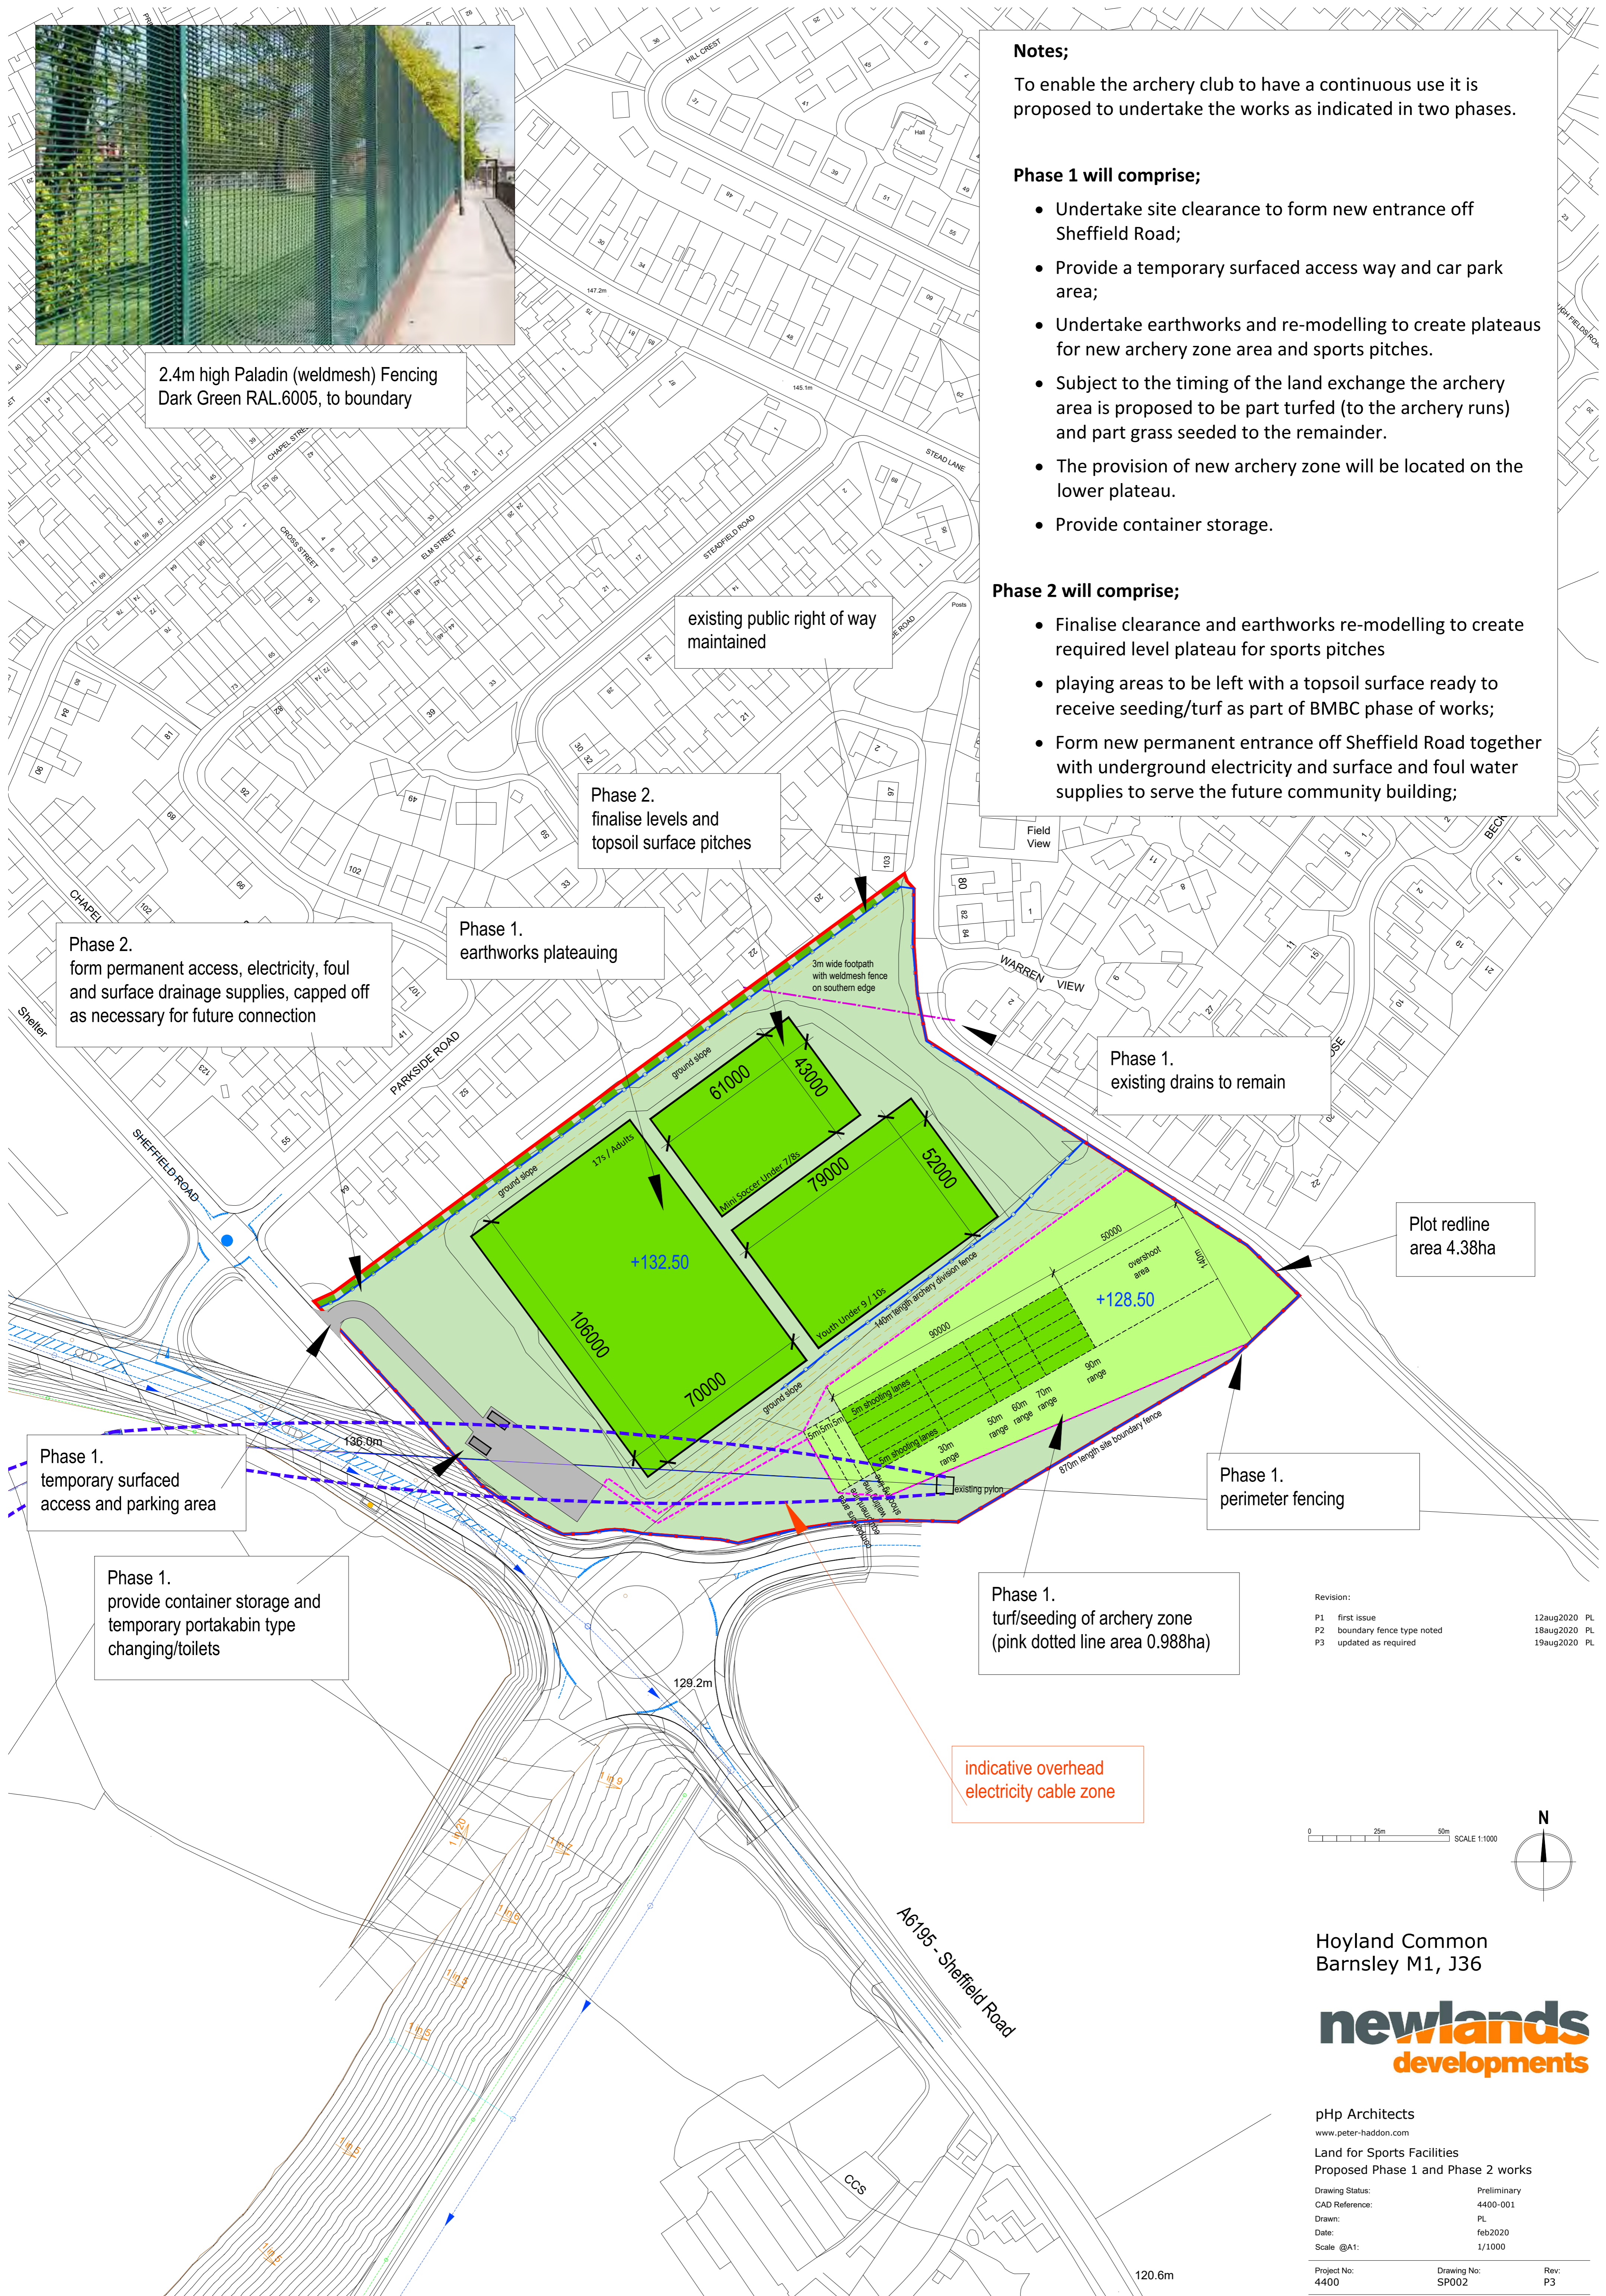
php Architects
www.peter-haddon.com
Land for Sports Facilities
Proposed Phase 1 and Phase 2 works
Drawing Status: Preliminary
CAD Reference: 4400-001
Drawn: PL
Date: feb2020
Scale @A1: 1/1000
Project No: 4400
Drawing No: SP002
Rev: P3

Phase 2 will comprise;

- Finalise clearance and earthworks re-modelling to create required level plateau for sports pitches
- playing areas to be left with a topsoil surface ready to receive seeding/turf as part of BMBC phase of works;
- Form new permanent entrance off Sheffield Road together with underground electricity and surface and foul water supplies to serve the future community building;

The proposals comprise the construction of football pitches and an archery pitch, temporary car parking and a temporary container for changing facilities, refreshments etc. There will be up to 2.9m of cut and up to 3.6m of fill required to create the proposed levels for the various pitches. The development will be carried out in two phases (Phase 1 and Phase 2). Details of the proposed layout, the proposed levels and the earthworks required are shown on various drawings included in Appendix A.

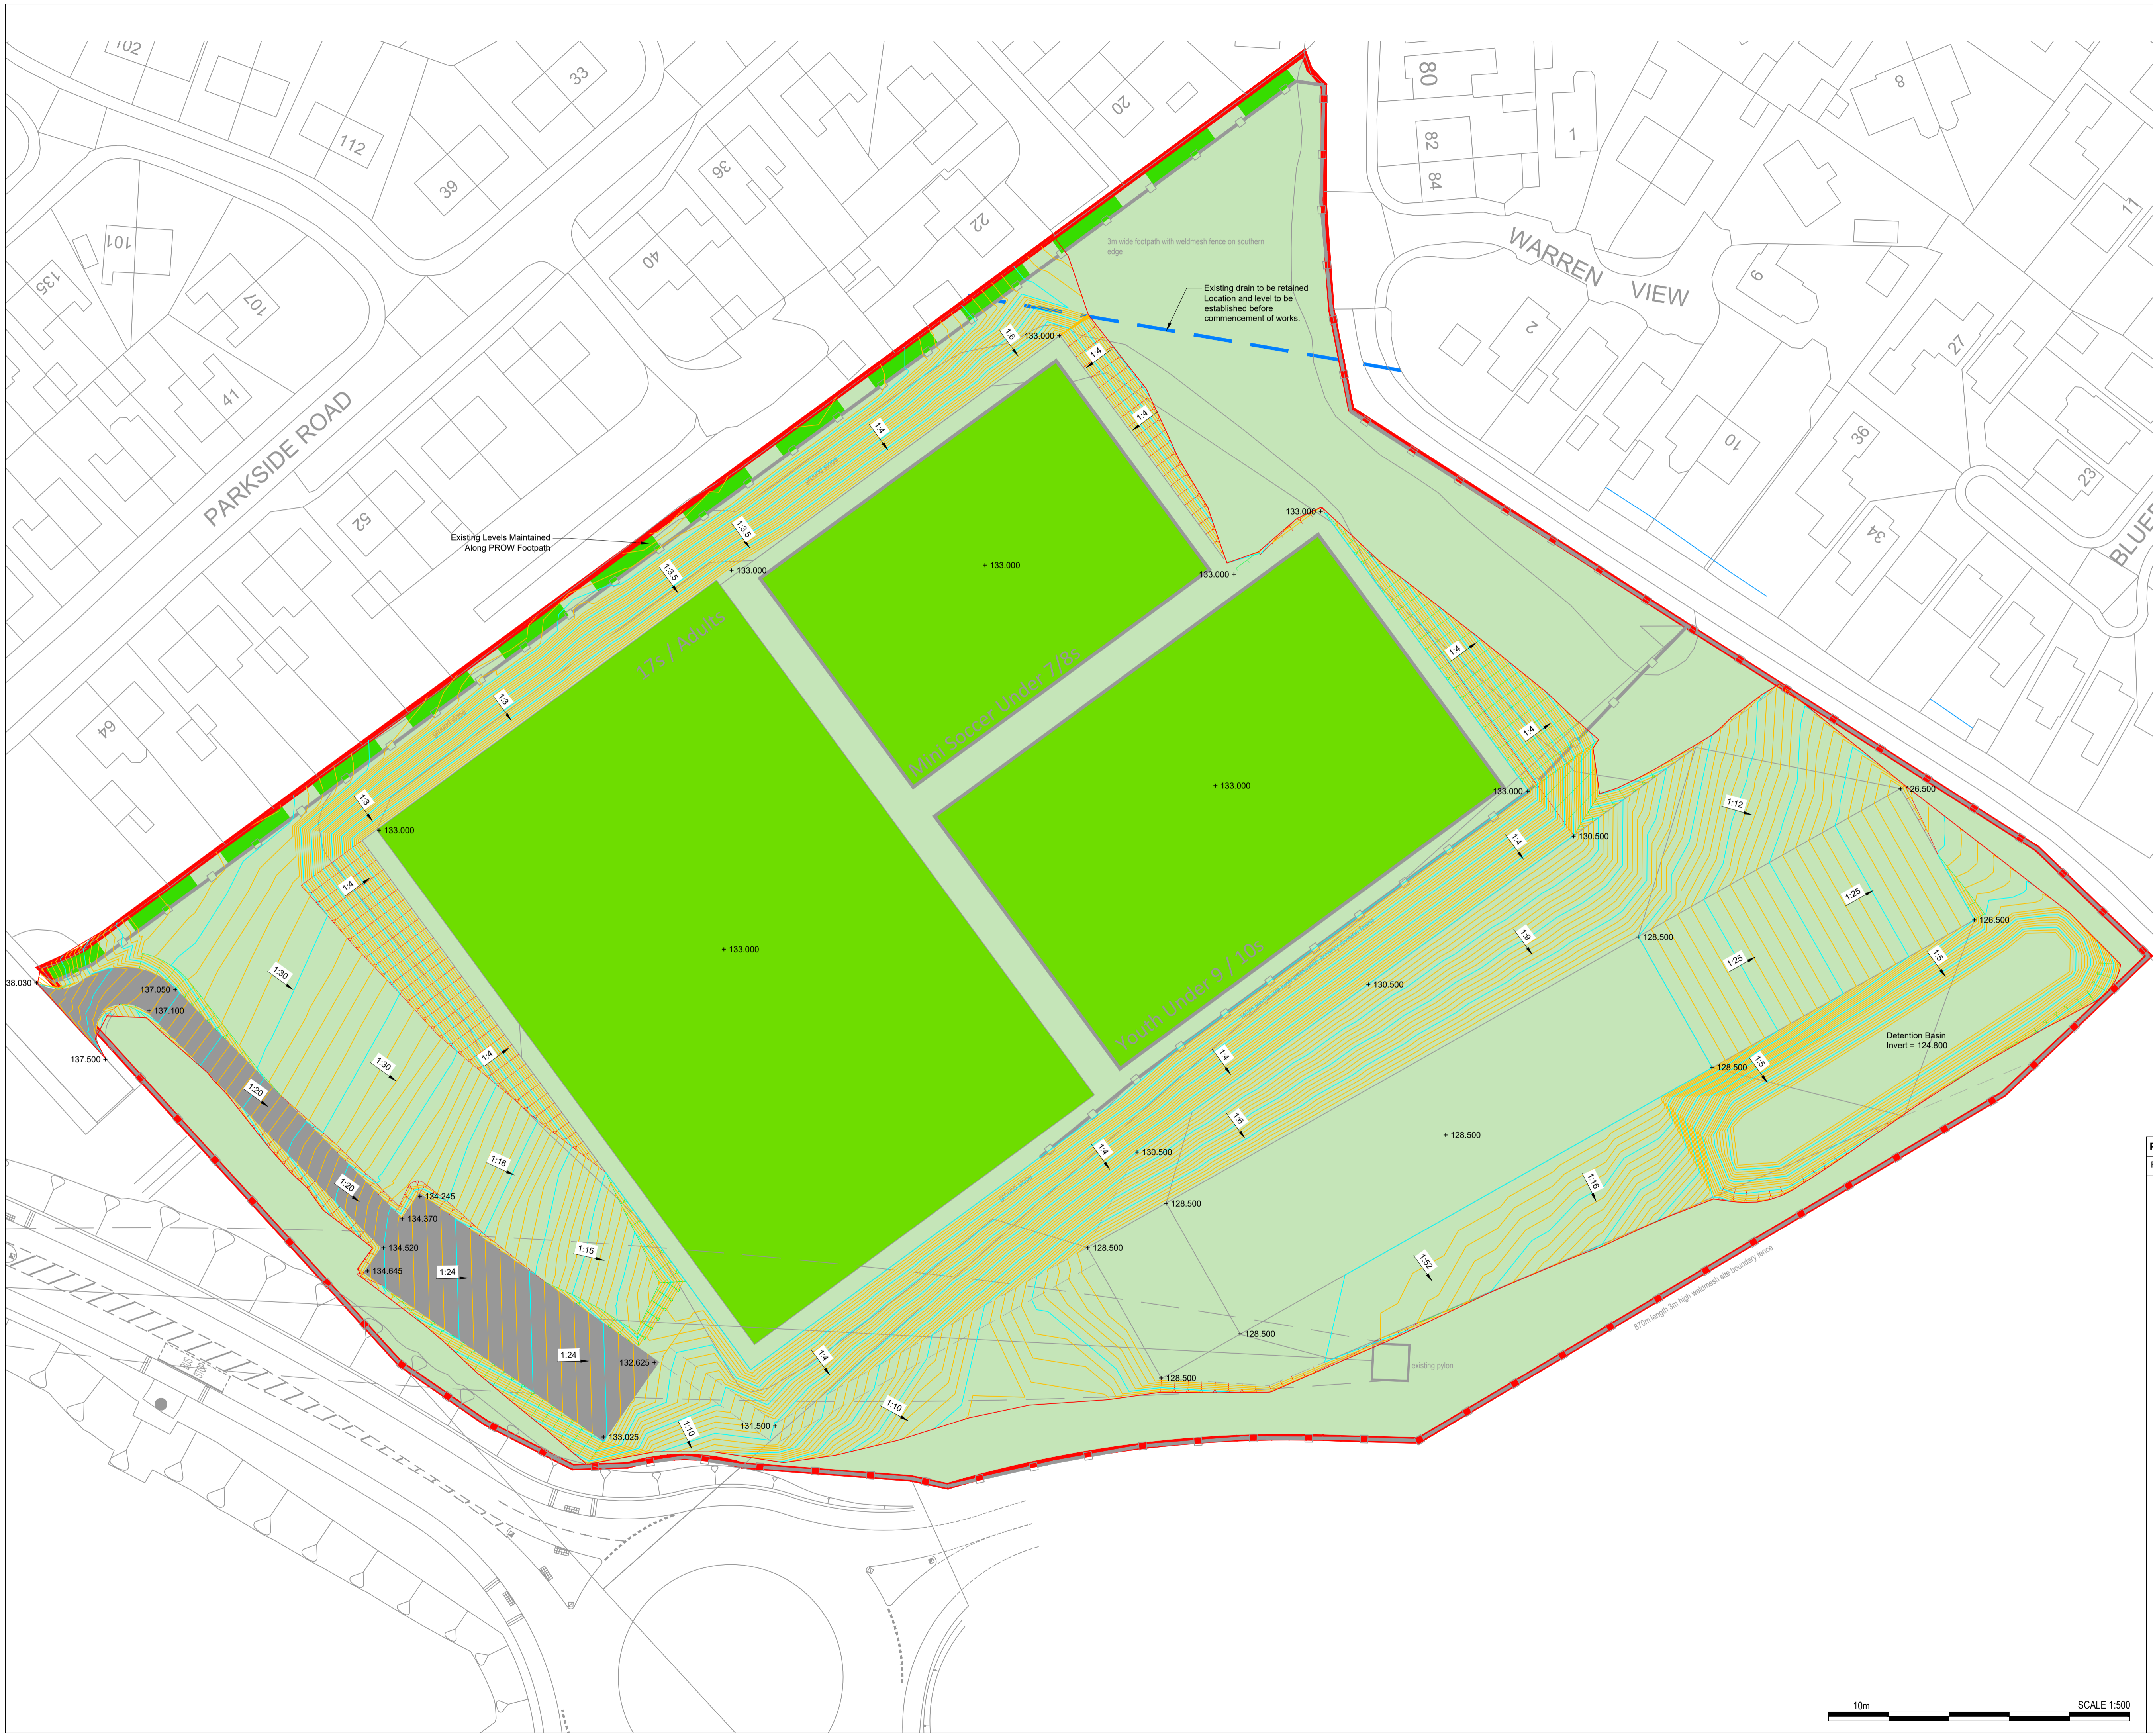
Title **Sports Facility
Proposed Levels**

- Key:
- + 130.500 : Proposed Level
 - 1:6 : Proposed Gradient
 - Major Contour 0.5m Intervals
 - Minor Contour 0.1m Intervals
