BARNSELY LEVELLING UP FUND, BARNSELY YOUTH CHOIR (BYC) DESIGN & ACCESS STATEMENT

3.0 THE BUILDING

3.1 EXISTING GENERAL ARRANGEMENT PLANS

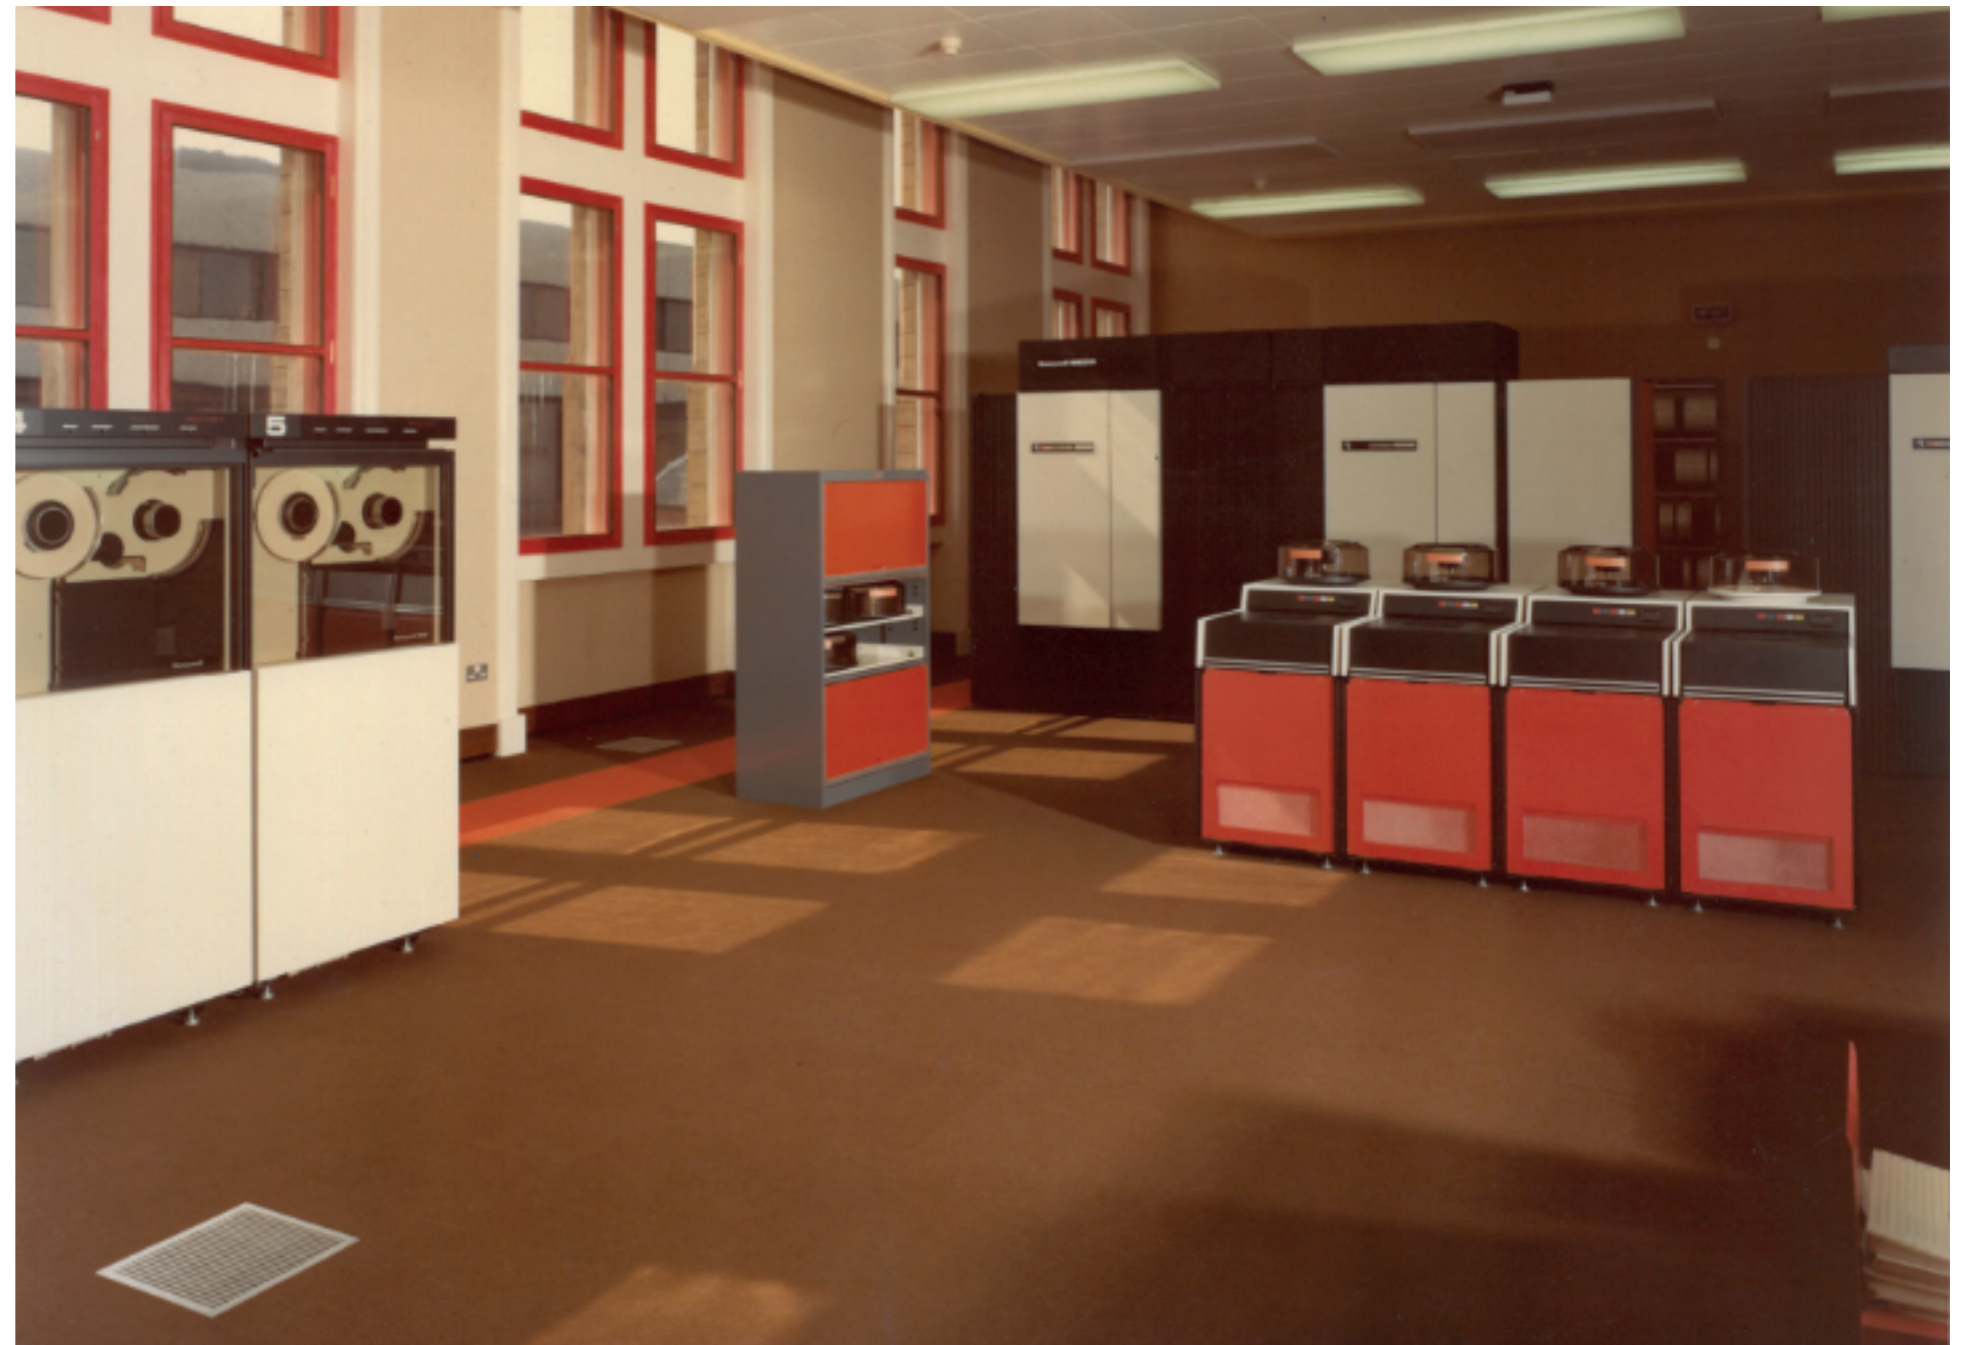
An undated image of the Computer Centre Main Hall, with the current Barnsley Law Court visible through the windows, which appear to have been secondary glazed. While not necessarily to be replicated for the current project, this image gives a rich insight into the late 1970s interior character and colour scheme, with finishes apparently matched to the computer equipment! The warmth of the colours are intensified by the time of day - the pattern of sunlight cast on the floor indicates it must have been mid-late afternoon.

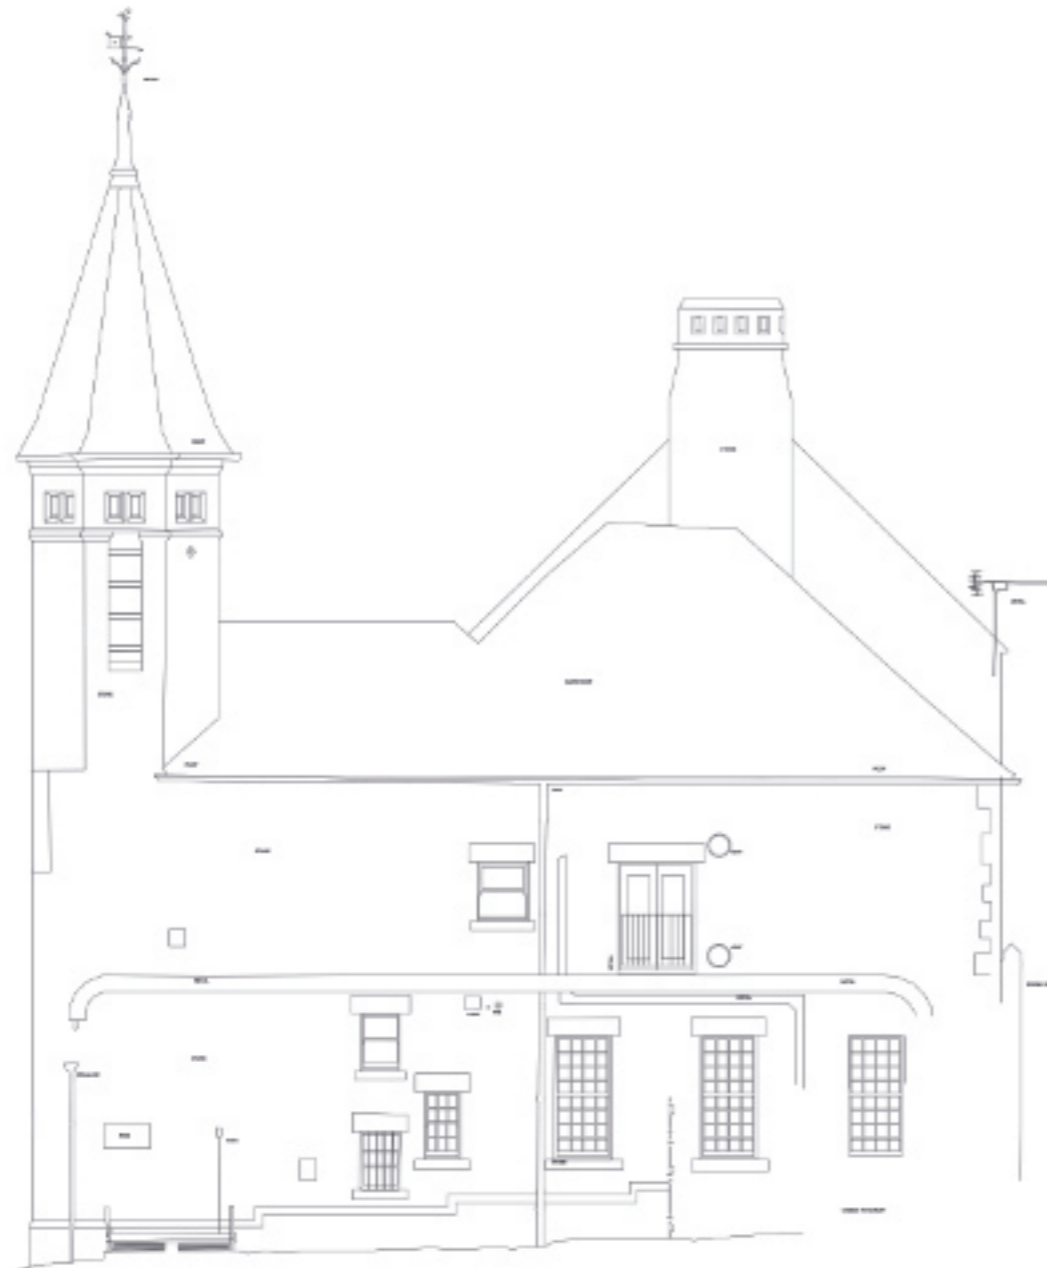
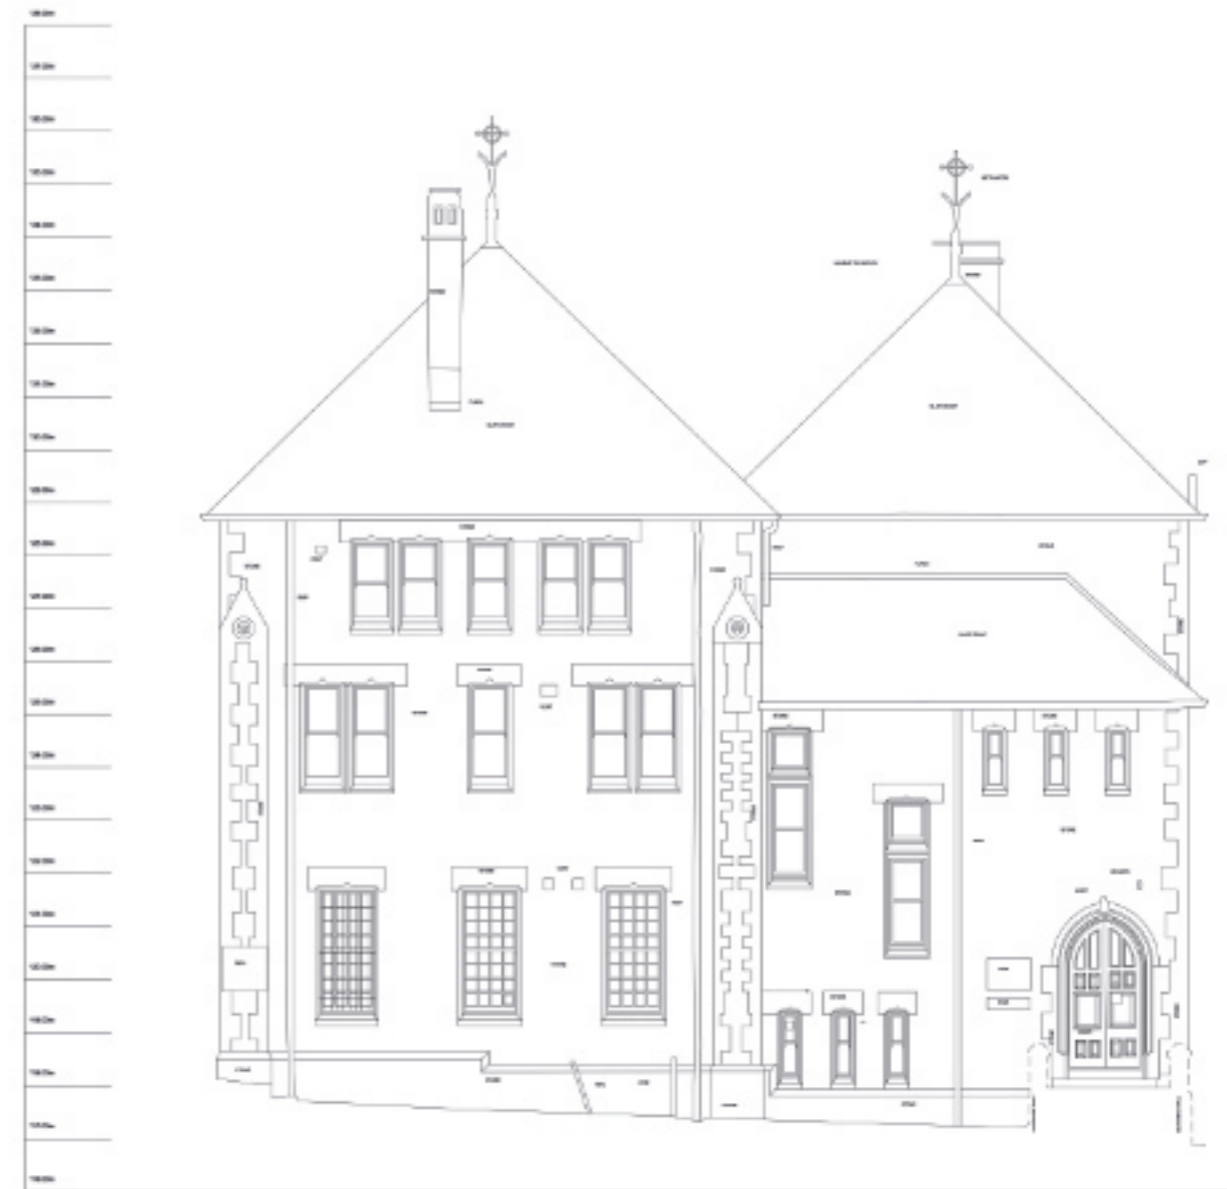
SOUTH ELEVATION

Existing Elevations show the building in its current state; elevations taken from measured survey data (see key above).

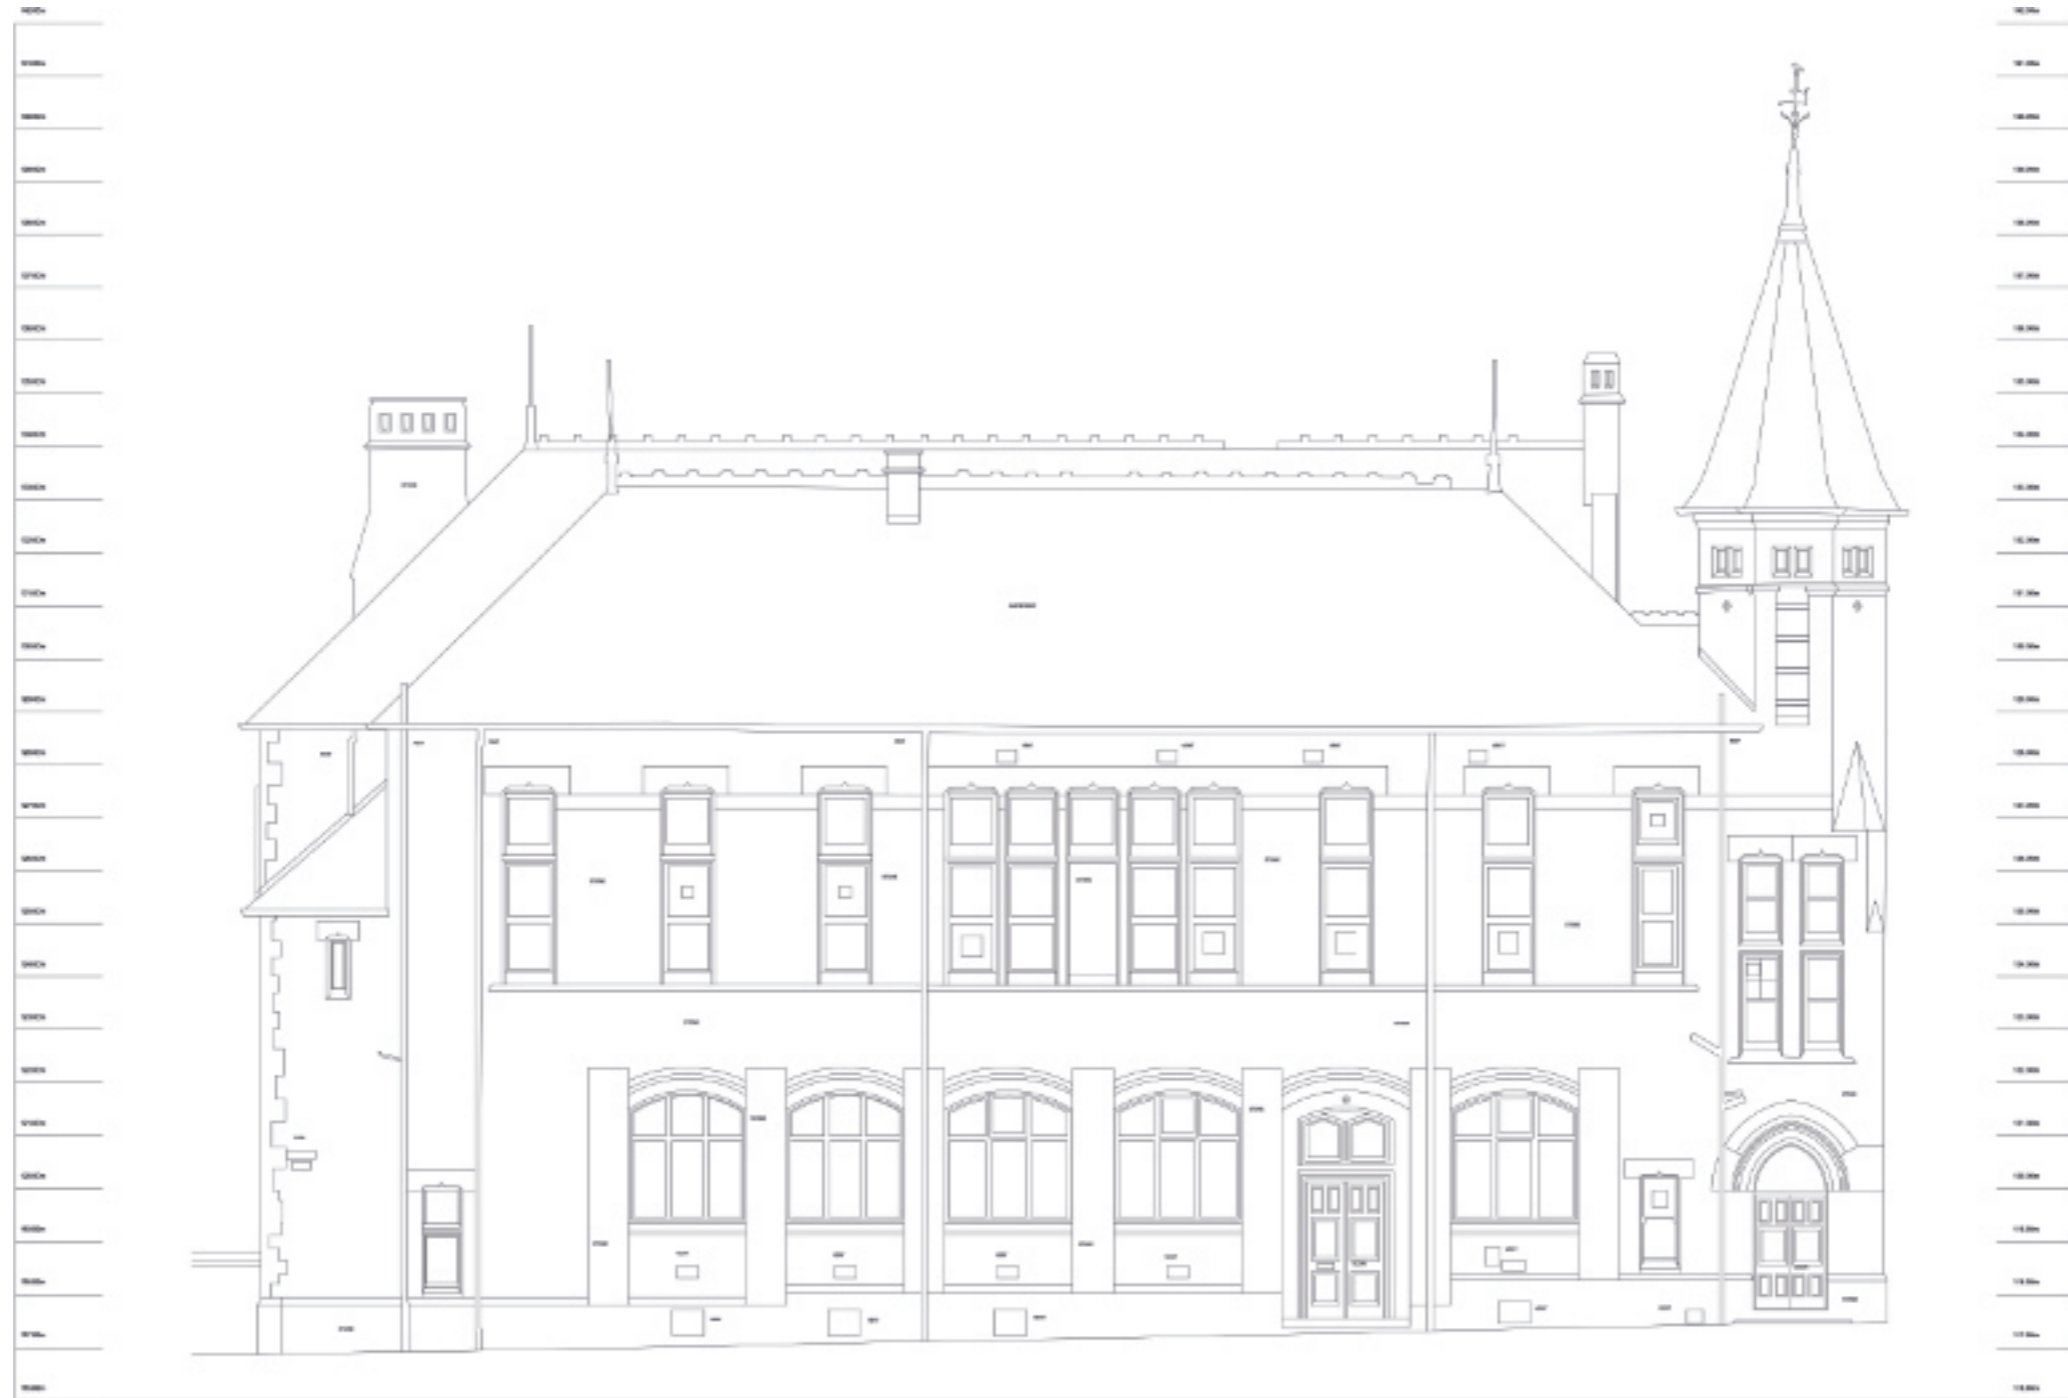
3.2.2 EAST ELEVATION

Existing Elevations show the building in its current state; elevations taken from measured survey data (see key above).

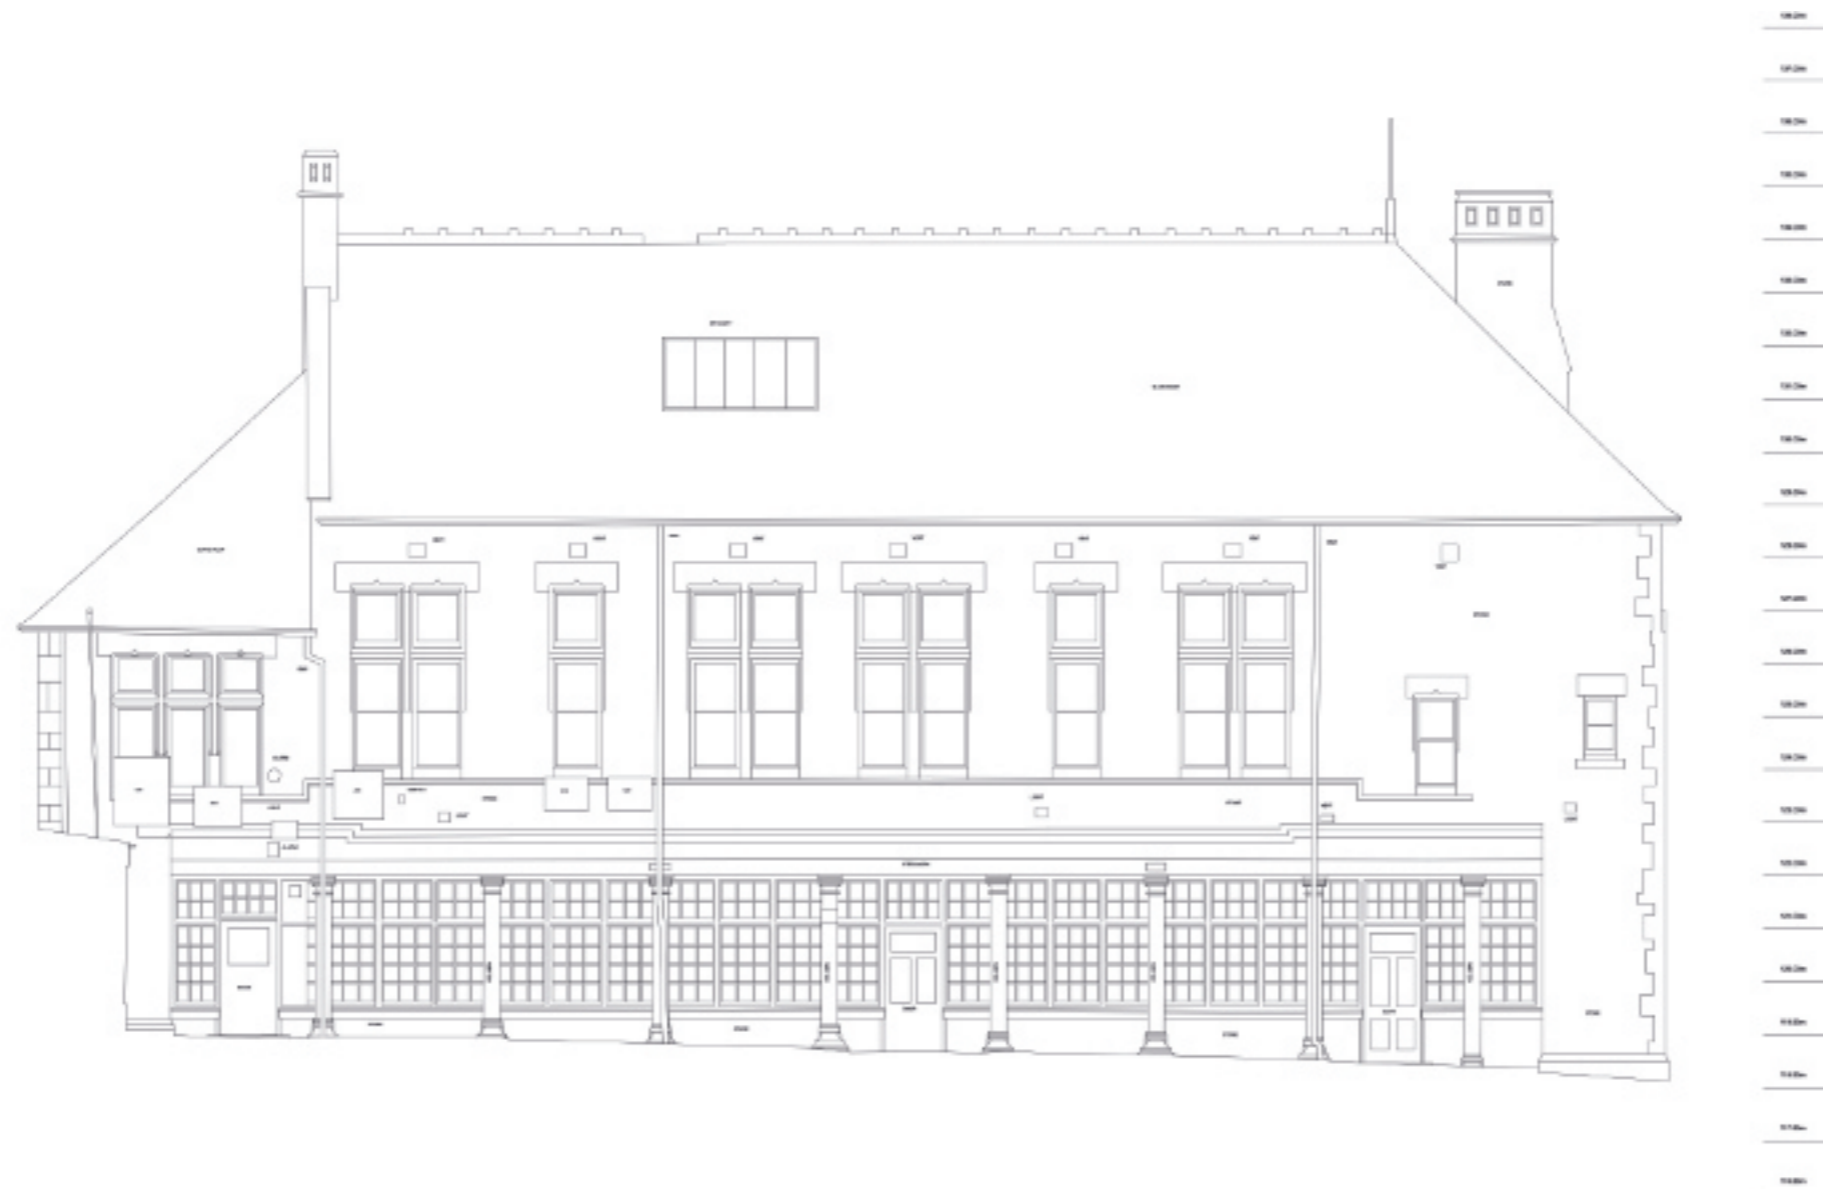
3.2.3 WEST ELEVATION

Existing Elevations show the building in its current state; elevations taken from measured survey data (see key above).

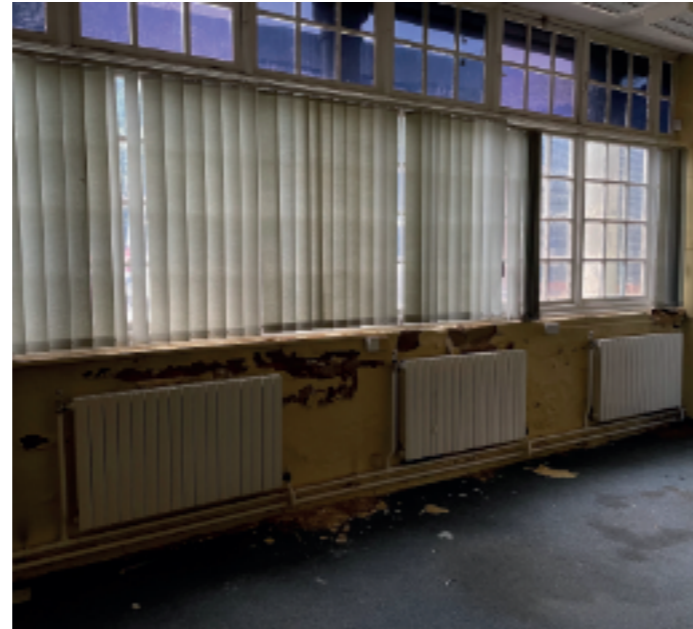
Western façade; severe water damage

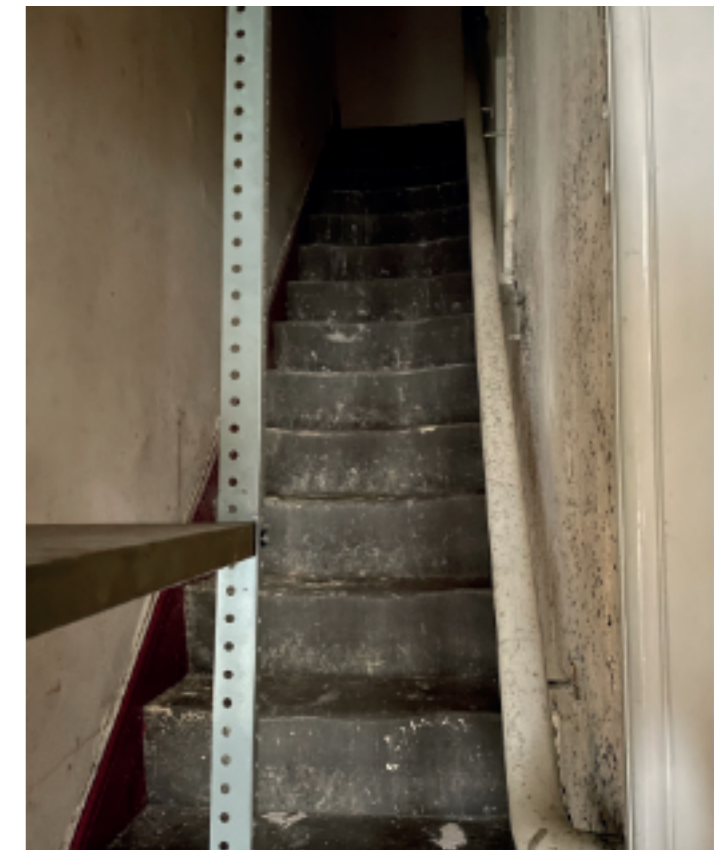
Prisoner's stair interior (blocked to First Floor)
