# Trinity Academy, Barnsley - Temporary Building

## Arboricultural Impact Statement

**Document Reference:** WIE17125-107-TN-3-1-3-AIS

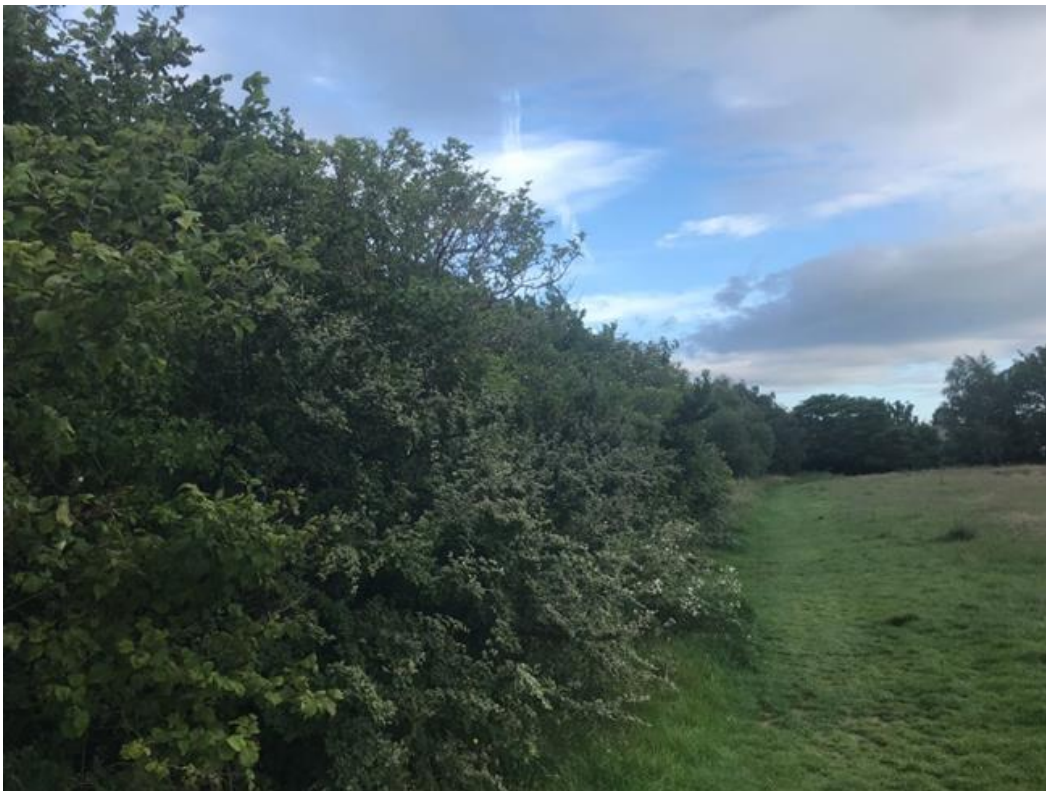
Photograph 1: Looking south east along the southern side of G75

- 2.5. G75 does extend slightly into the main part of the Site, and therefore it is proposed that a small portion of this group will be removed to facilitate the development and to provide 2m clearance beyond the Site boundary. This group consists of very young small trees, with an average stem diameter of 80mm and therefore the removal of a small section is not considered to have a significant impact on the treescape within or immediately adjacent to the Site.
- 2.6. The canopy of the eastern side of G75 and the RPA and crown of T76 both extend over and below the eastern car park part of the Site, however as only resurfacing work is proposed in this area, it is not considered that there will be any impacts on these trees.

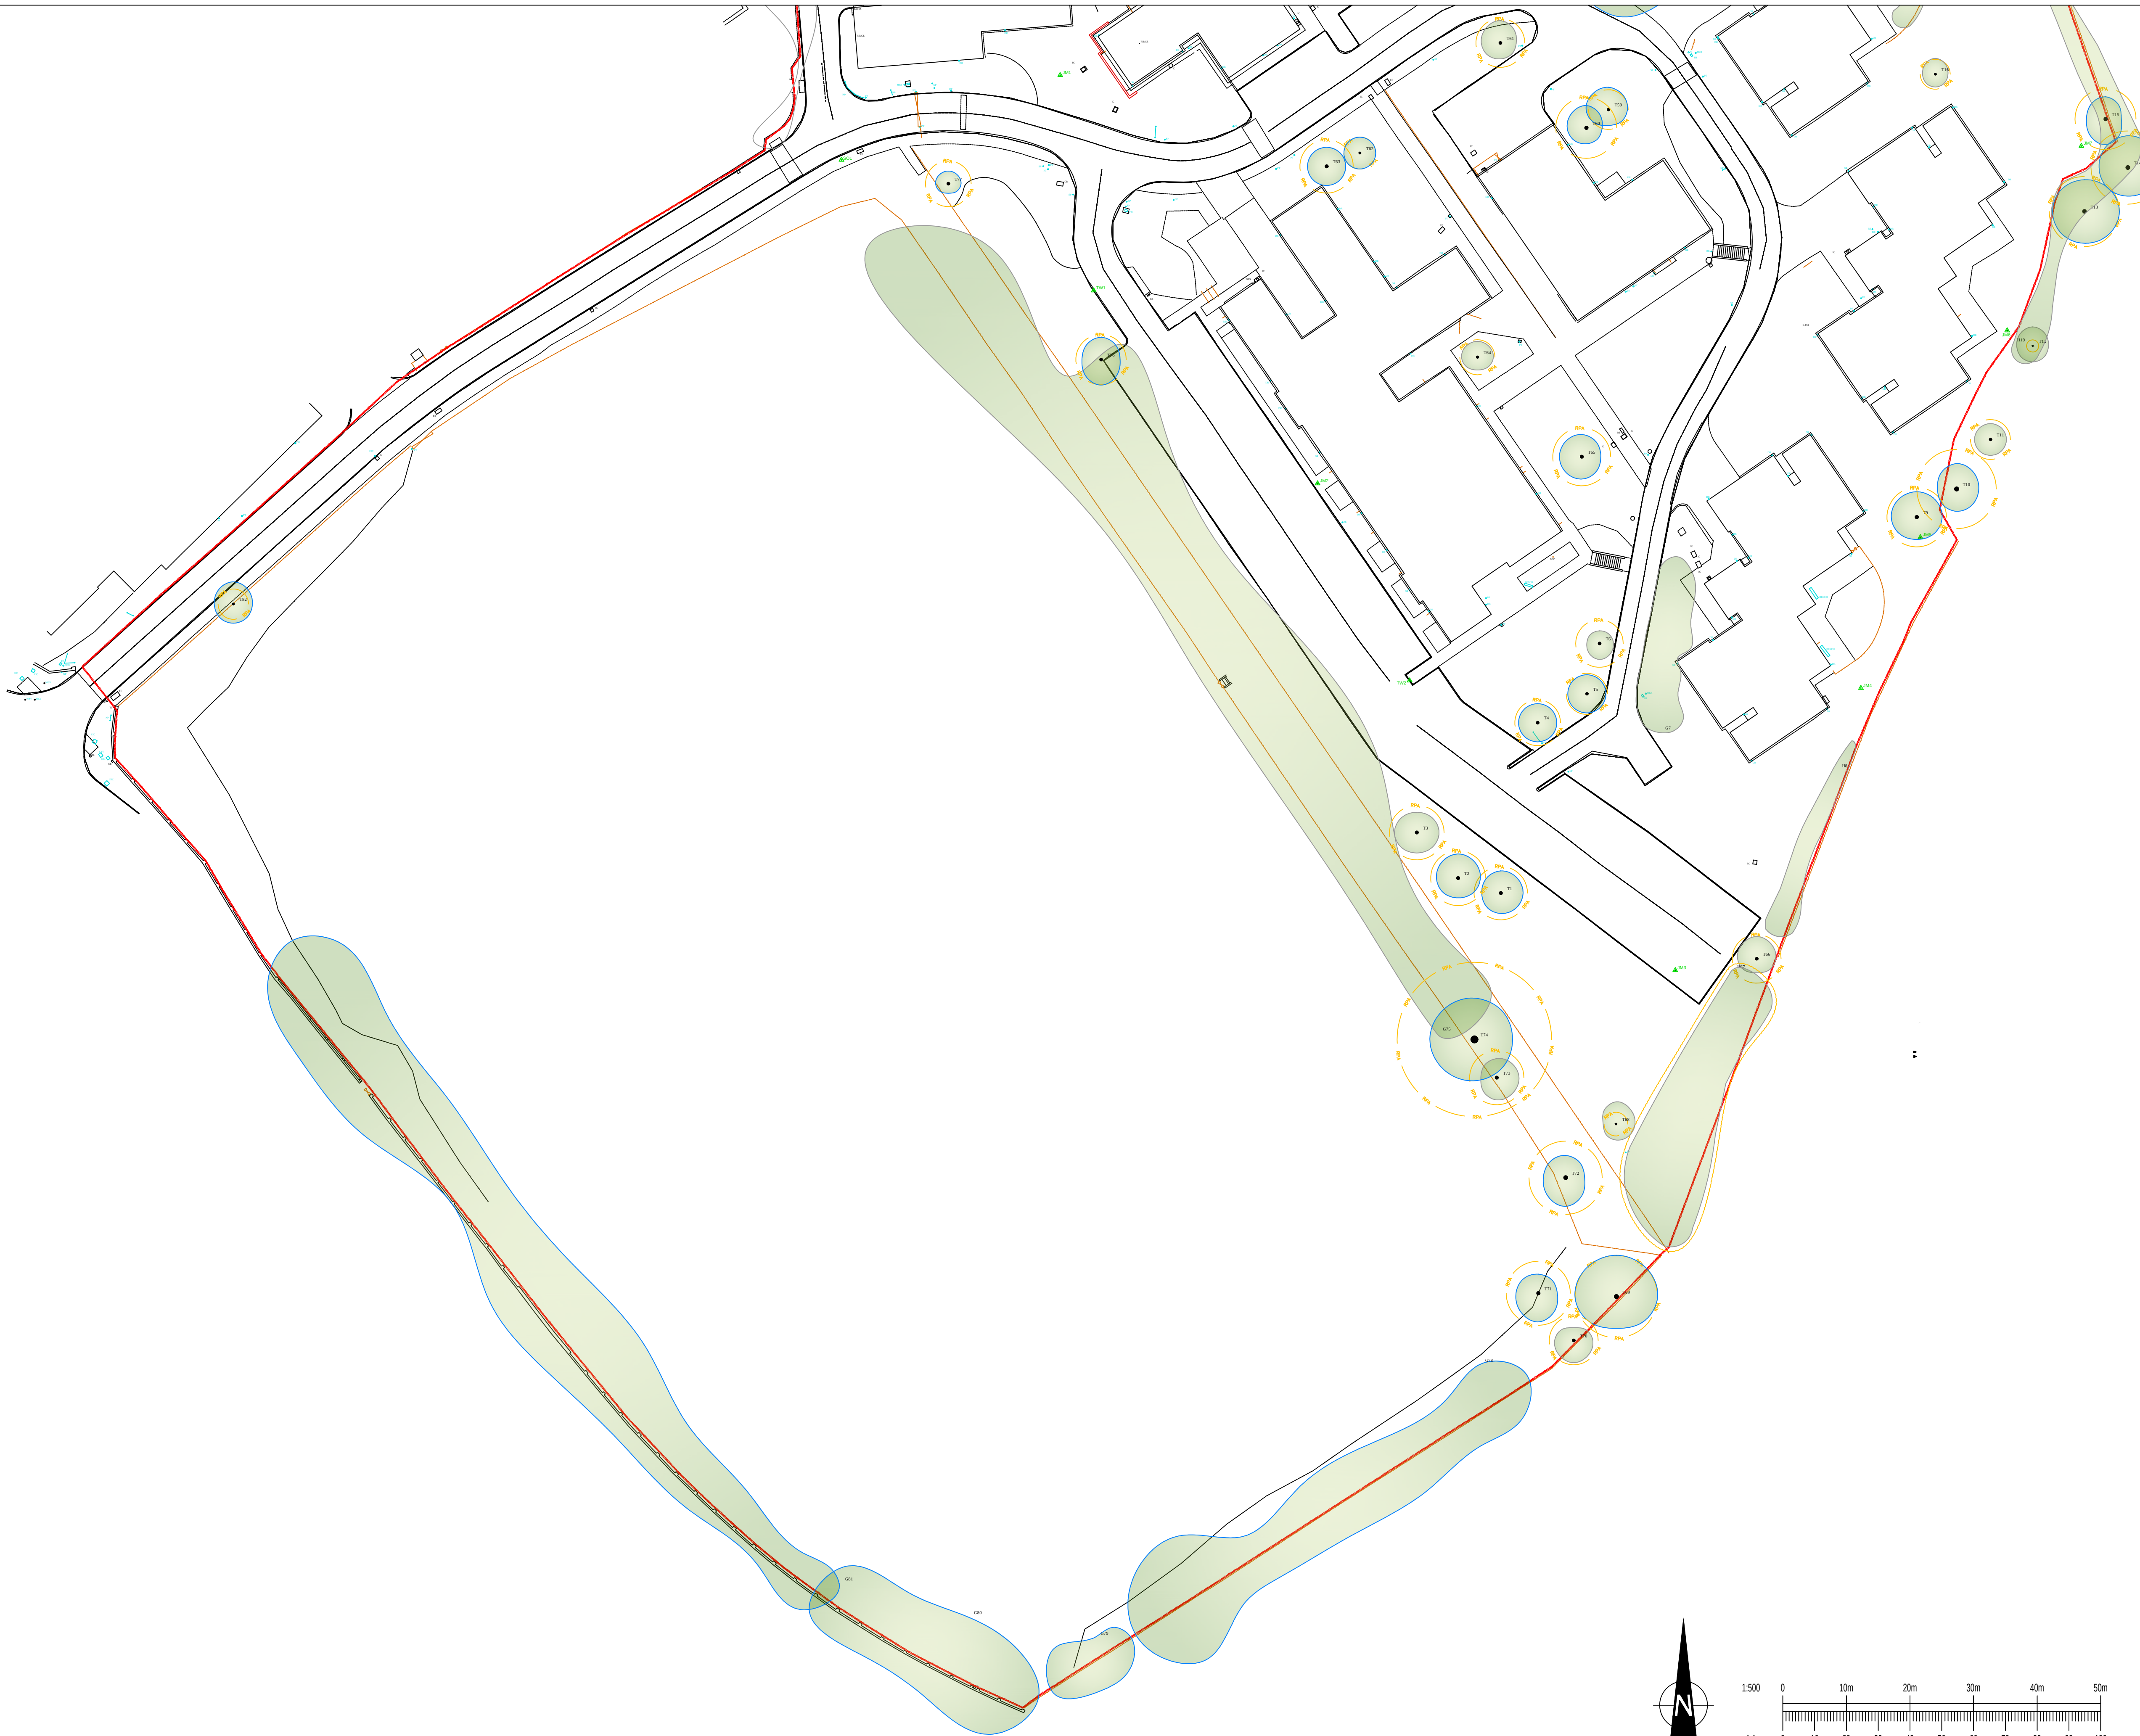
| WIE17125-ZZ-XX-107-DR-77001 | P01 |

- CATEGORY GRADE A  
Trees of high quality
- CATEGORY GRADE B  
Trees of moderate quality
- CATEGORY GRADE C  
Trees of low quality
- CATEGORY GRADE U  
Trees unsuitable for retention
- ROOT PROTECTION AREAS (RPA)
- SITE BOUNDARY
