**STONELEA BUNGALOW, LEE LANE,  
MILLHOUSES GREEN.**

**BAT SURVEY.**

**Ref No: 230324.**

**Date: 21<sup>st</sup> March 2023.**

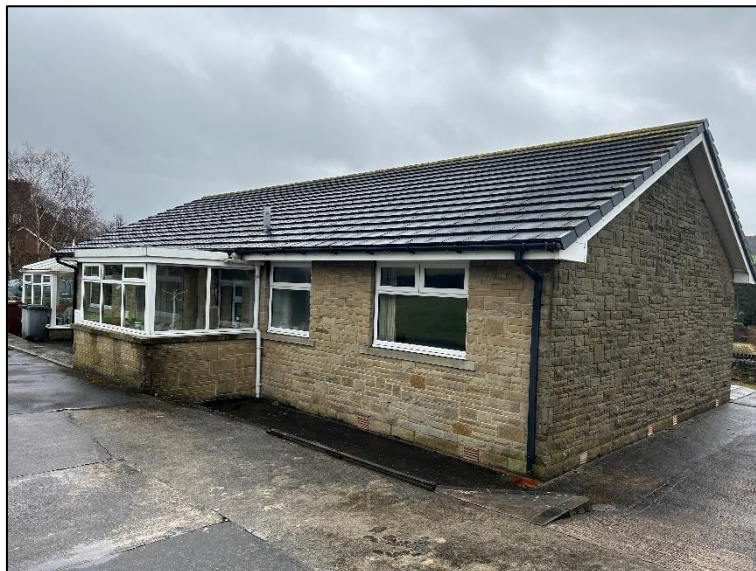
3.2.3. The survey area comprises a single building, a bungalow with stone walls and a pitched roof covered by interlocking tiles. Internally, the building has a large loft space lined with breathable roofing felt. The western aspect of the building is shown below.

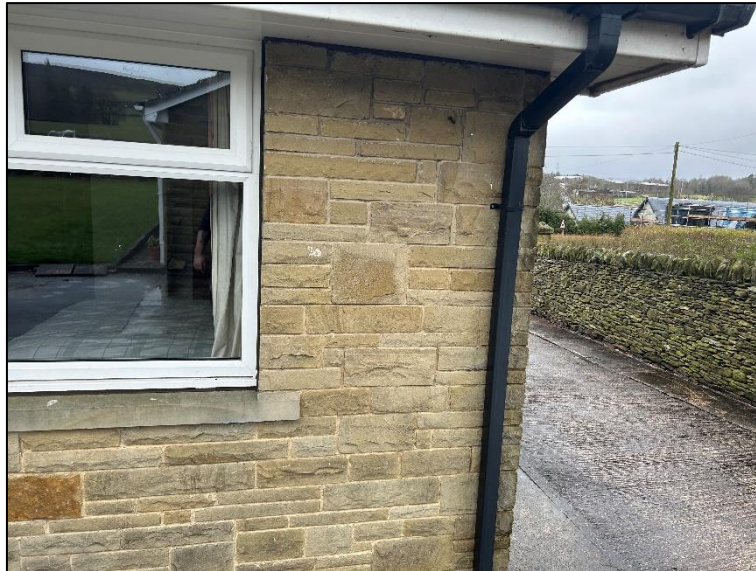
3.3.1. The stone walls of the building are in very good condition with no areas of missing mortar providing potential features for roosting bats. The below photograph shows the good condition of the walls.

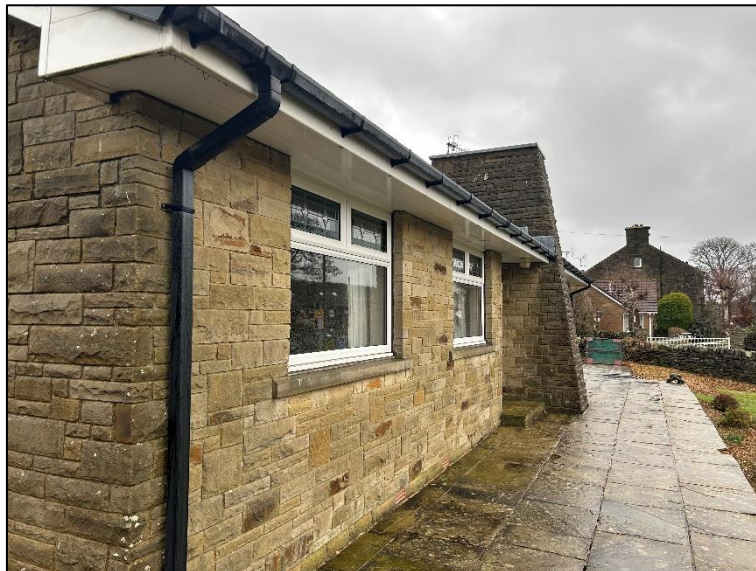
3.3.2. The soffits were in good condition and well-sealed against the wall of the building.

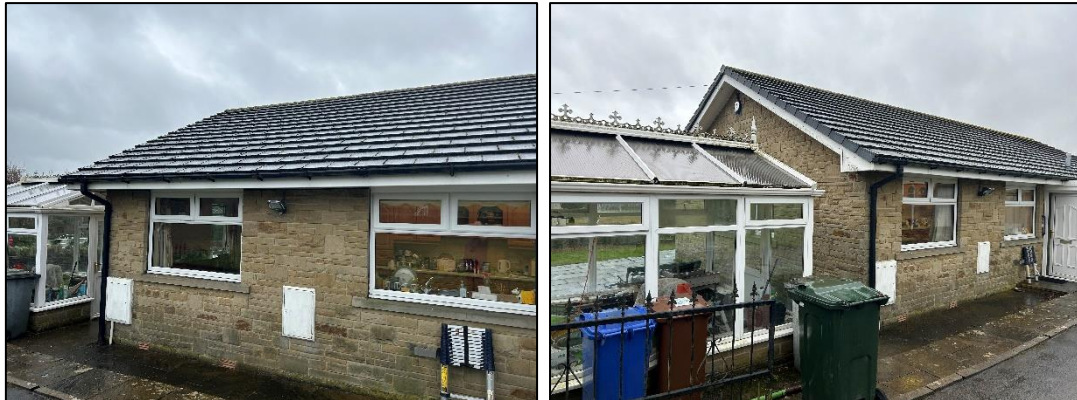
3.3.3. The roof tiles are in good condition with no slipped or damaged tiles, the photograph below shows the good condition of the tiles. There are plastic caps on the gable ends of the roof, however, given the good condition of the rest of the building it

is considered extremely unlikely any areas of missing mortar are concealed beneath these caps. The flashing around the chimney was also found to be in good condition.

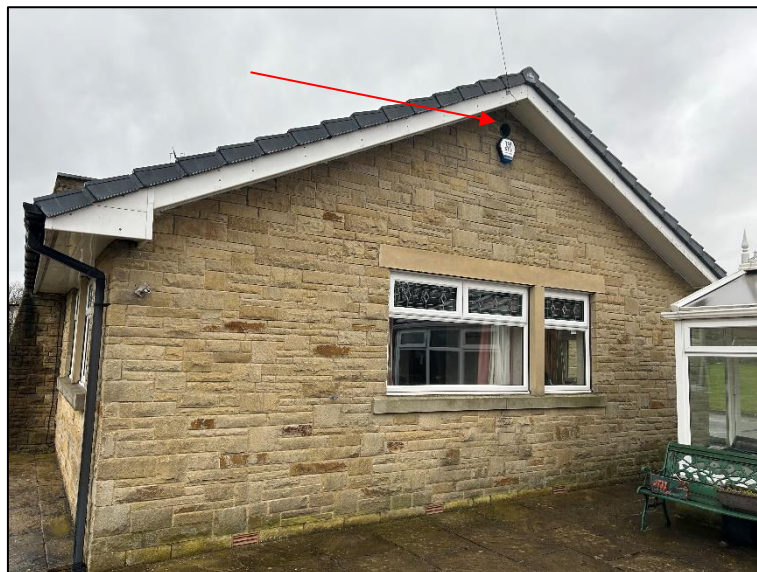
3.3.4. There are two ventilation holes in the gables of the building, both of these were visibly sealed internally and therefore do not offer access for roosting bats, however may be used externally by nesting birds.

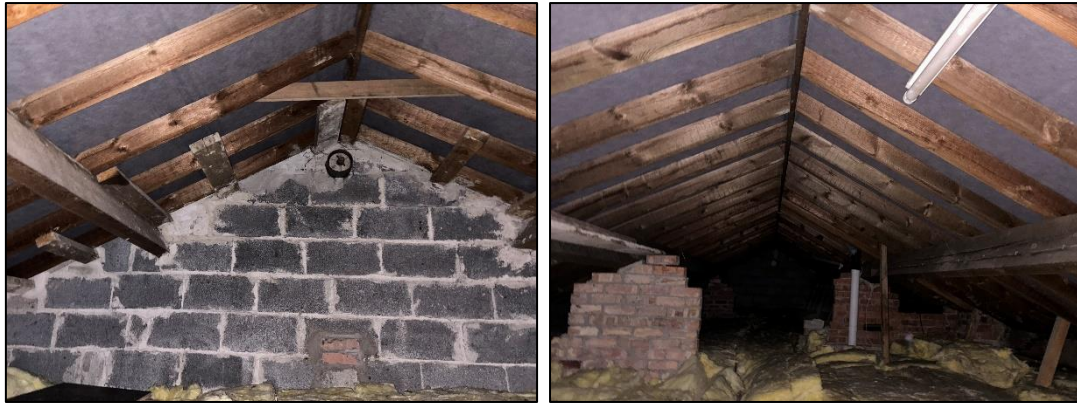
3.3.5. Internally, access was available to inspect the entirety of the loft space with no bat field signs present. The loft had timber rafters and was notably large. The roofing felt was in good condition with no visible access points or daylight showing. There were no bat feeding remains or droppings within the loft. The photographs below shows the loft space internally and also where the ventilation has been sealed.
