## **SUPPLEMENTARY PHASE 2: GROUND INVESTIGATION REPORT**

### **PROPOSED RESIDENTIAL DEVELOPMENT 'MAPPLEWELL 2'**

### **LAND NORTH EAST OF WAKEFIELD ROAD**

**Project No: 26-405**

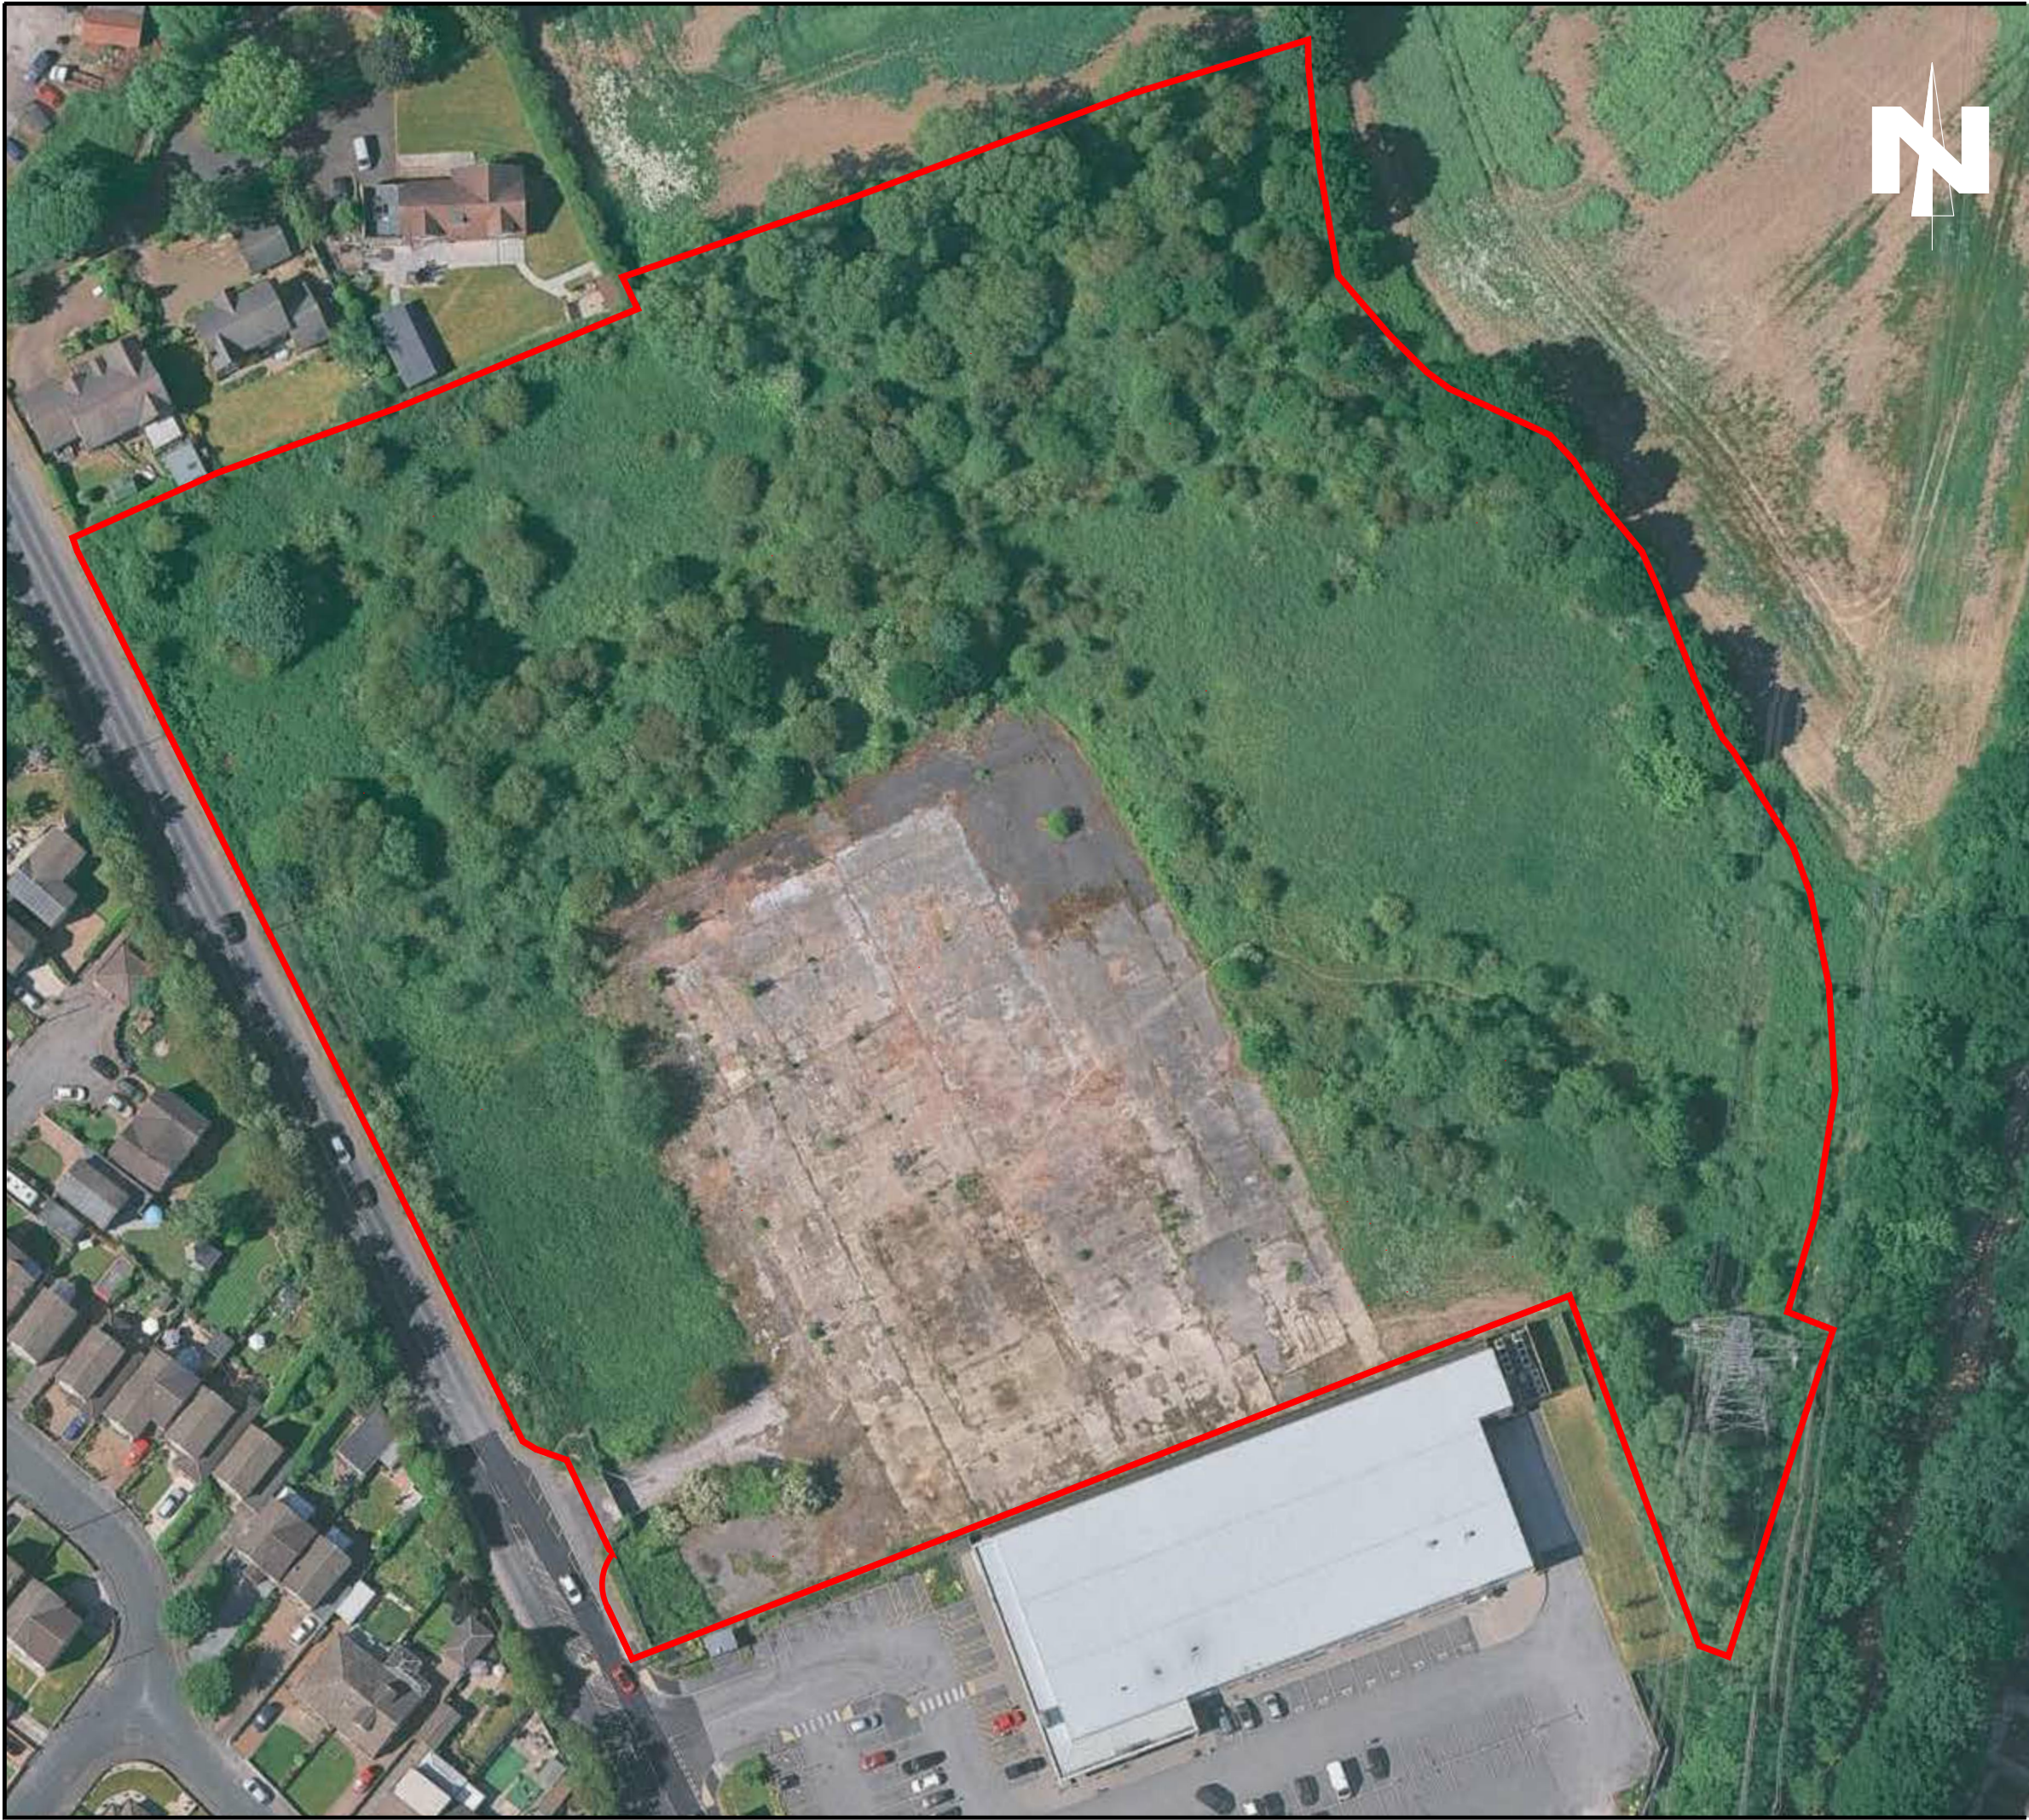
The positions of these investigation locations can be seen on the Existing and Proposed Exploratory Hole Location Plan, copies of which is attached in Appendix I. It should be noted that this plan is for orientating purposes only, as the plan is not to a standard scale.
